APPENDIX B

Photographs

Concord River Diadromous Fish Restoration Feasibility Study

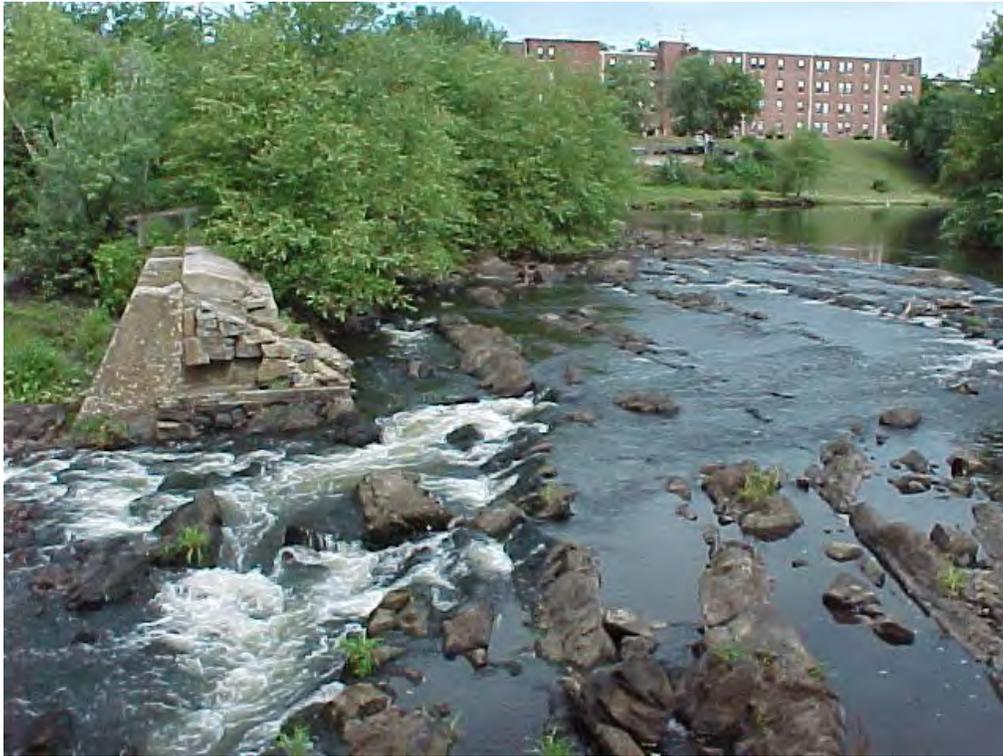
Photo 1: Middlesex Falls – Main Channel

Looking upstream from left bank during low flow period (McKeon, 2002)

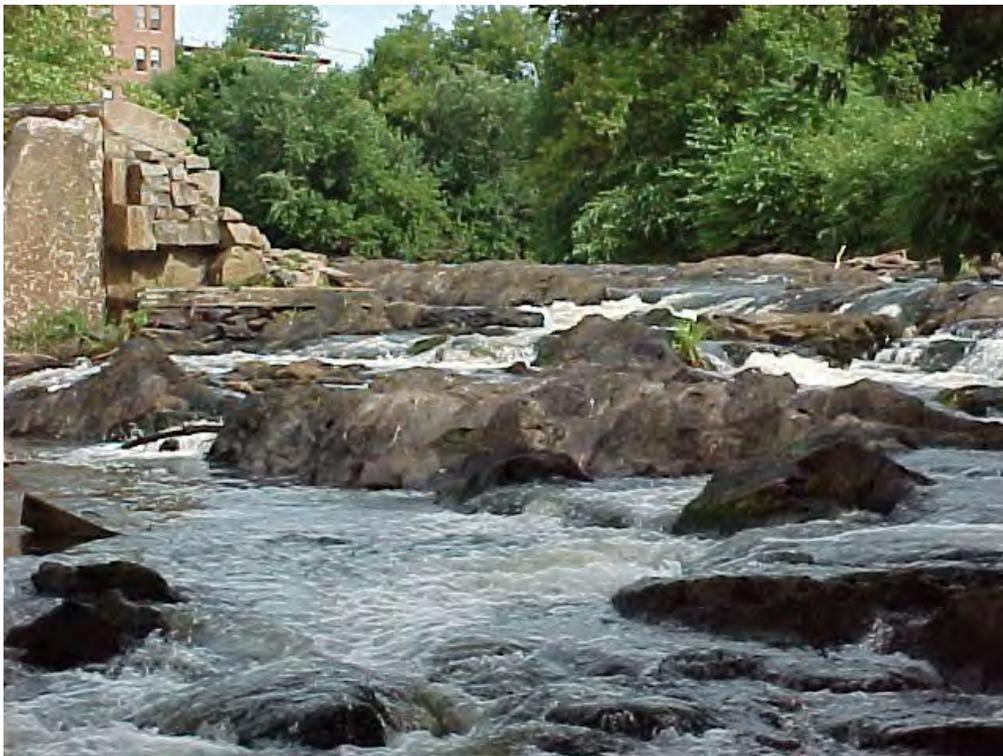
Photo 2: Middlesex Falls – Main Channel

Close-up of ledge during low flow period (McKeon, 2002)

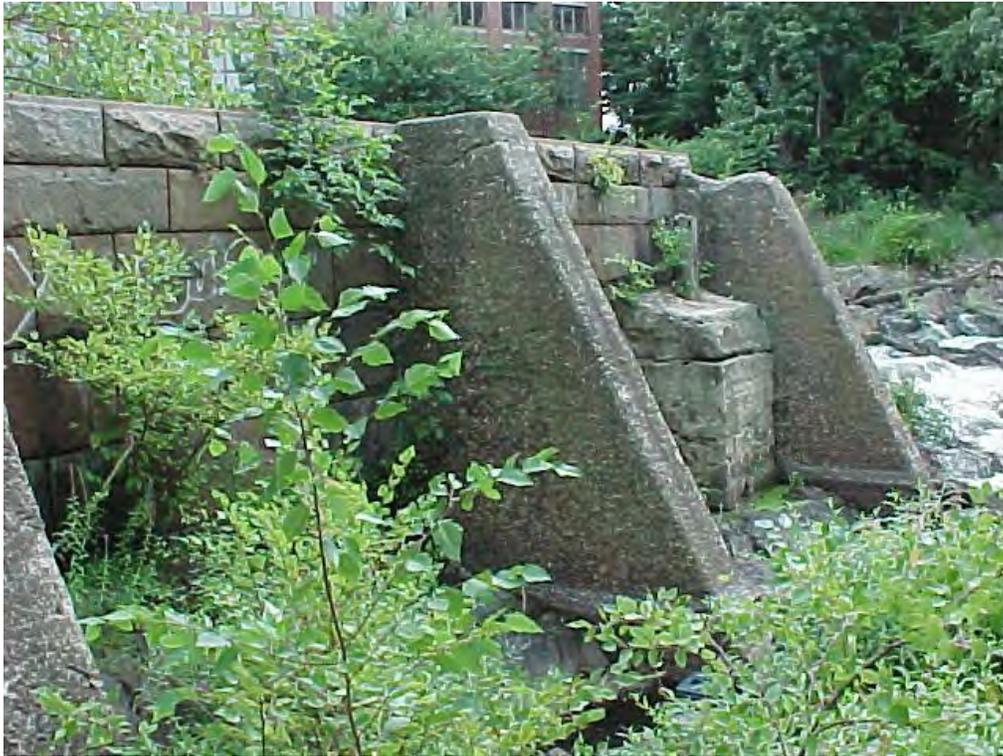
Photo 3: Middlesex Falls – Former Dams

Downstream face of former right Middlesex Dam abutment (McKeon, 2002)

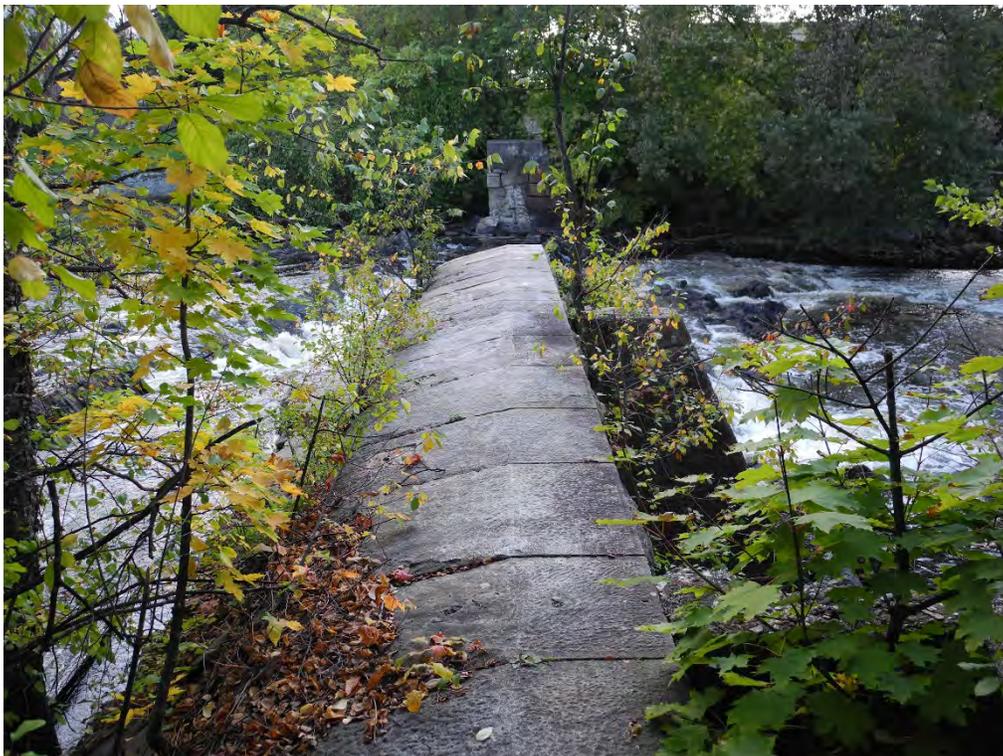
Photo 4: Middlesex Falls – Former Dam Abutments

Looking toward river left bank/abutment from left dam abutment (GSE, 10/6/14)

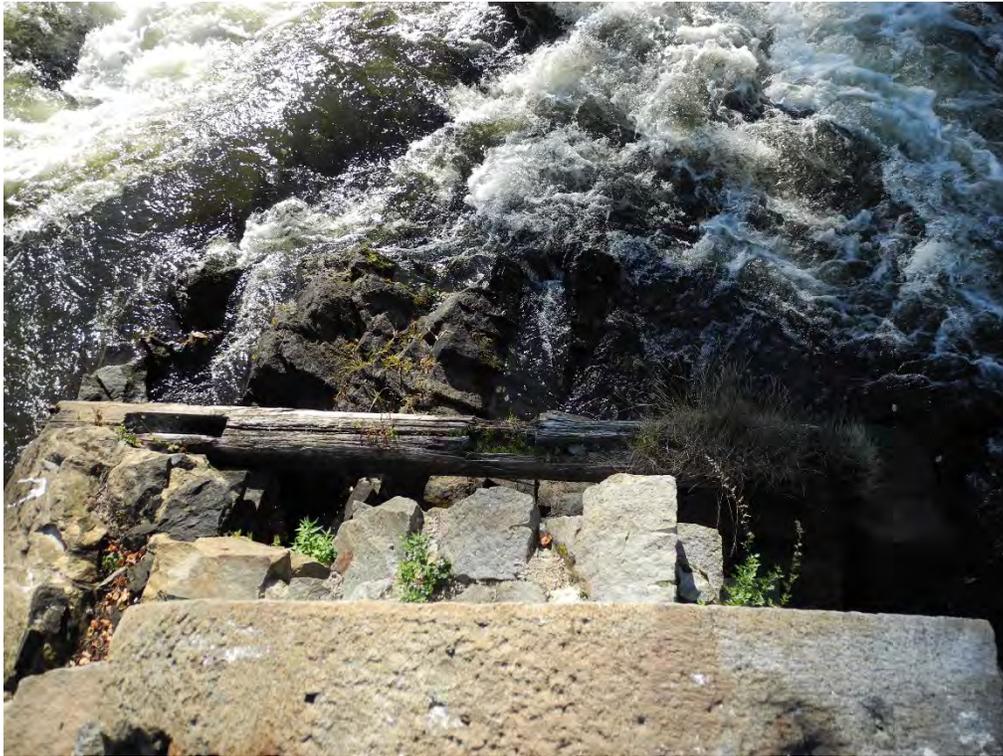
Photo 5: Middlesex Falls – Former Dam Abutments

Looking down at toe of right abutment from top of abutment (GSE, 10/6/14)

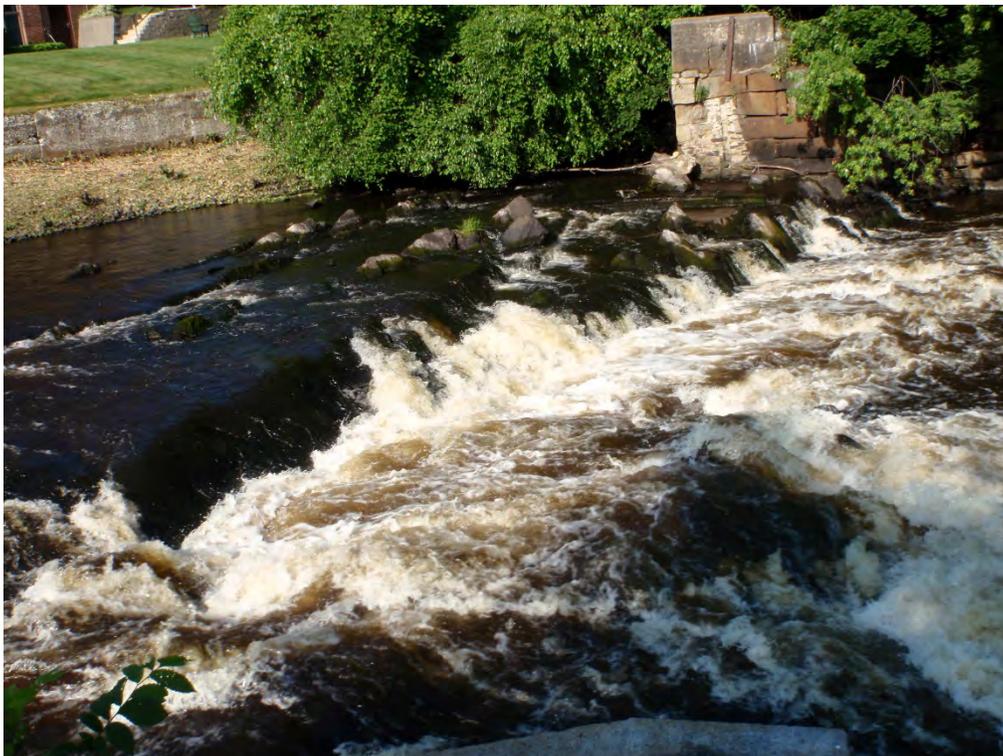
Photo 6: Middlesex Falls – Former Dam Abutments

Looking toward river left bank/abutment from right abutment (NOAA, 6/21/12)

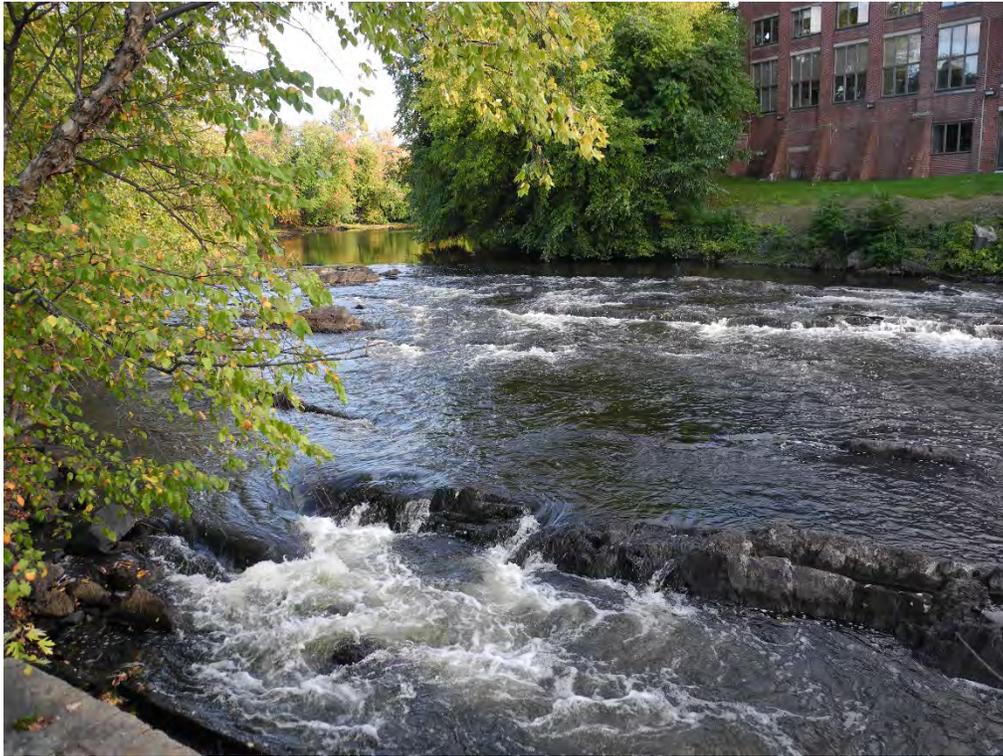
Photo 7: Middlesex Falls – Main Channel

Looking upstream from right abutment (GSE, 10/6/14)

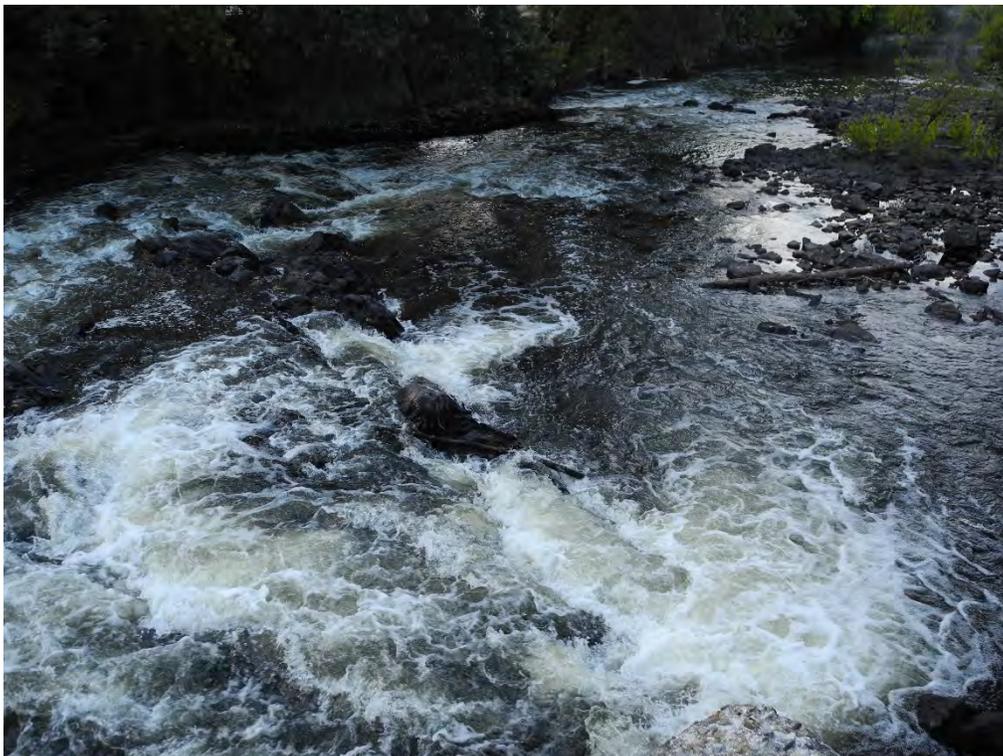
Photo 8: Middlesex Falls – Main Channel

Looking downstream from right abutment (GSE, 10/6/14)

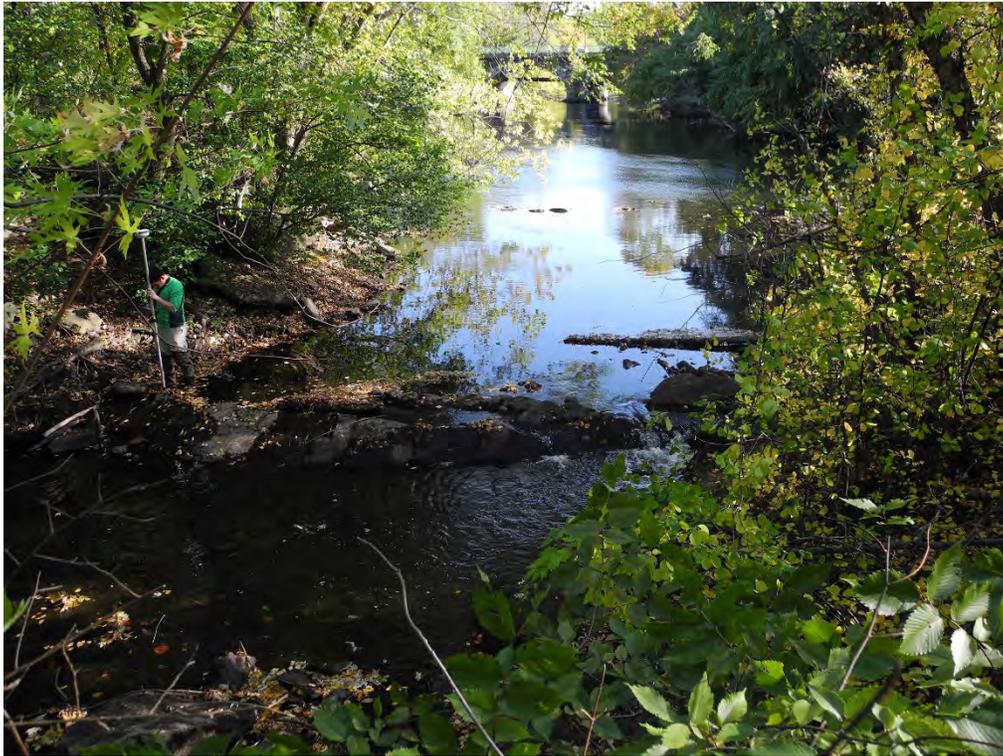
Photo 9: Middlesex Falls – Former Raceway

Looking upstream at former raceway inlet; Church St bridge in background (GSE, 10/6/14)

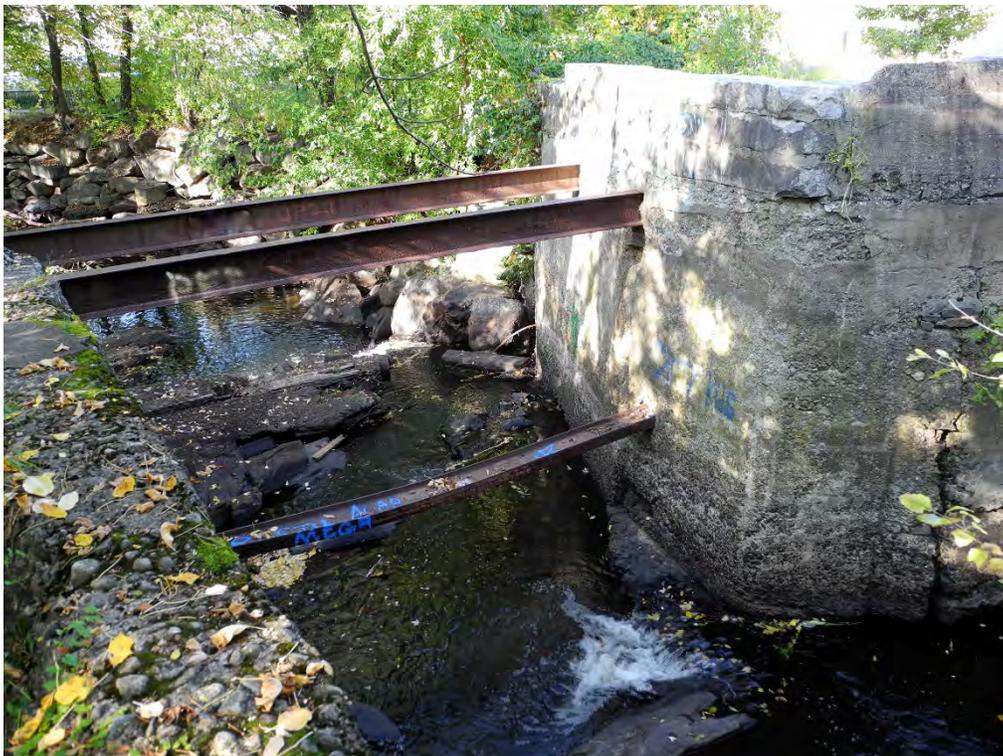
Photo 10: Middlesex Falls – Former Raceway

Looking downstream through former raceway structures (GSE, 10/6/14)

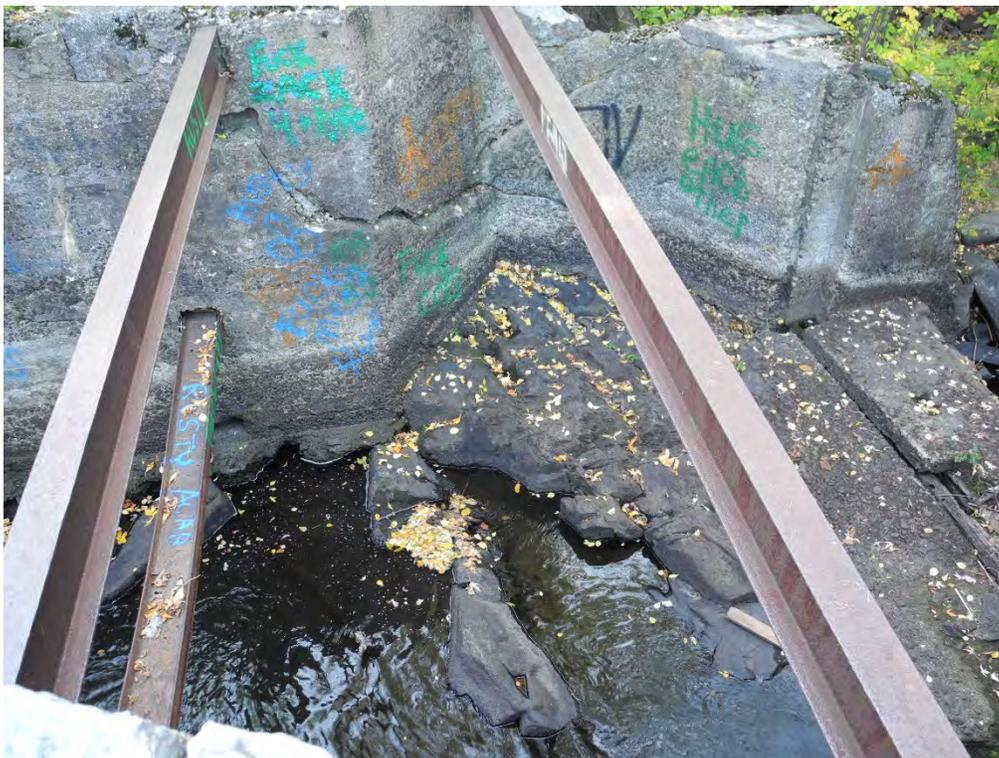
Photo 11: Middlesex Falls – Former Raceway

Looking across steel beams to left channel wall in former raceway (GSE, 10/6/14)

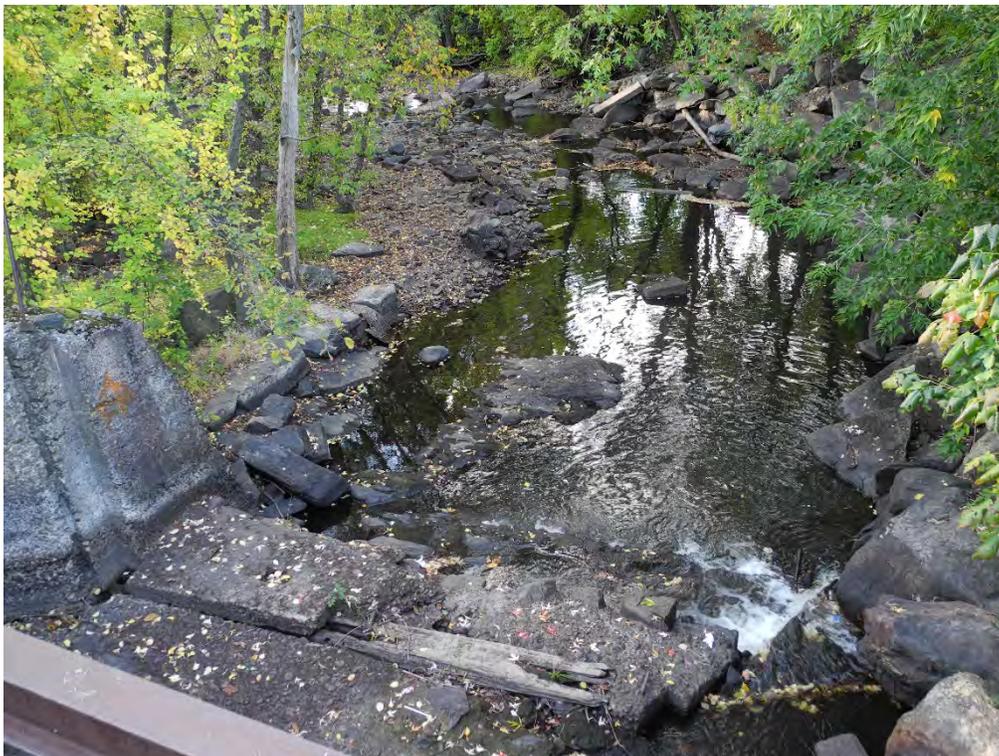
Photo 12: Middlesex Falls – Former Raceway

Looking downstream from outlet of former raceway; note concrete sill (GSE, 10/6/14)

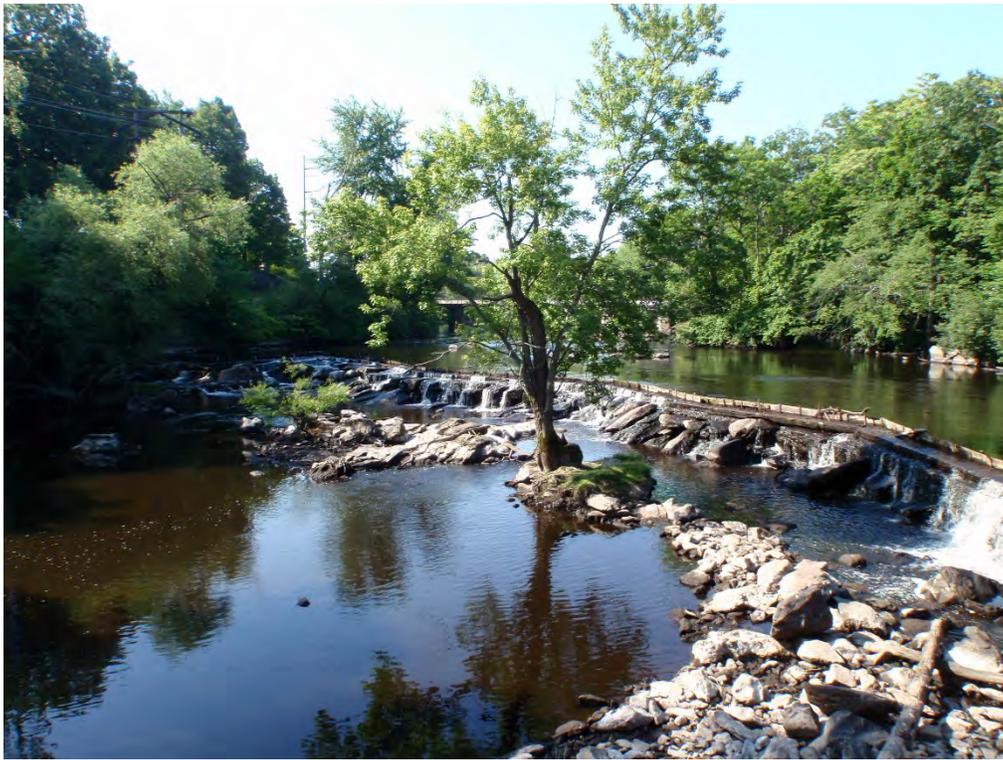
Photo 13: Centennial Falls Dam – Spillway

Looking upstream (NOAA, 6/21/12)

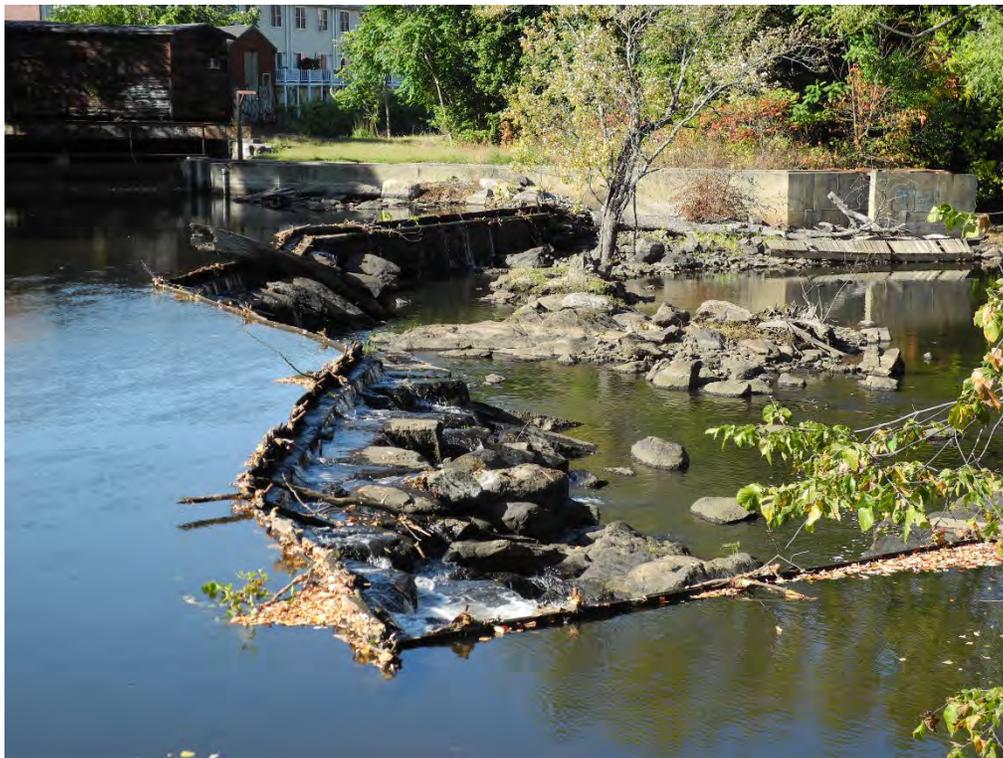
Photo 14: Centennial Falls Dam – Spillway

Looking toward river-left bank, with fishway and gatehouse in background (GSE, 10/6/14)

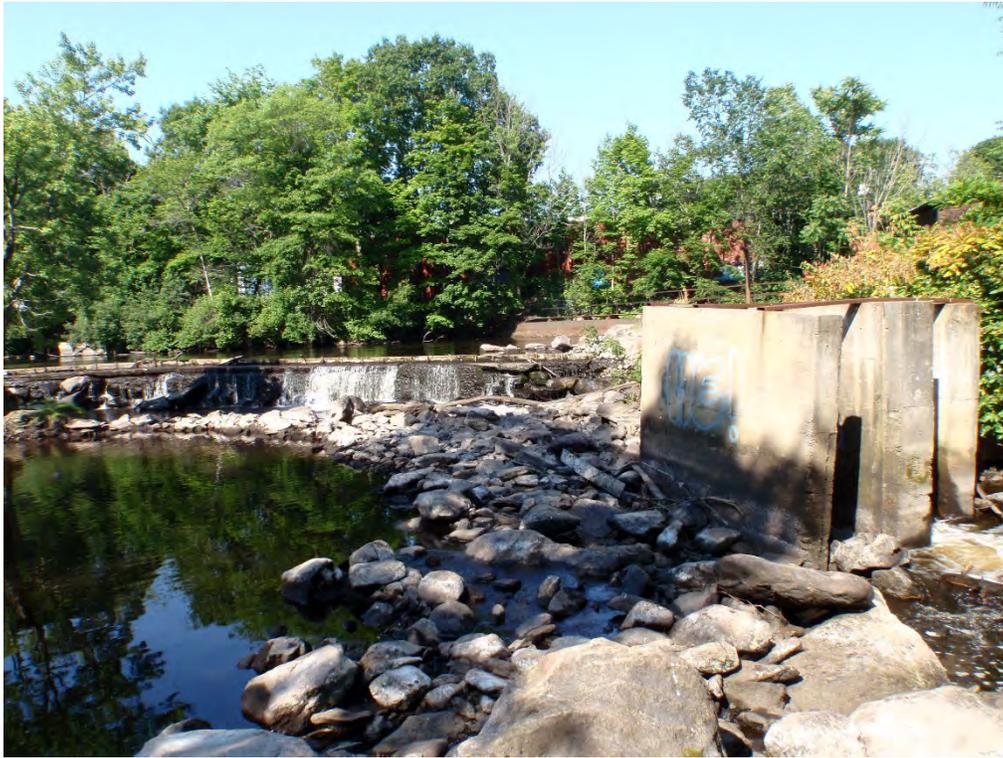
Photo 15: Centennial Falls Dam – Fishway

Looking upstream at non-overflow section (left) and fishway entrance (right) (NOAA; 6/21/12)

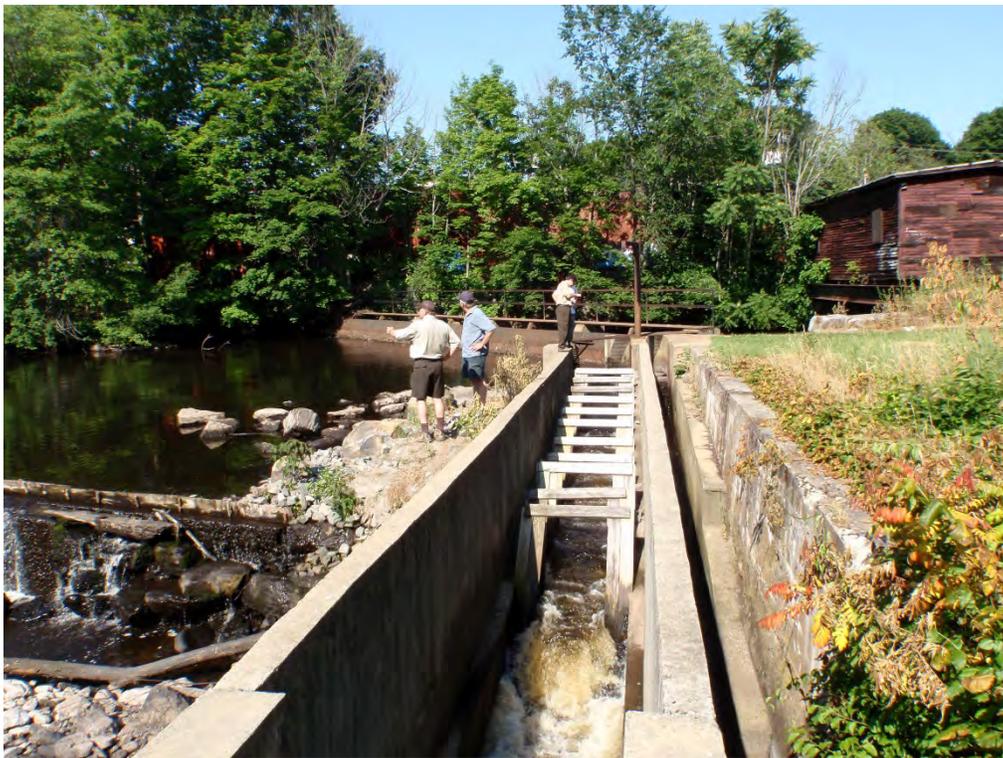
Photo 16: Centennial Falls Dam – Fishway

Looking upstream. Note misaligned baffles (NOAA; 6/21/12)

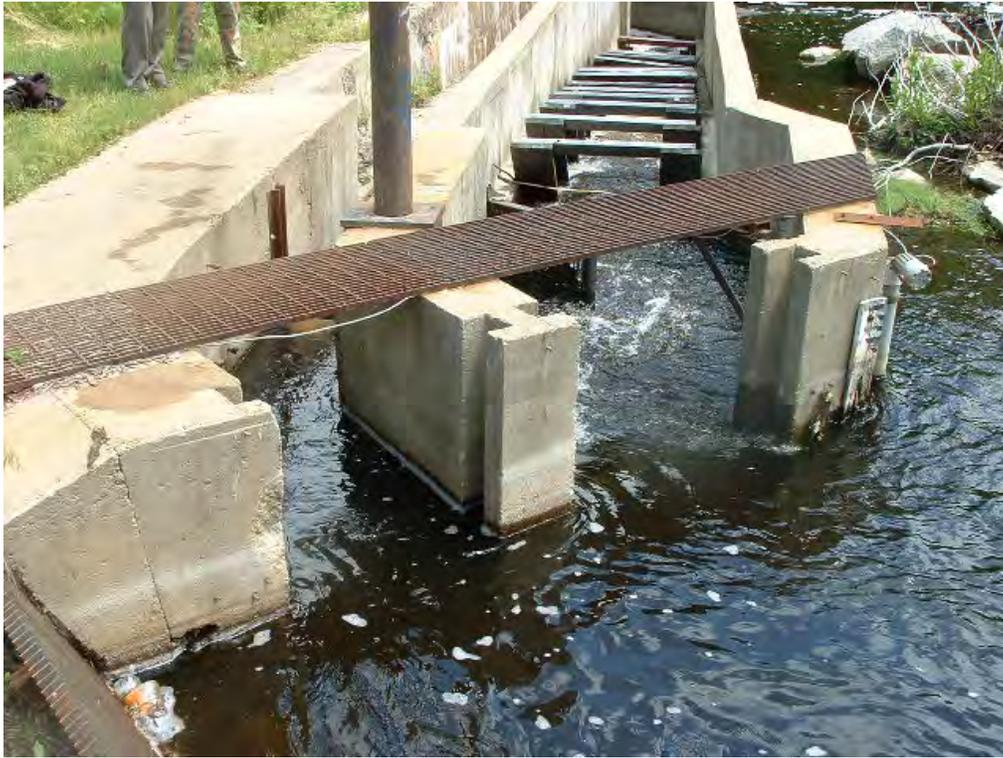
Photo 17: Centennial Falls Dam – Fishway

Looking downstream. Canal trashrack on left, bypass entrance center, Denil exit on right (USFWS, 2004)

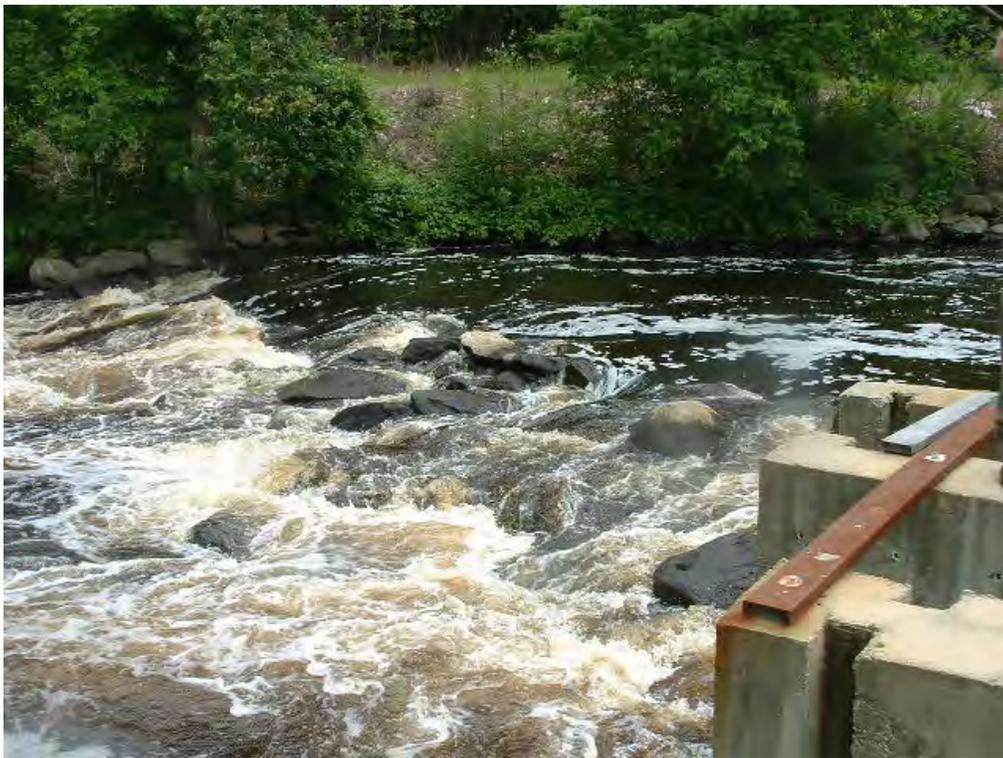
Photo 18: Centennial Falls Dam – Fishway Barrier Dam

Denil entrance in foreground with non-overflow section behind; flow approximately 650 cfs (USFWS, 2004)

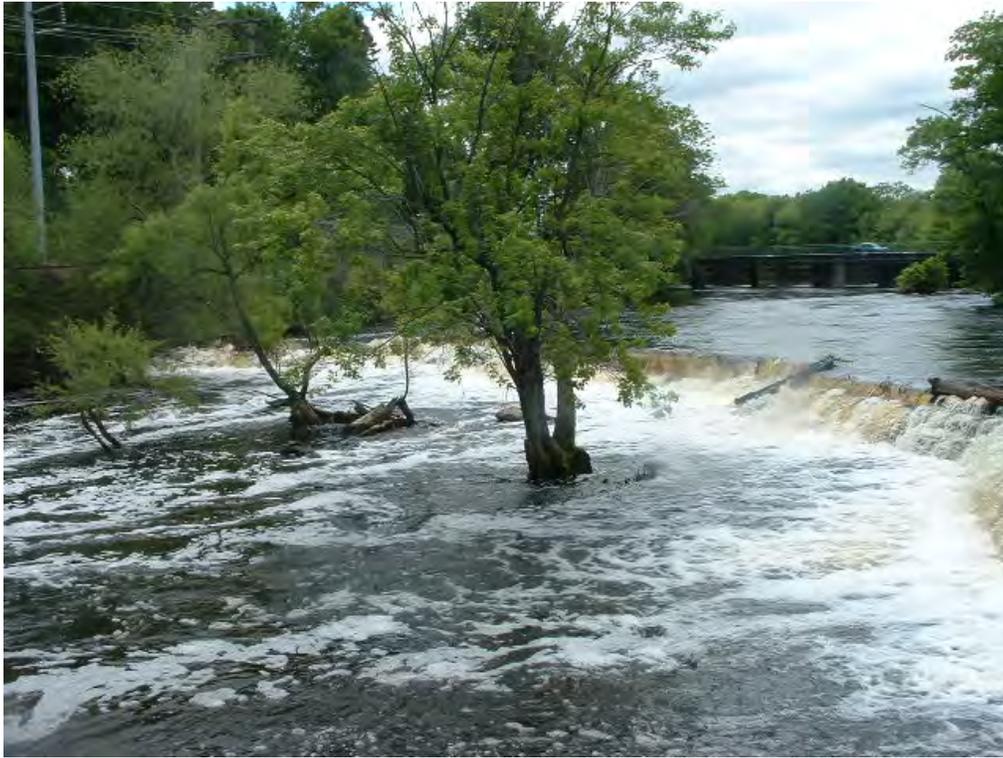
Photo 19: Centennial Falls Dam – High Flow

Looking upstream; flow approximately 1,050 cfs at Concord, MA gage (6/16/03, USFWS)

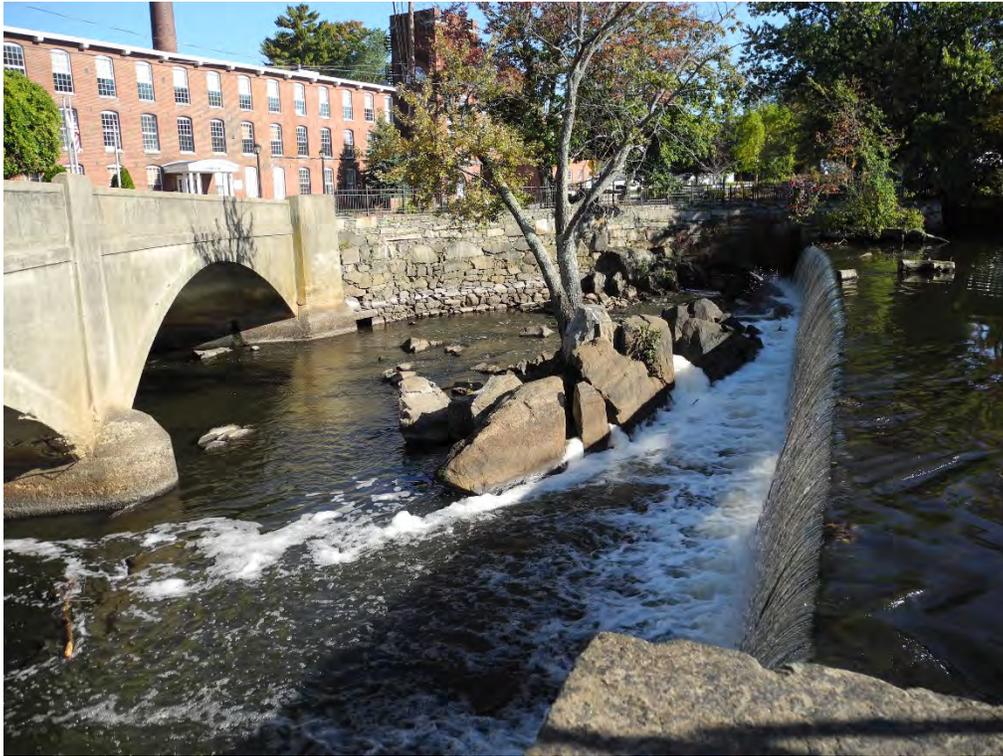
Photo 21: Talbot Mills Dam – Spillway

Looking downstream toward Faulkner Street bridge from left abutment (GSE, 10/6/14)

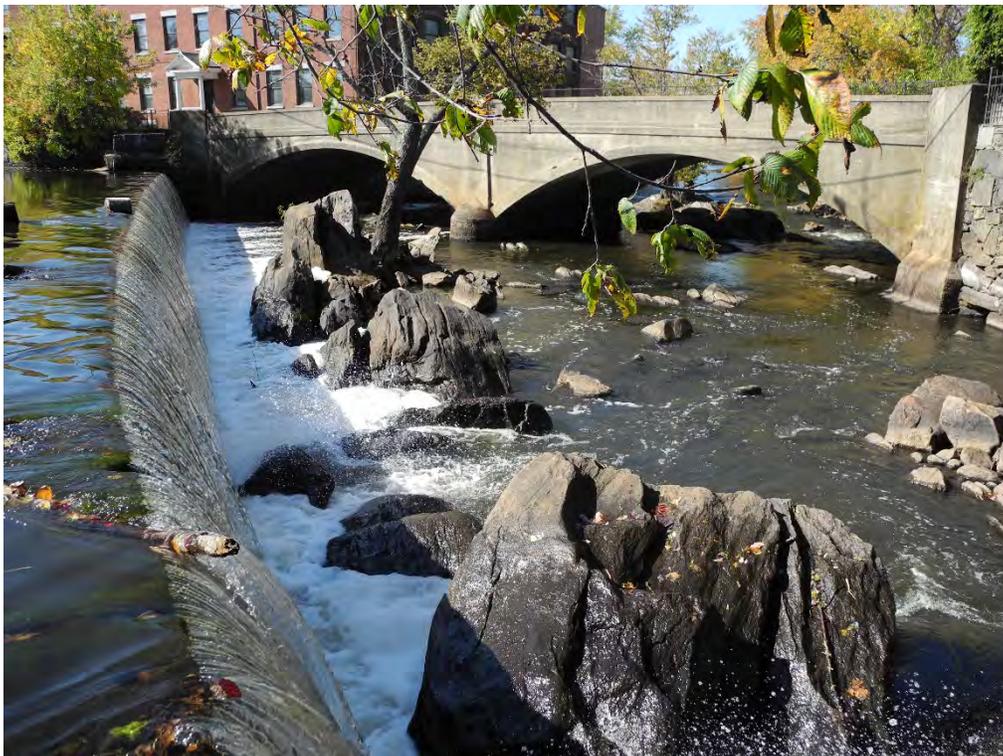
Photo 22: Talbot Mills Dam – Spillway

Looking downstream toward Faulkner Street bridge from right abutment (GSE, 10/6/14)

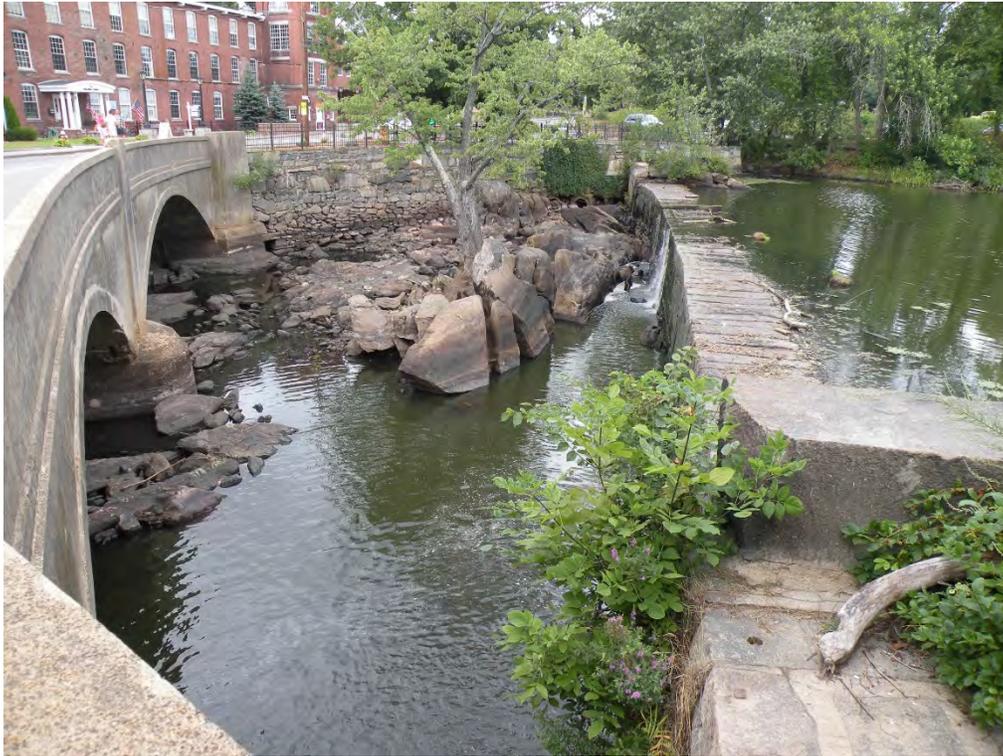
Photo 23: Talbot Mills Dam – Spillway

Looking from left abutment during extreme low flow (Reiner, 8/16/10)

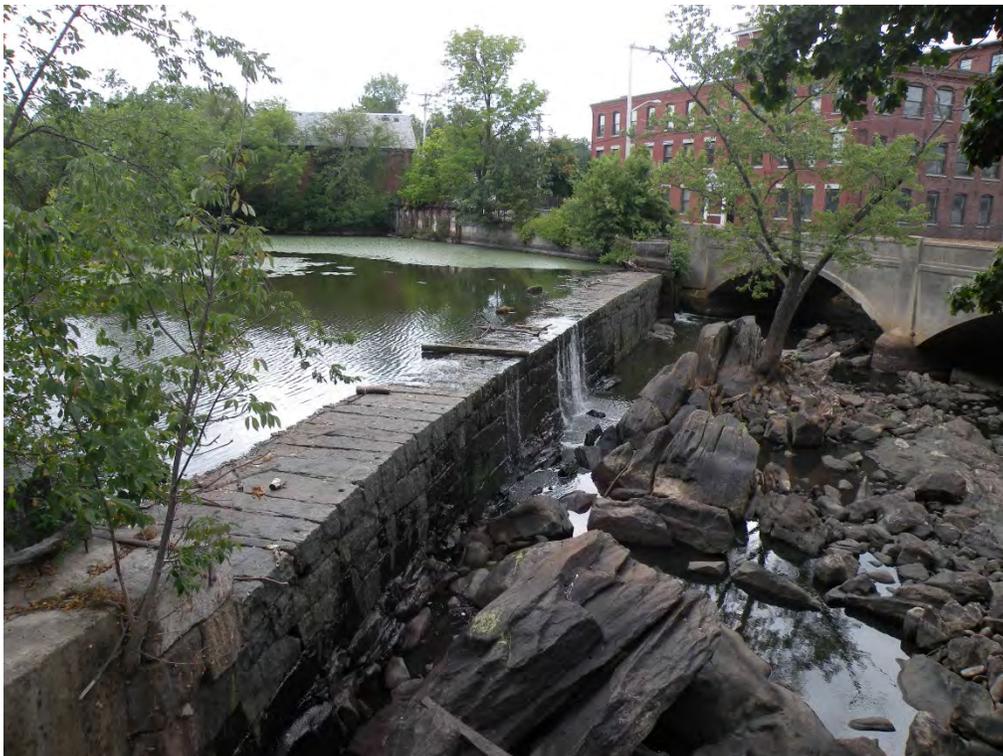
Photo 24: Talbot Mills Dam – Spillway

Looking from right abutment during extreme low flow (Reiner, 8/16/10)

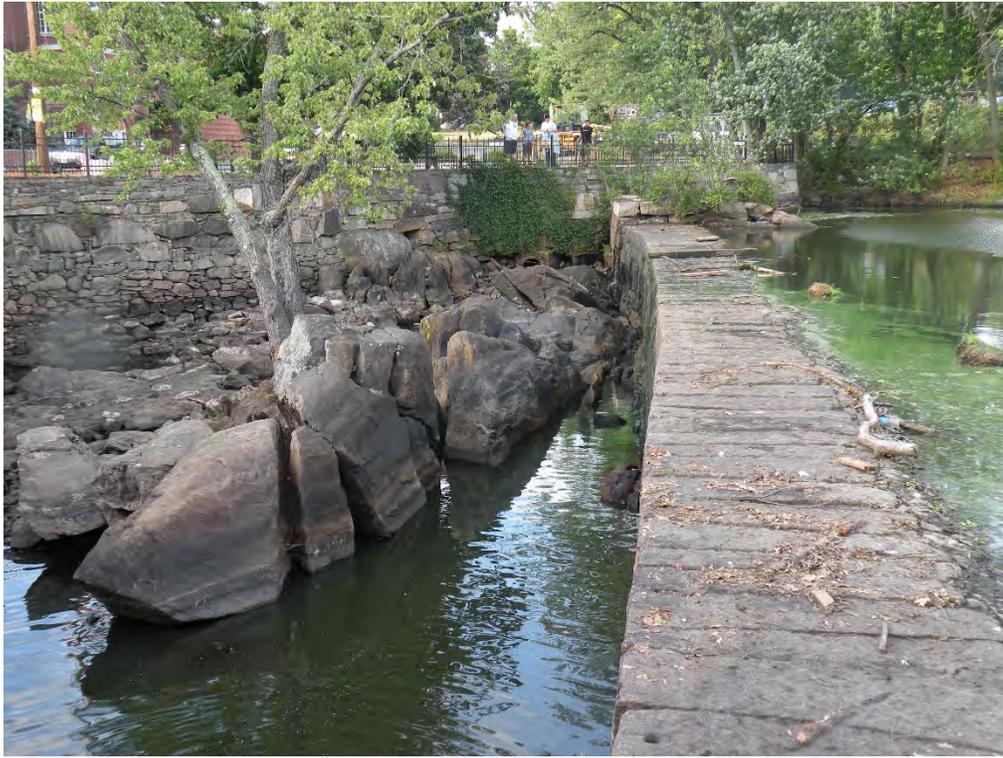
Photo 25: Talbot Mills Dam – Spillway

Looking from left abutment during extreme low flow (Reiner, 8/16/10)

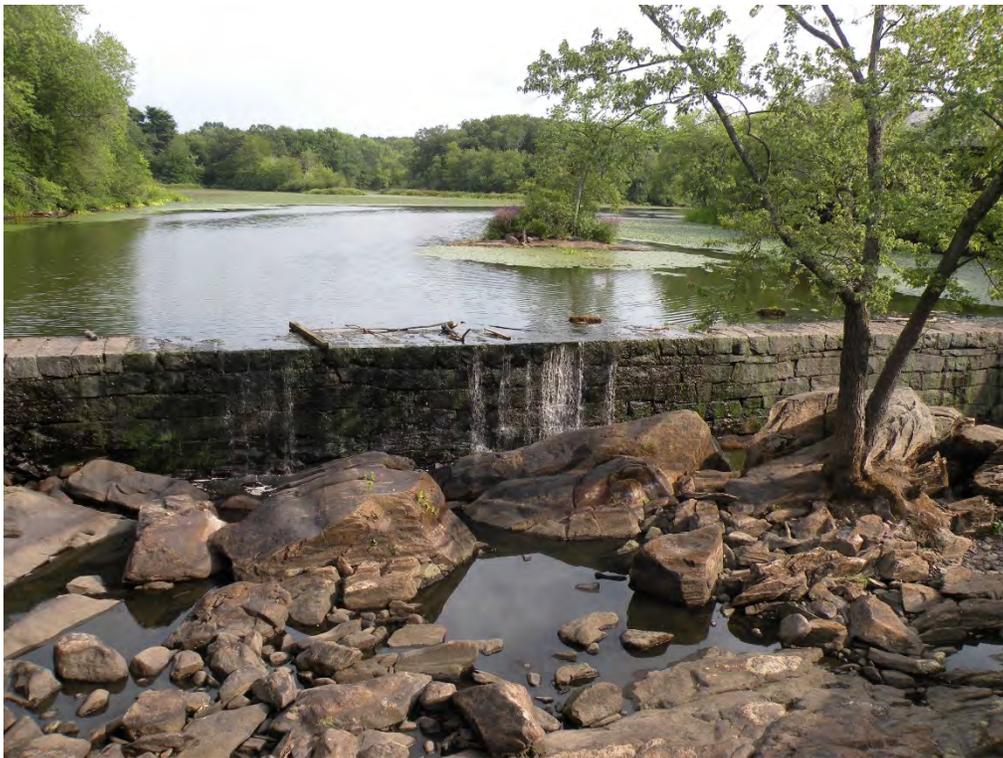
Photo 26: Talbot Mills Dam – Spillway

Looking from Faulkner Street bridge during extreme low flow (Reiner, 8/16/10)

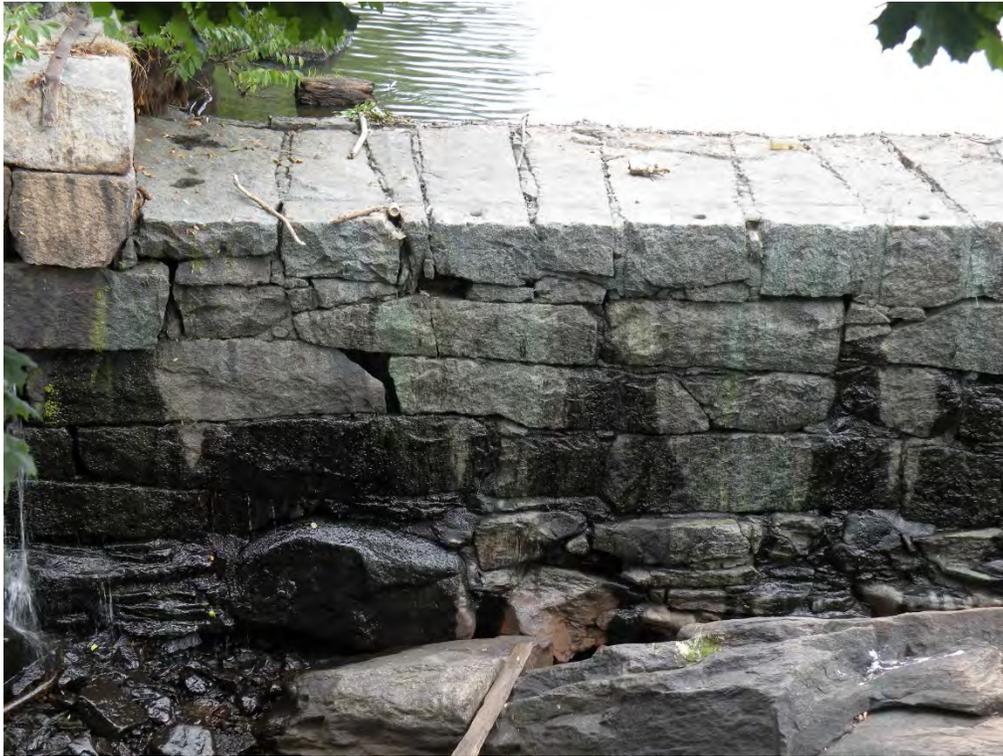
Photo 27: Talbot Mills Dam – Spillway

Close-up of right side of spillway during extreme low flow (Reiner, 8/16/10)

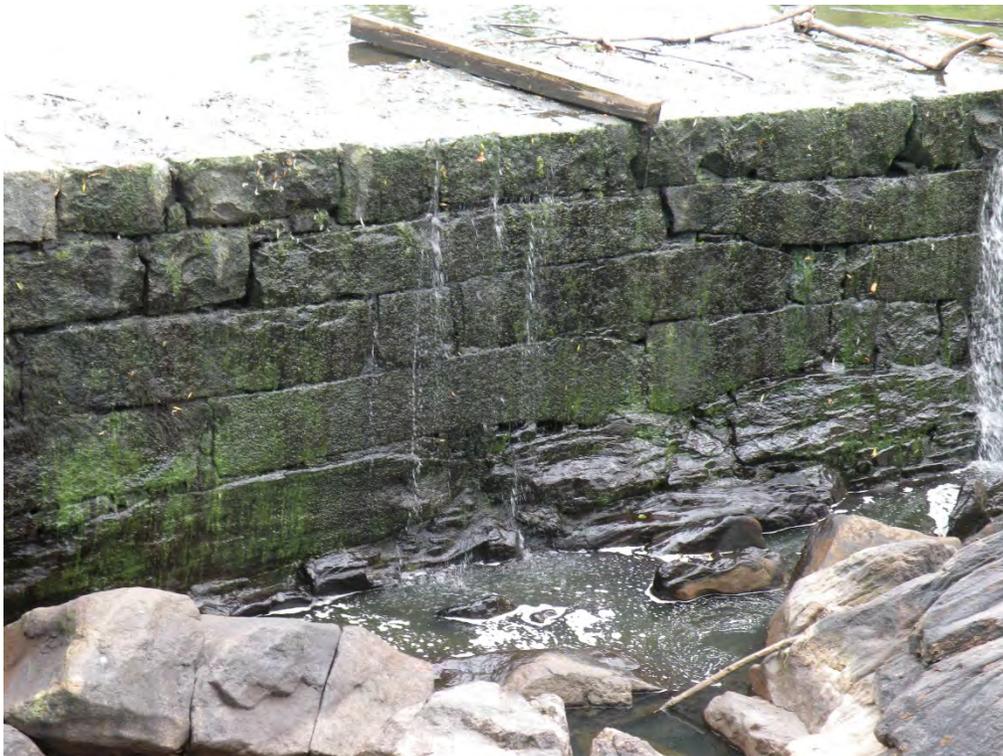
Photo 28: Talbot Mills Dam – Spillway

Close-up of center right side of spillway during extreme low flow (Reiner, 8/16/10)

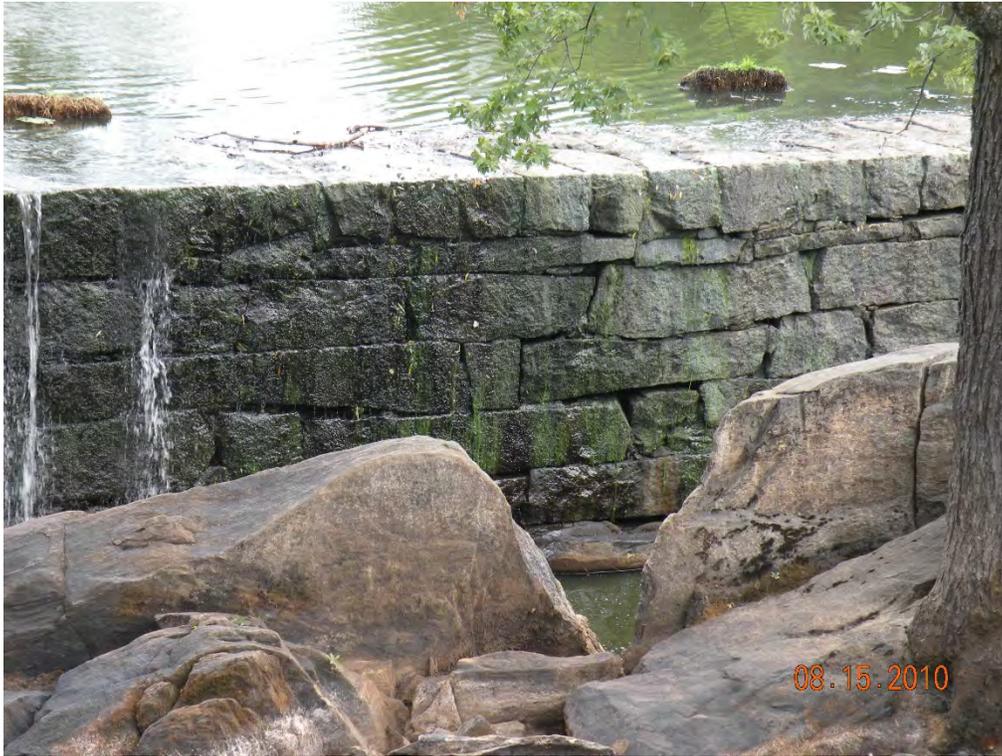
Photo 29: Talbot Mills Dam – Spillway

Close-up of center left side of spillway during extreme low flow (Reiner, 8/16/10)

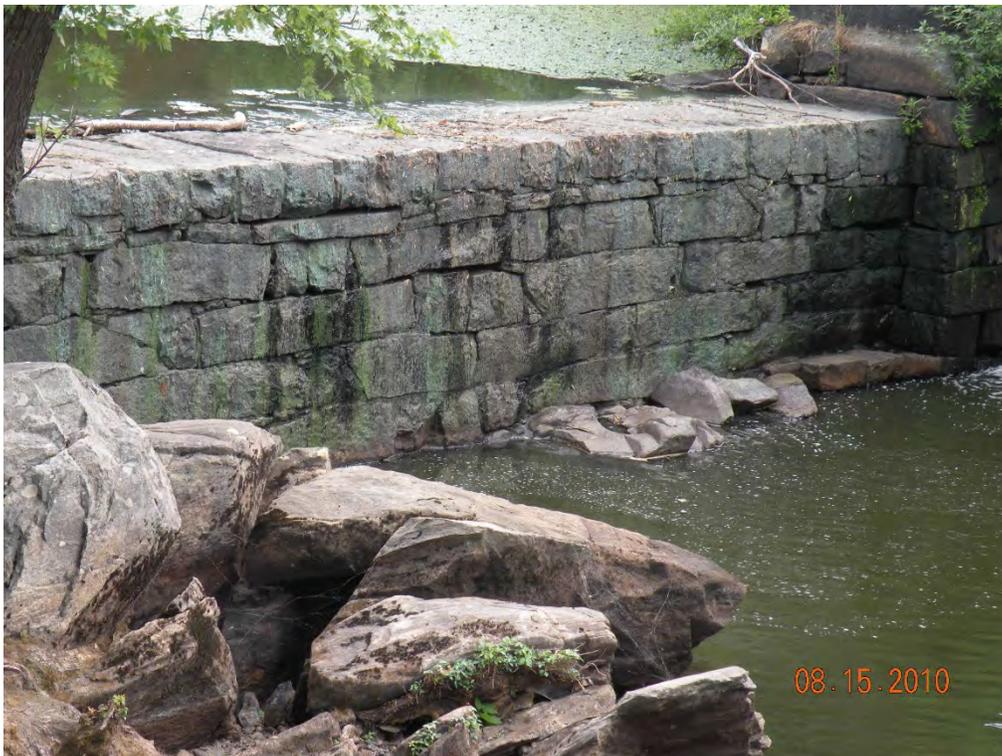
Photo 30: Talbot Mills Dam – Spillway

Close-up of left side of spillway during extreme low flow (Reiner, 8/16/10)
