APPENDIX B

Photographs

Concord River Diadromous Fish Restoration Feasibility Study

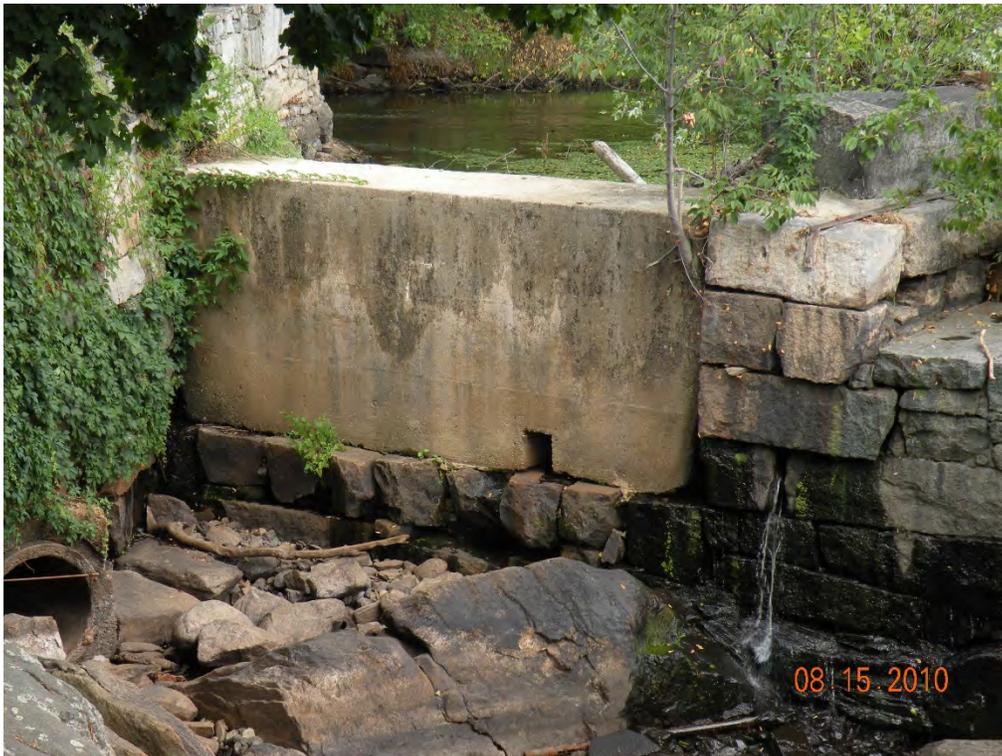
Photo 31: Talbot Mills Dam – Right Abutment

Right abutment showing concrete plug in former fishway and leakage (Reiner, 8/16/10)

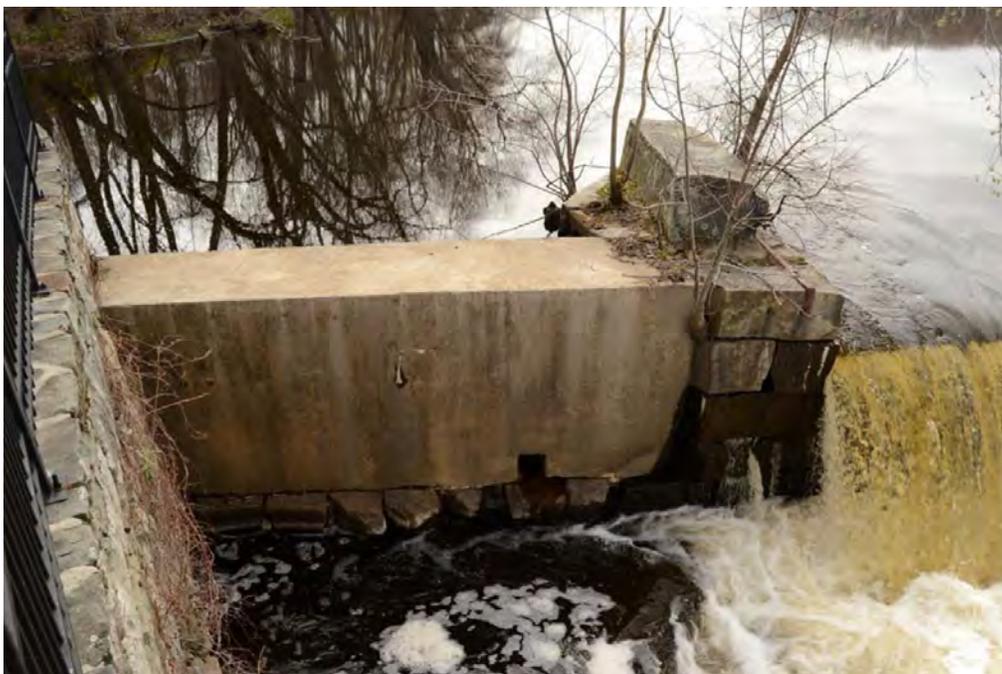
Photo 32: Talbot Mills Dam – Right Abutment

Right abutment showing granite capstone and leakage (PAL, 2015)

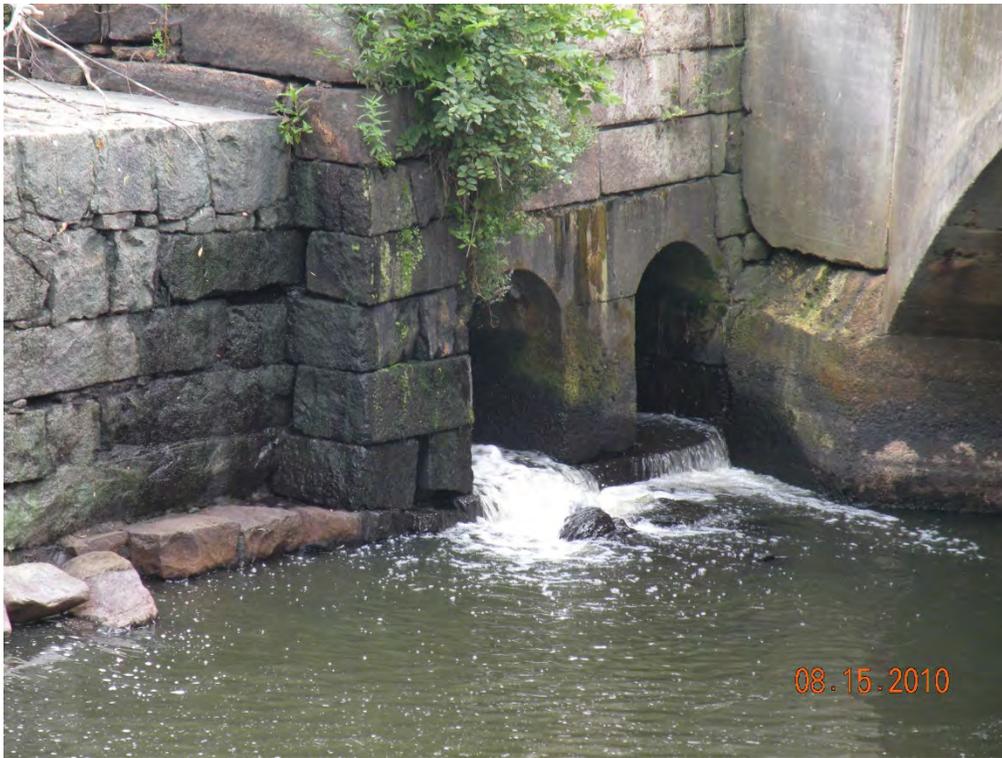
Photo 33: Talbot Mills Dam – Left Abutment

Left abutment showing leakage through inoperable low level outlets (Reiner, 8/16/10)

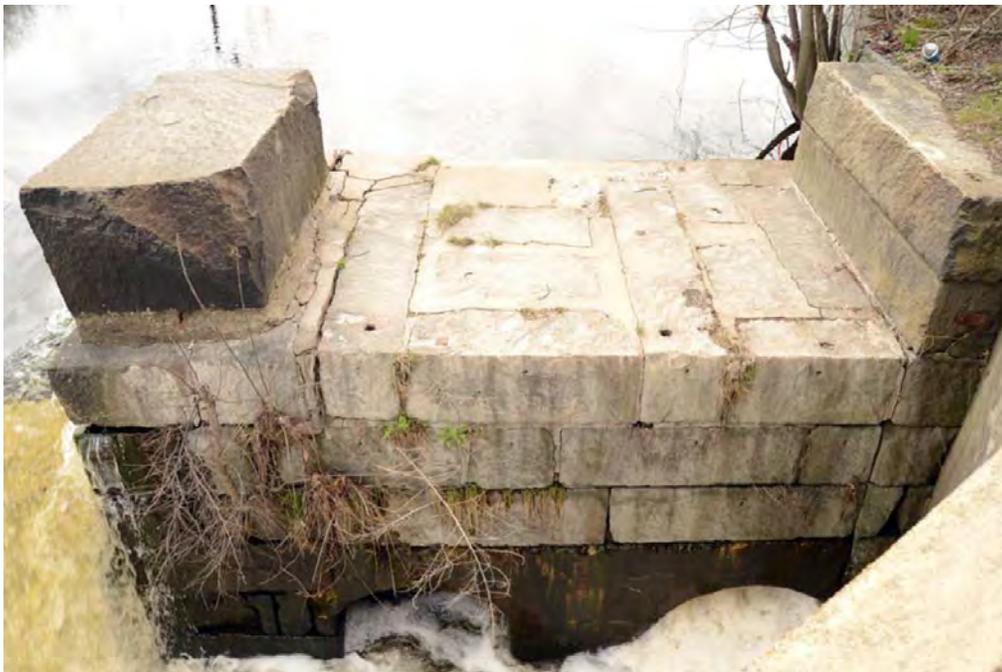
Photo 34: Talbot Mills Dam – Left Abutment

Left abutment showing granite capstone (PAL, 2015)

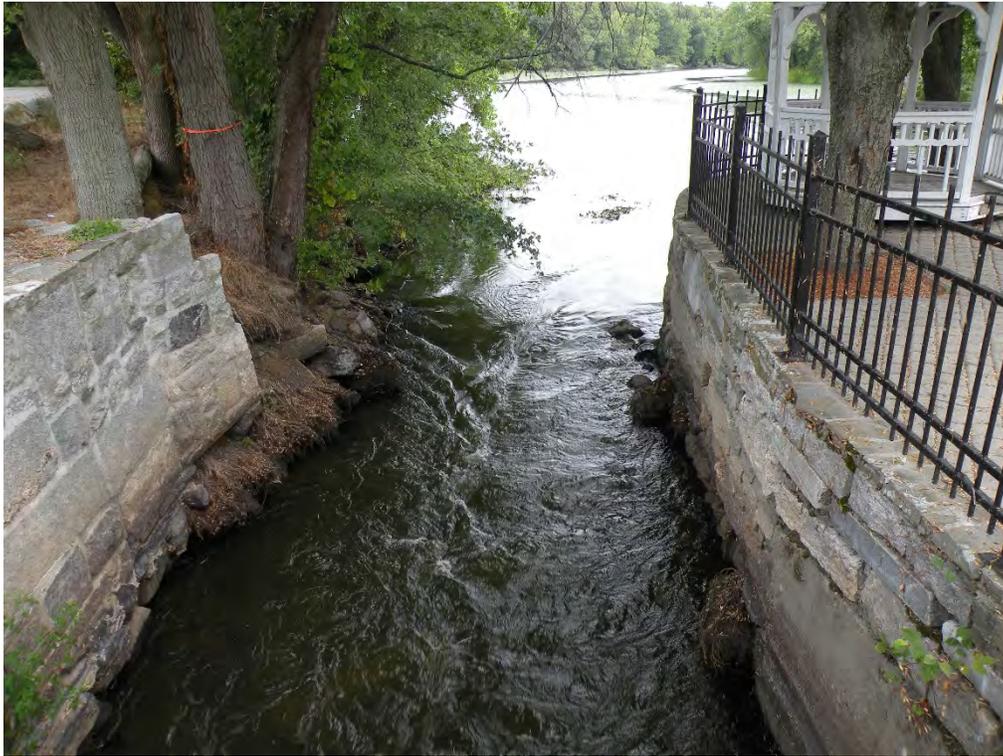
Photo 35: Talbot Mills Dam – Sluiceway

Looking upstream toward sluiceway inlet from footbridge (Reiner, 8/16/10)

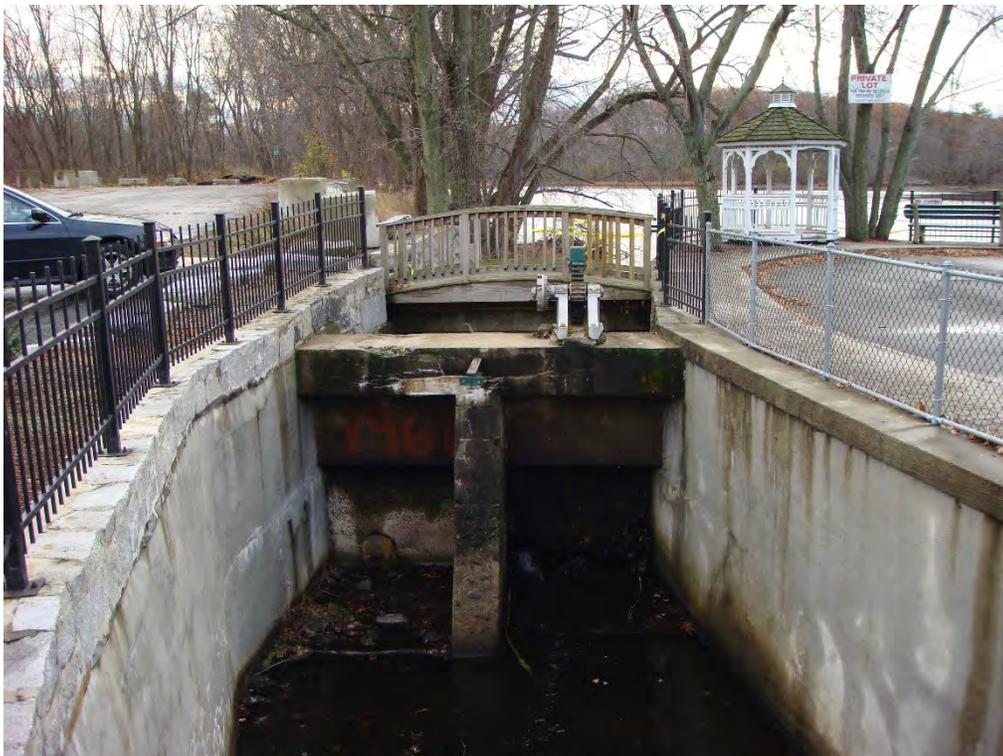
Photo 36: Talbot Mills Dam – Sluiceway

Looking upstream in sluiceway at concrete weir with sluice gate and footbridge (NOAA, 11/27/07)

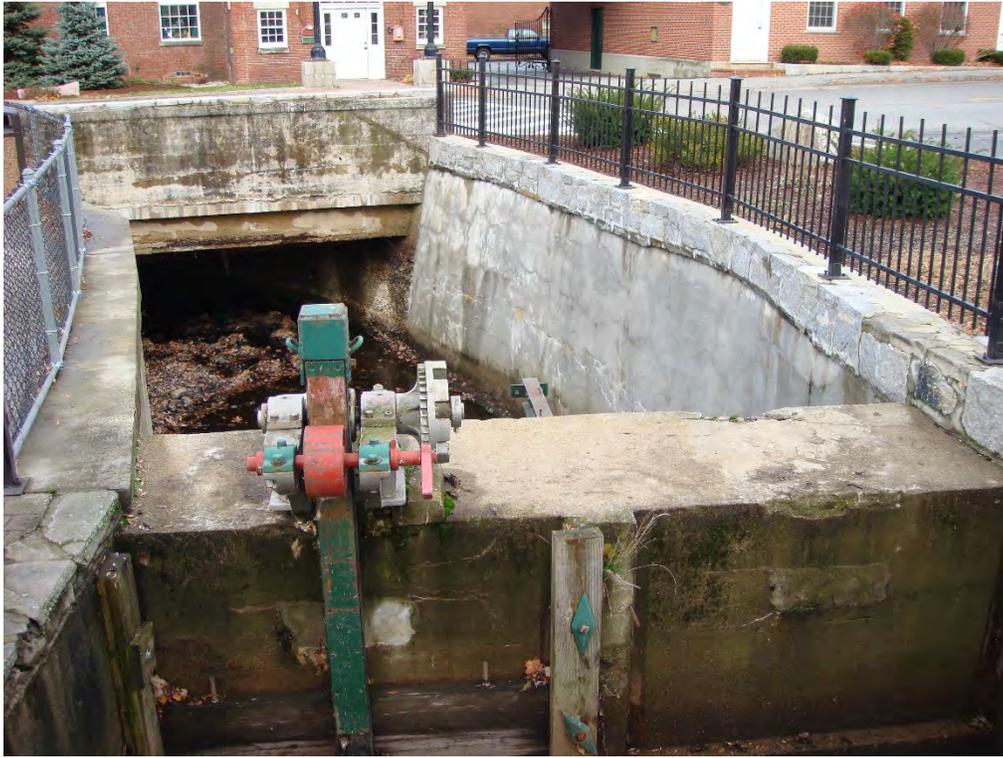
Photo 37: Talbot Mills Dam – Sluiceway

Looking downstream in sluiceway at concrete weir with sluice gate and Faulkner Street beyond (NOAA, 11/27/07)

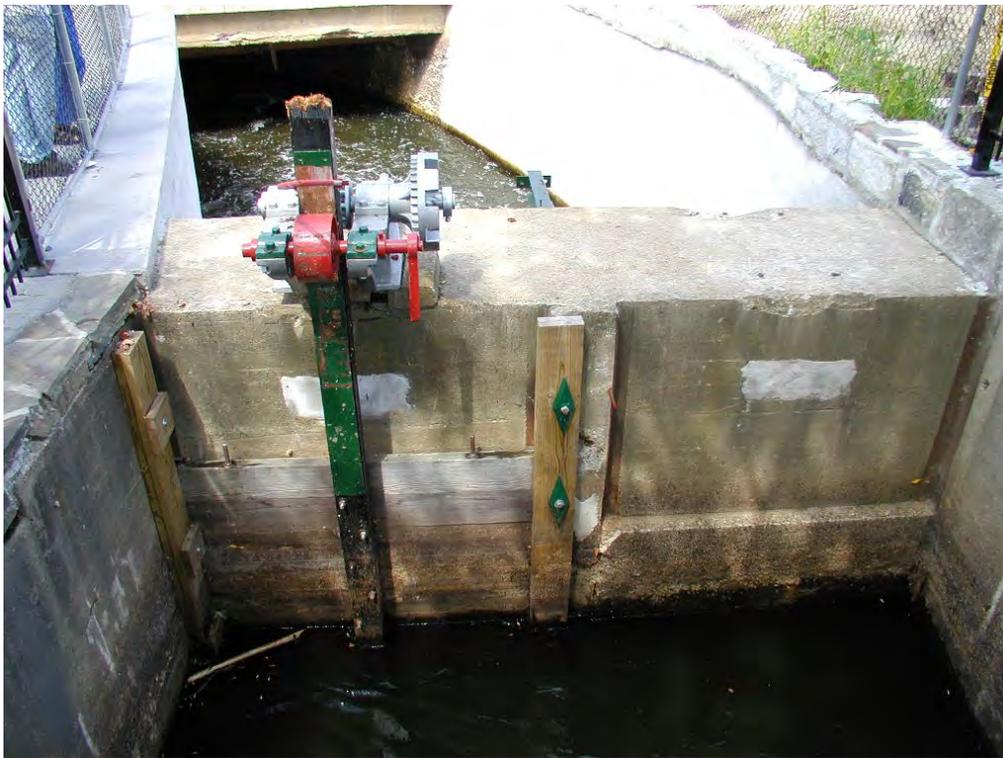
Photo 38: Talbot Mills Dam – Sluiceway

Close-up of upstream face of sluice gate (Reiner, 8/23/02)

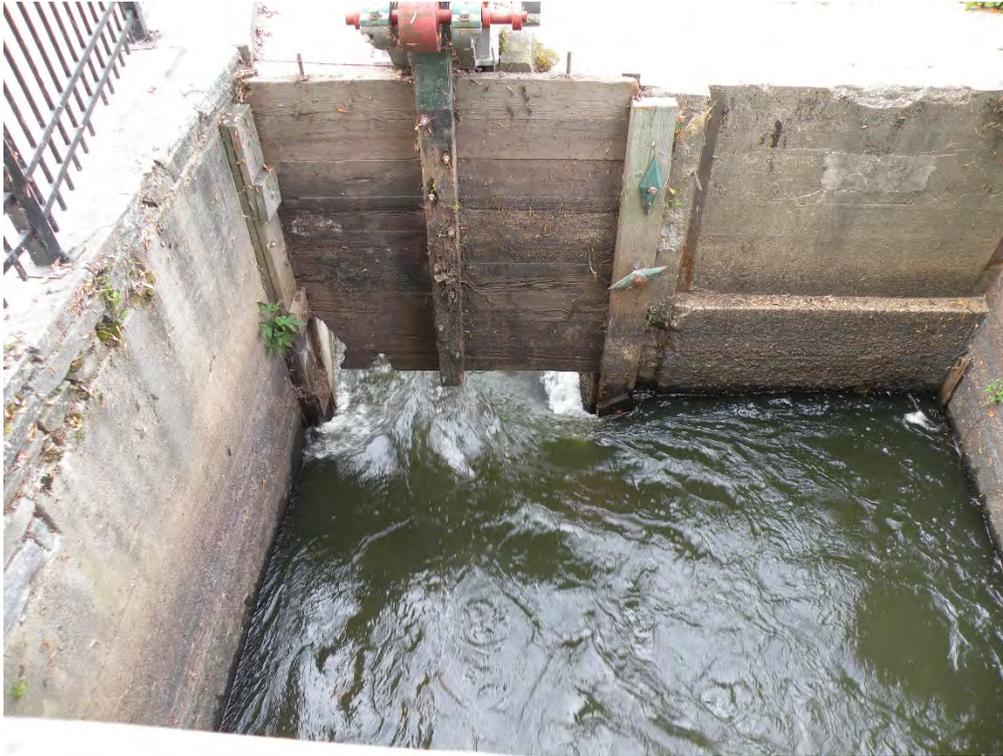
Photo 39: Talbot Mills Dam – Sluiceway

Upstream face of sluice gate in open position during low flow showing rotted sections (Reiner, 8/16/10)

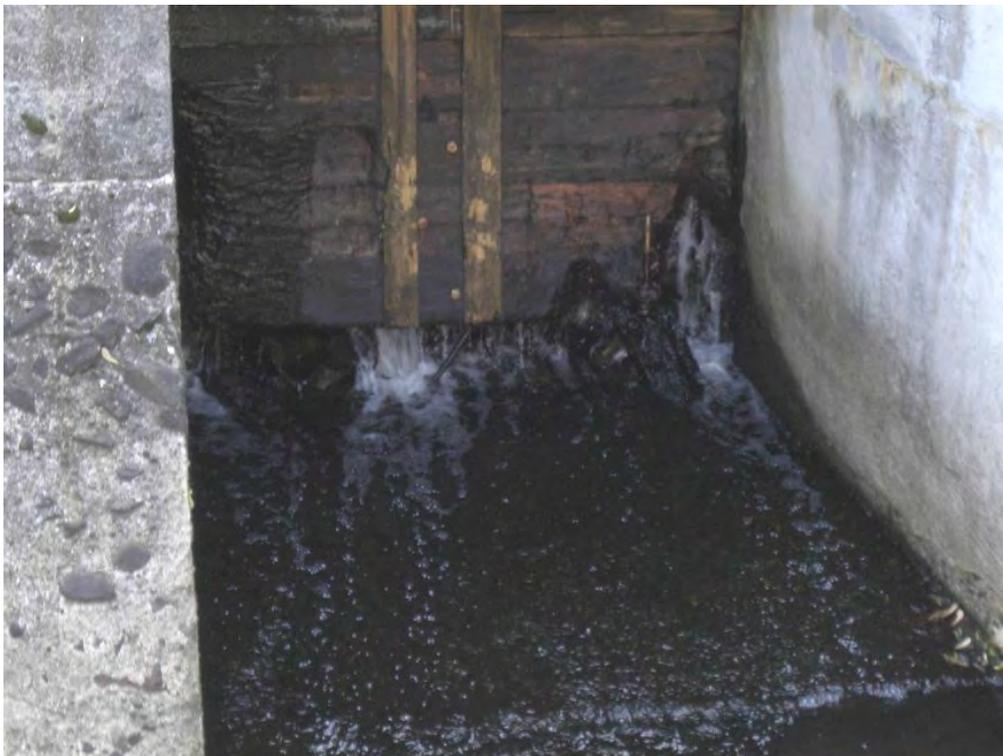
Photo 40: Talbot Mills Dam – Sluiceway

Close-up of downstream face of sluice gate in closed position showing leakage (Geotechnical Consultants, 2015)

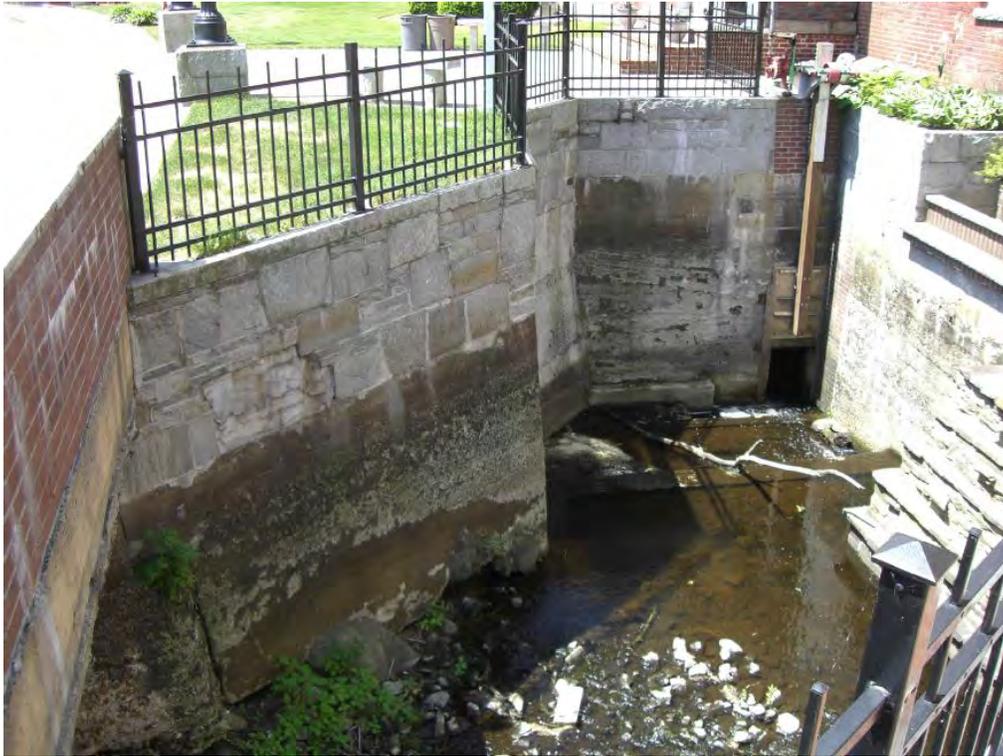
Photo 41: Talbot Mills Dam – Stilling Basin

Looking downstream in stilling basin toward outlet gate to Faulkner Mill (Geotechnical Consultants, 2015)

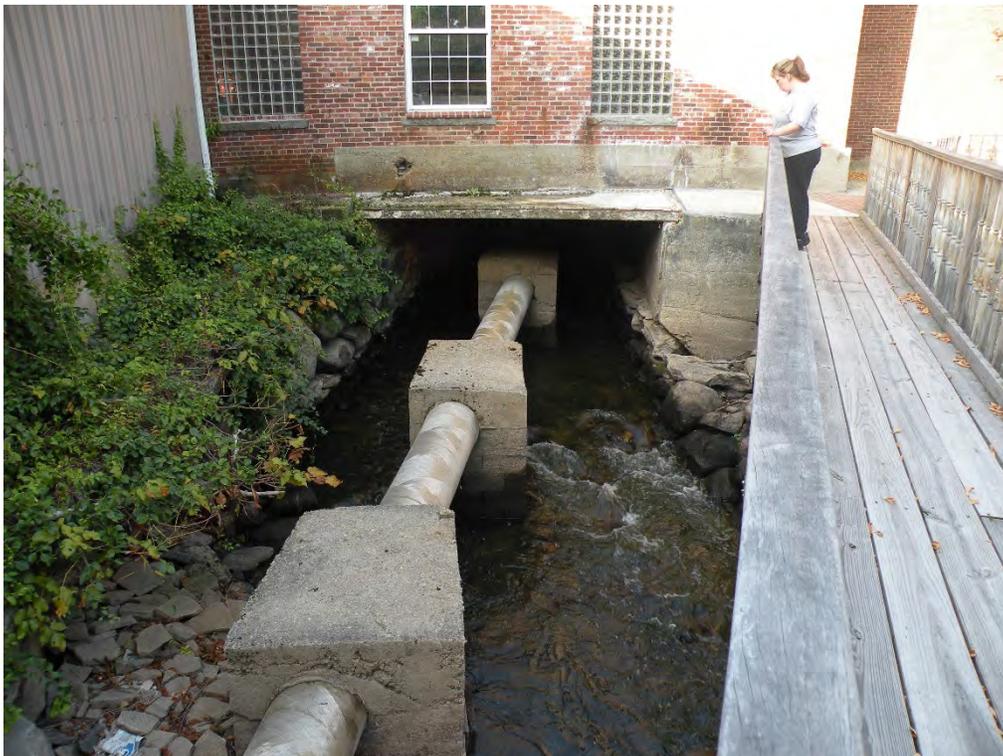
Photo 42: Talbot Mills Dam – Sluiceway Outlet

Looking upstream at outlet of sluiceway under Faulkner Mill showing sewer line (Reiner, 8/16/10)

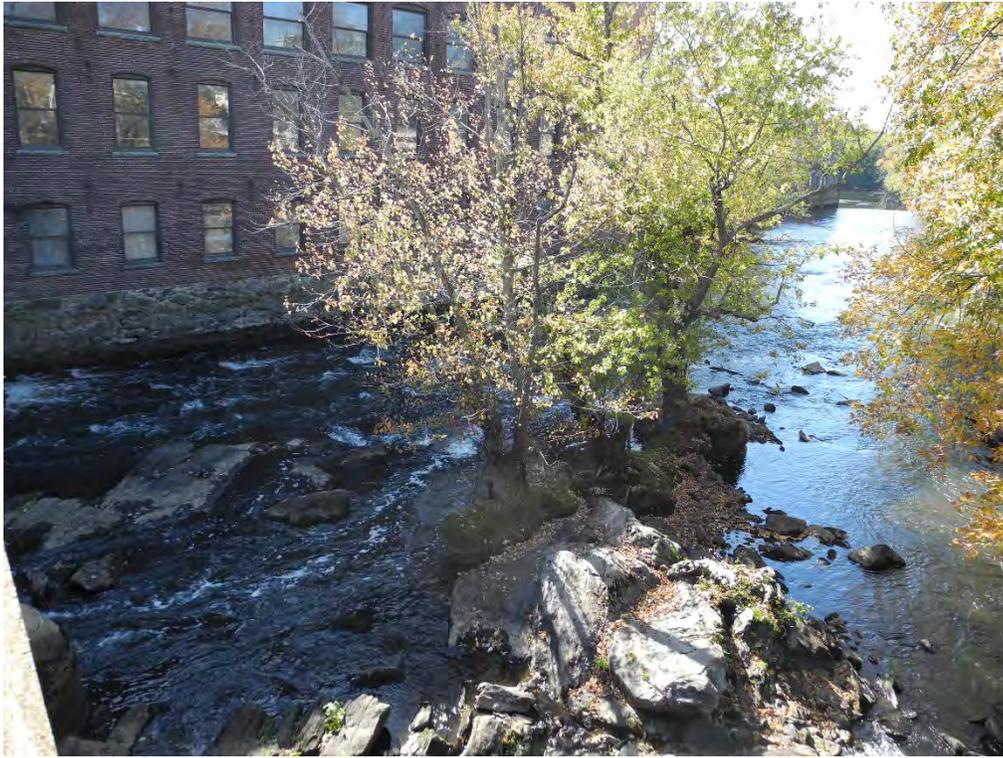
Photo 43: Talbot Mills Dam – Downstream Channel

Looking downstream at channel below Faulkner Street toward Talbot Mill (GSE, 10/6/14)

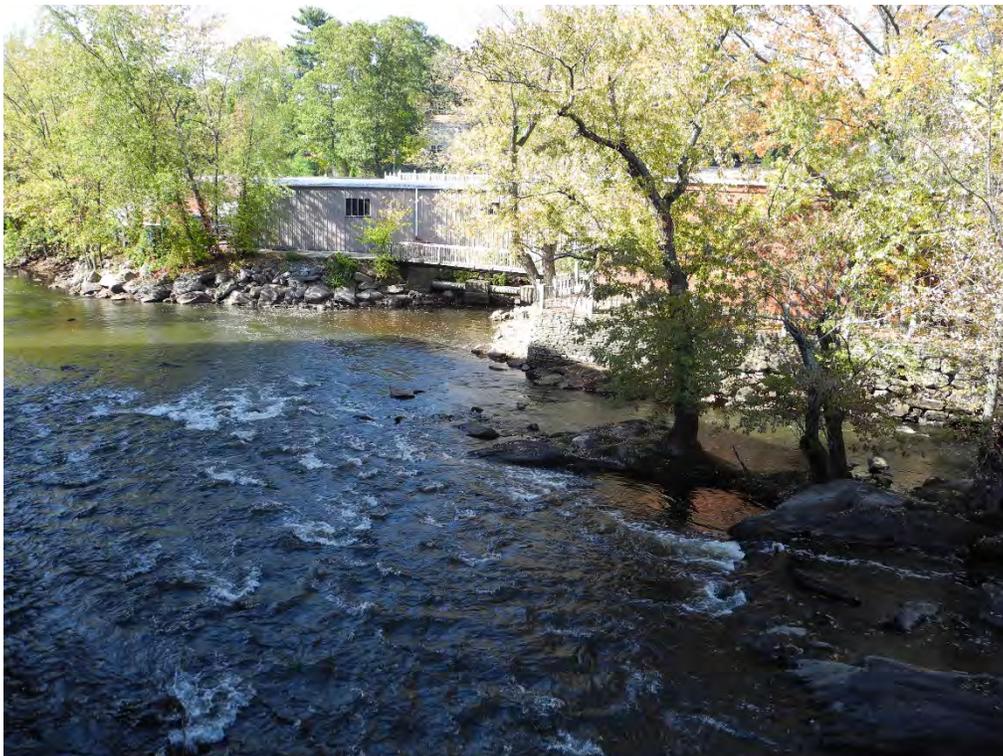
Photo 44: Talbot Mills Dam – Downstream Channel

Looking downstream at channel below Faulkner Street toward Faulkner Mill and sluiceway outlet (GSE, 10/6/14)

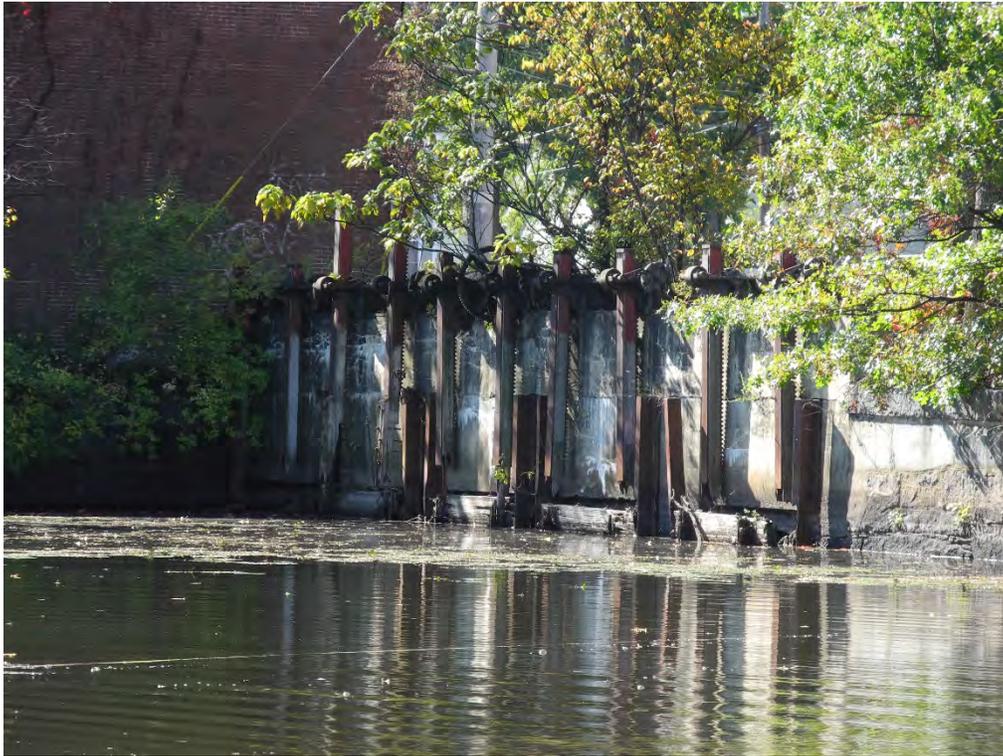
Photo 45: Talbot Mills Dam – Former Intake Structures

Former intakes to Talbot Mill (GSE, 10/6/14)

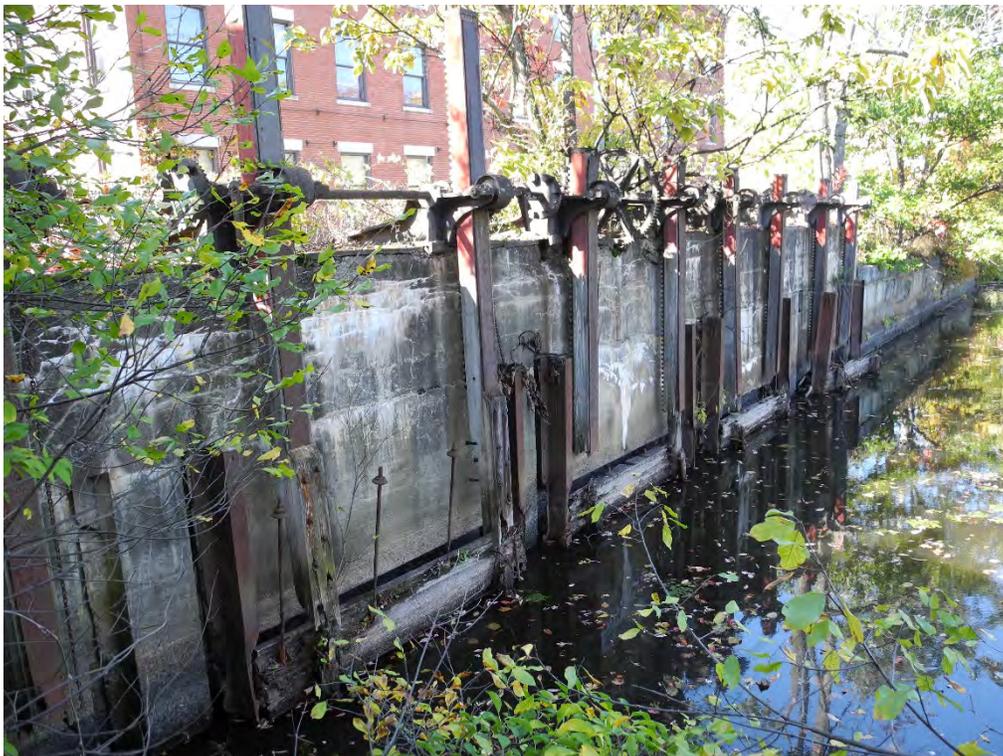
Photo 46: Talbot Mills Dam – Former Intake Structures

Close-up of former intakes to Talbot Mill (GSE, 10/6/14)

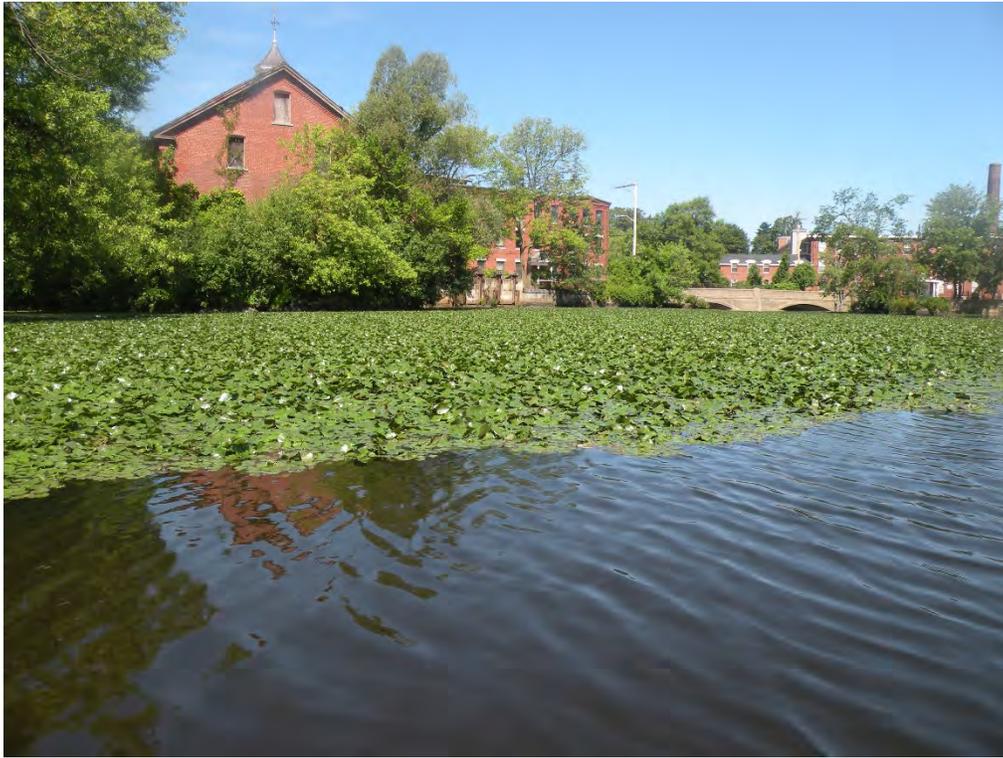
Photo 55: Talbot Mills Dam – Impoundment

View of impoundment looking downstream showing invasive water chestnut (Reiner, 7/31/11)

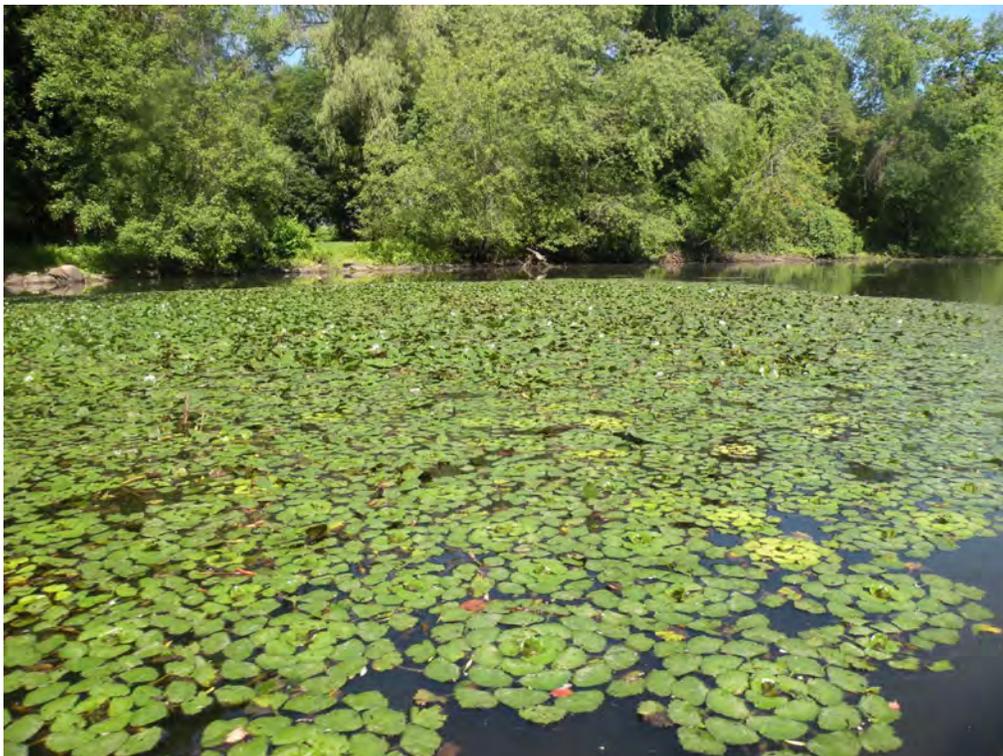
Photo 56: Talbot Mills Dam – Impoundment

Close-up of invasive water chestnut in impoundment (Reiner, 7/31/11)

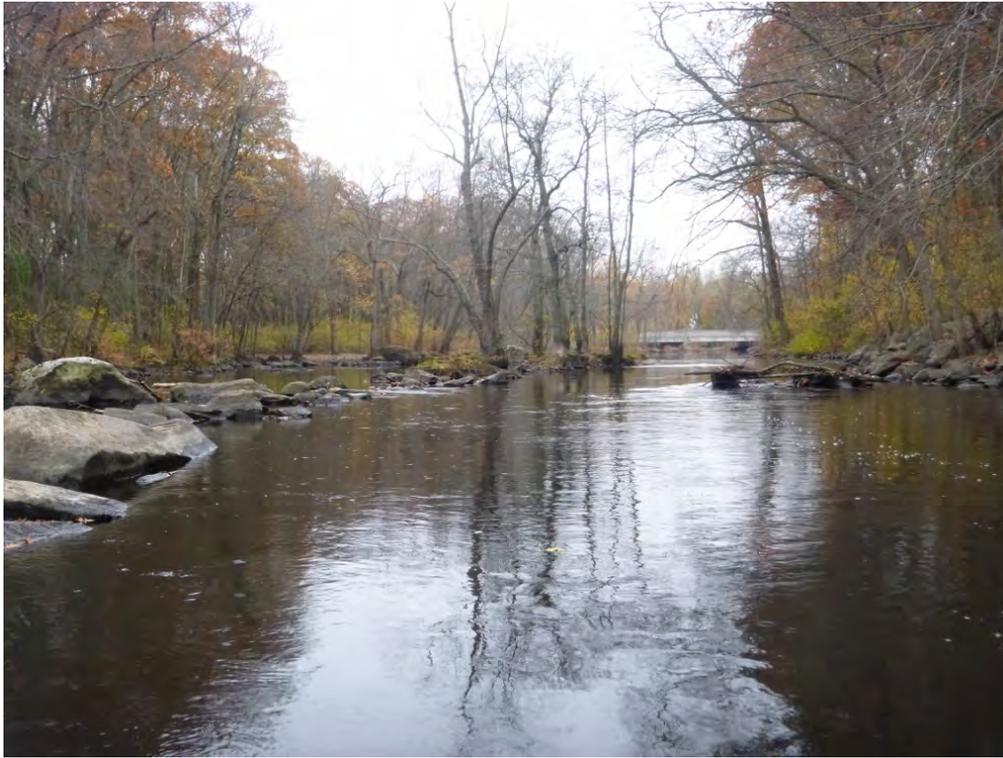
Photo 57: Talbot Mills Dam – Fordway Bar

Looking upstream at rocky outcroppings below Fordway Bar (Pollard Street bridge in background) (GSE, 11/6/14)

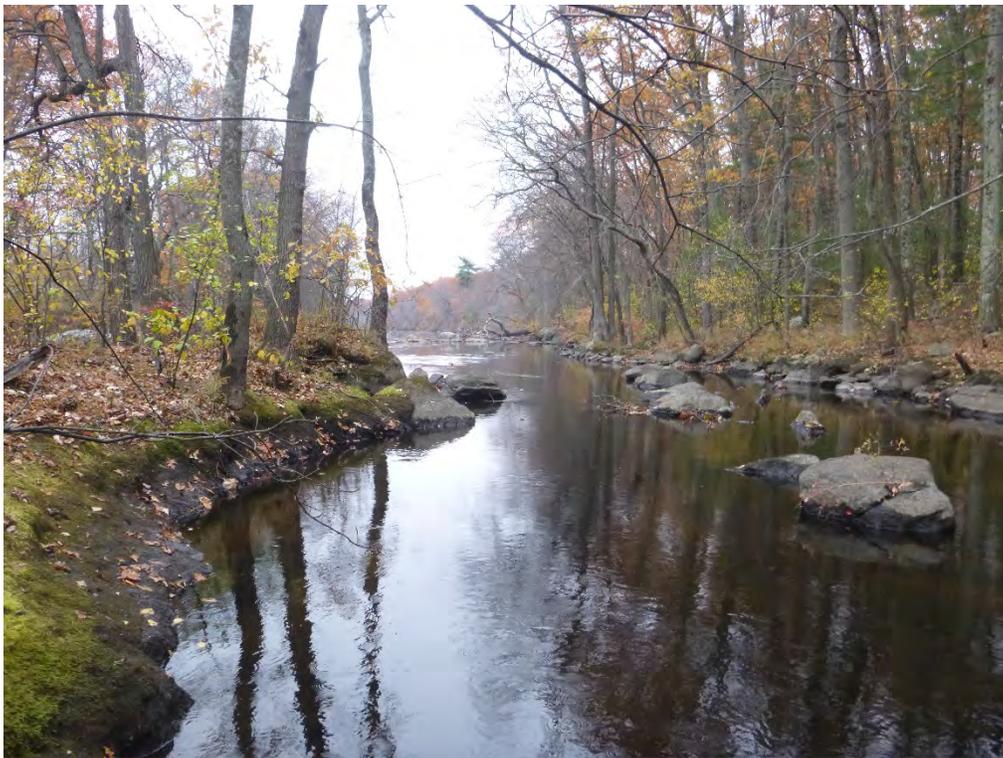
Photo 58: Talbot Mills Dam – Impoundment

Looking upstream at rocky outcroppings below Fordway Bar (GSE, 11/6/14)

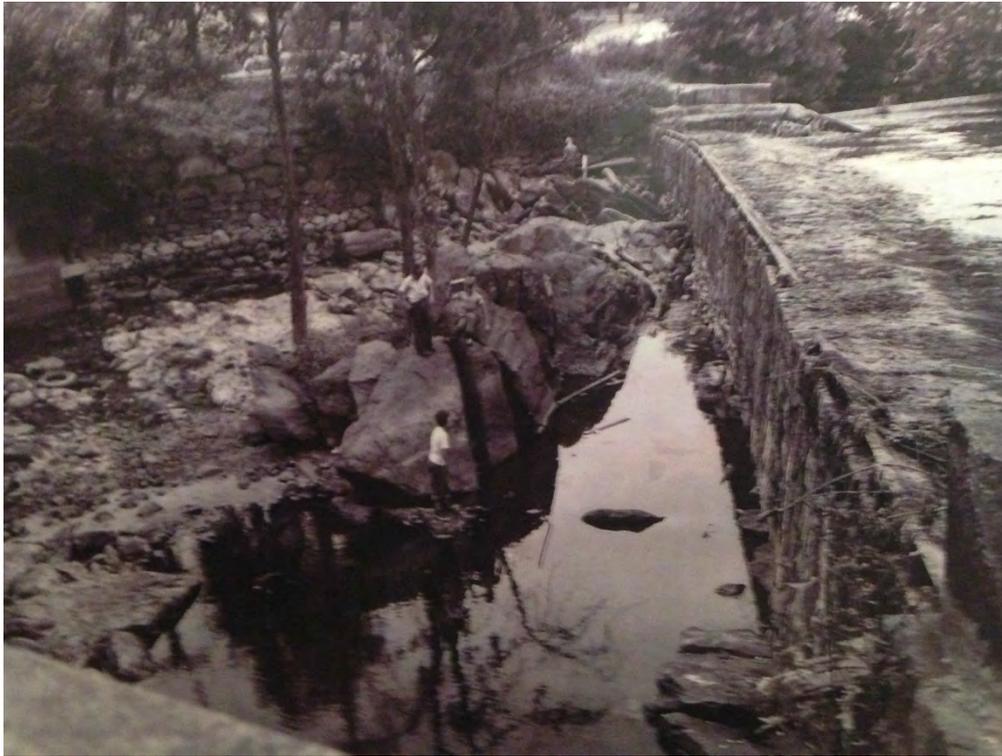
Photo 59: Talbot Mills Dam – Historical Photo

View from left abutment showing dewatered dam with flashboards (Middlesex Canal Museum, date unknown)

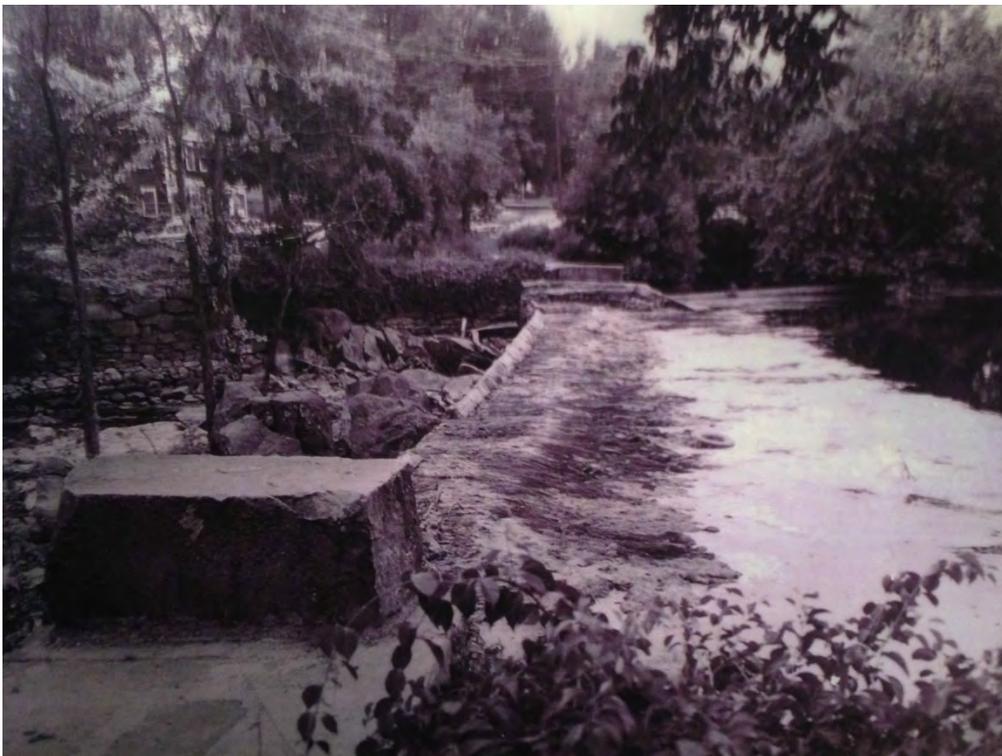
Photo 60: Talbot Mills Dam – Historical Photo

View from left abutment showing dewatered dam with flashboards (Middlesex Canal Museum; date unknown)
