Compliance Inspection Report
Helmet Creek Restoration
Adak Petroleum Diesel Spill

January 10, 2014

Polaris Applied Sciences: on behalf of Adak Petroleum LLC

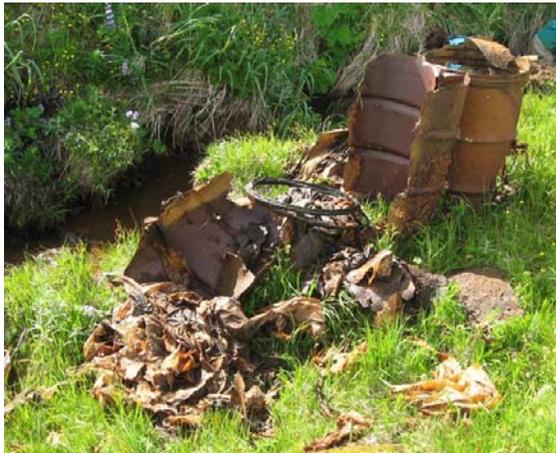
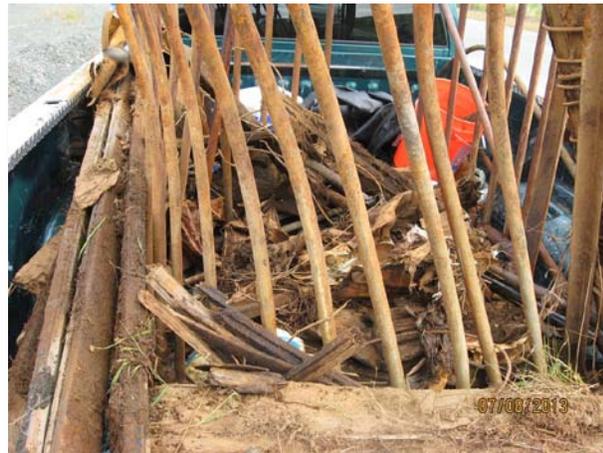
Figure 3: Example of debris removed from creek

Several hundred pieces of anthropogenic debris (mainly sheet plastic, scrap wood, and scrap metal) were removed from the creek (Figure 3). Only a few pieces were deliberately left in place where removal was judged likely to cause more damage to the streambed or banks than was acceptable given the expected benefit. Wood, metal and plastic were separated. Untreated wood will be burned or reused. Metal was hauled to the local metal recycling area. Plastic and treated wood were stored at the Adak Petroleum yard for future disposal in an appropriate manner. On future monitoring trips, this exercise will be repeated to remove any future accumulations of debris in or near the streambed.

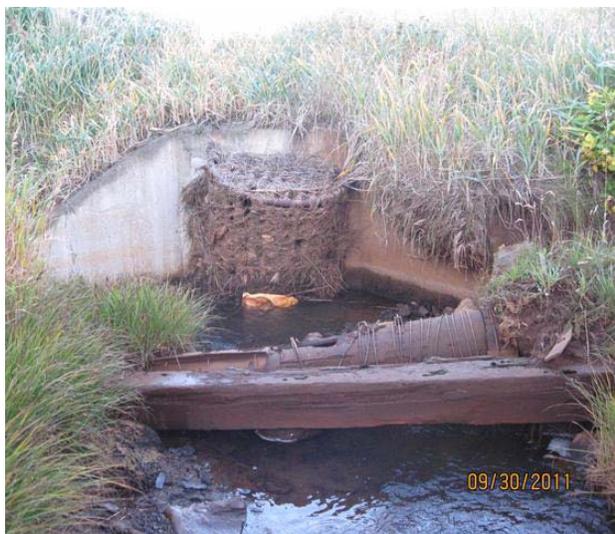
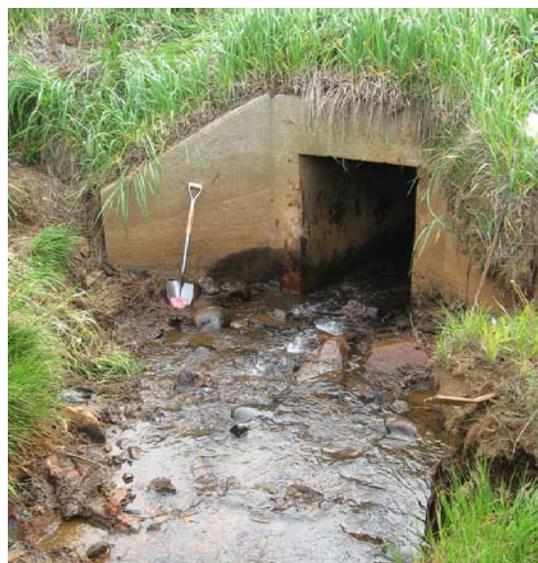
Figure 4: Culvert #2 before (Left - 2011) and after (Right - 2013) restoration

A wood stave pipe and timber located immediately above Culvert #2 was removed and the banks were restored (Figure 4). Inspection of the removal site revealed that revegetation and seeding were required at the removal site and this work was conducted. Vegetation monitoring will occur in future monitoring trips as described in the revegetation section.

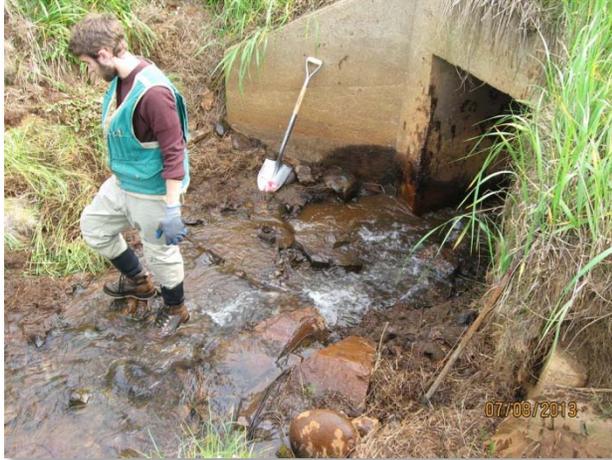
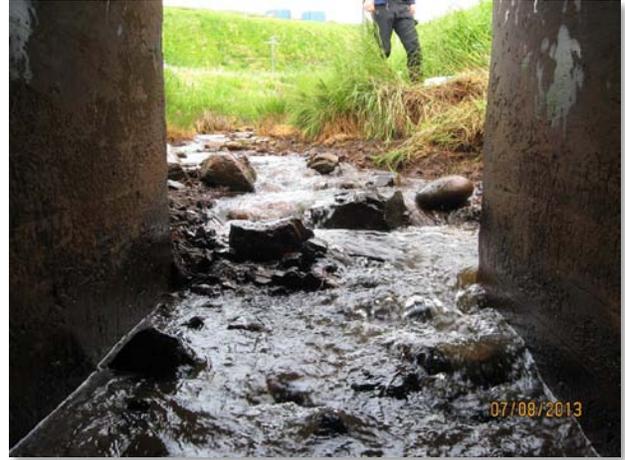
Figure 5: New channel bed created at Culvert #2

Culvert #2: The trash rack at Culvert #2 was removed on July 3 by RP staff using a backhoe operating from the adjacent road (Figure 4). On July 8, the channel bed spanning about 15 feet upstream of the culvert was reconfigured by hand to create a number of small steps leading out of the culvert (Figure 5). Rocks and small boulders found nearby in the creek were moved to create the final configuration. The site was revisited on July 9, 10, and 11 to make additional small adjustments. The final channel contains no drops in excess of six inches. Streambed profile and width data were collected on July 10 (data provided in Section D.1.ii).

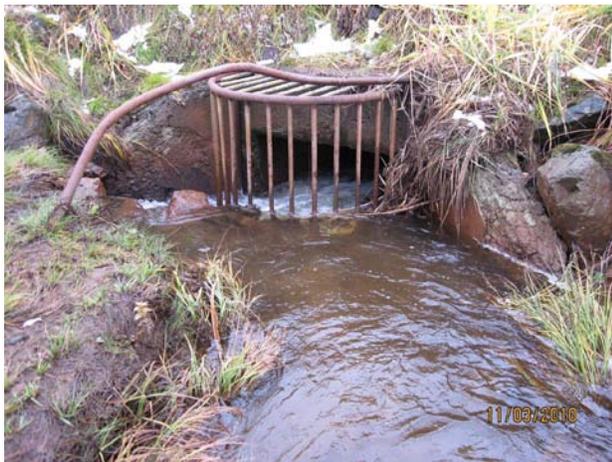
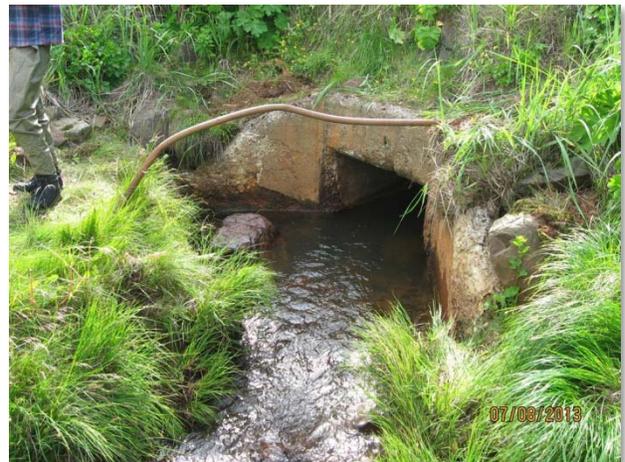
Figure 6: Culvert #3 before (Left - 2010) and after (Right - 2013) trash rack removal

Culvert #3: The trash rack at Culvert #3 was removed on July 8 by the restoration crew using hand tools and manual labor (Figure 6). The water surface through Culvert 3, including the trash rack area, is completely backwatered by a bed control located about 10-feet downstream of the culvert. As such, no fish passage issues were immediately created by removal of the trash rack, and no channel bed disturbance was judged to be necessary. The site was revisited on July 9 and 10 but no evidence of change was noted. Streambed profile data were collected on July 8 and again on July 10 along with stream width.

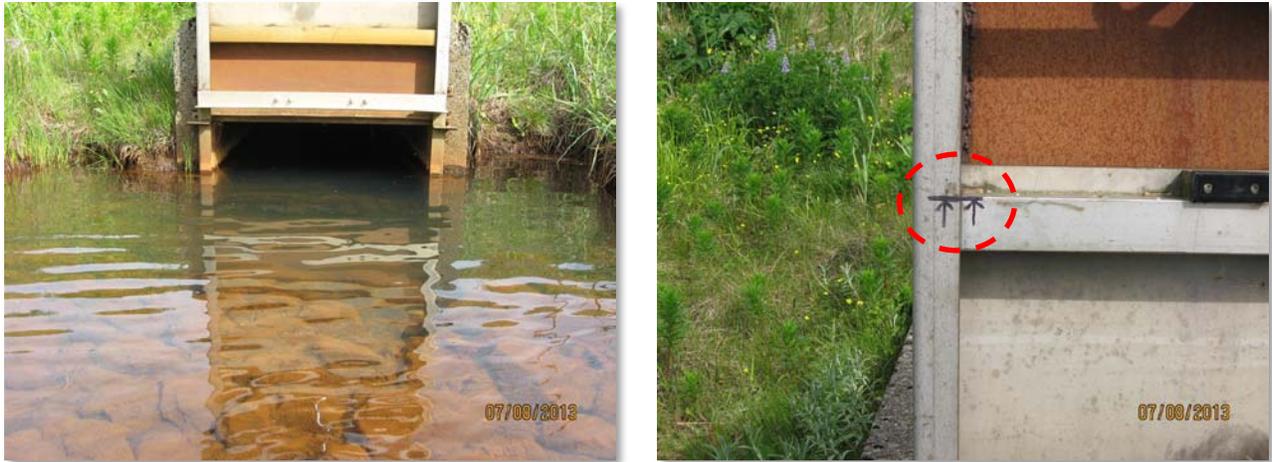
Figure 7: Spill control gate on Culvert #3 and reference mark (highlighted)

Three spill control gates are located on Helmet Creek: one on the downstream end of Culvert #3 and one each on the upstream and downstream ends of Culvert #5. The gate on Culvert #3 was set approximately 6-inches above the moderate flow observed on July 8 (Figure 7). A

mark showing the adequate level of opening was added for future reference by monitoring personnel and Adak Petroleum staff (Figure 7).

Monitoring confirmed that the spill control gates located on the downstream end of Culvert #3 and the upstream end of Culvert #5 had been set approximately 6-inches above the moderate flow level observed on July 8 (Figure 7). The spill control gate on the downstream end of Culvert #5 was set approximately 4-inches above the moderate flow level and could not be moved higher without structural changes. All three gates allowed light to enter the culverts and fish passage should not be a problem.

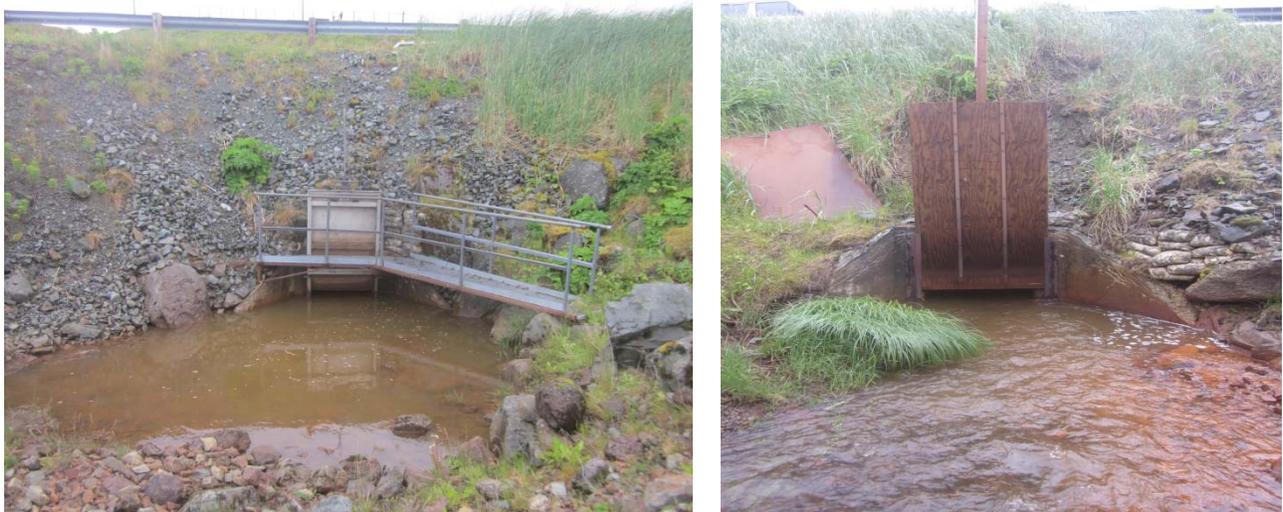
Figure 8: Spill control gates on Culvert #5 (lower and upper)

Culvert #5 has spill control gates at both ends (Figure 8). According to Adak Petroleum staff the downstream gate is rarely used. This gate has been raised to its highest position and will be left as is. On July 10 the gate was approximately 4-inches above the moderate flow level. The upstream gate has a longer range of travel. On July 10 the gate was approximately 6-inches above the moderate flow level. A mark was added for future reference of opening adequacy. In future monitoring trips a measurement will be taken to reference in case the markings wear off.

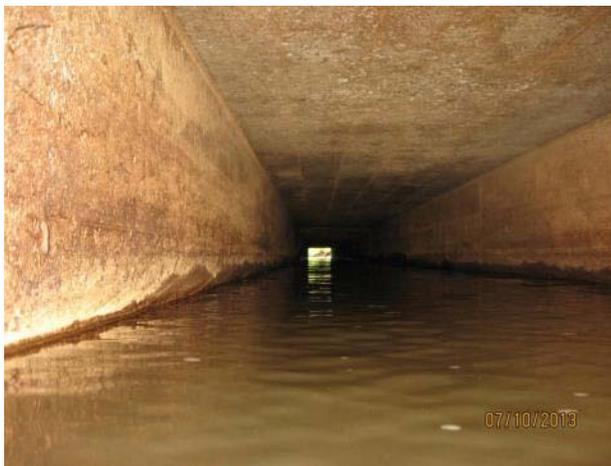
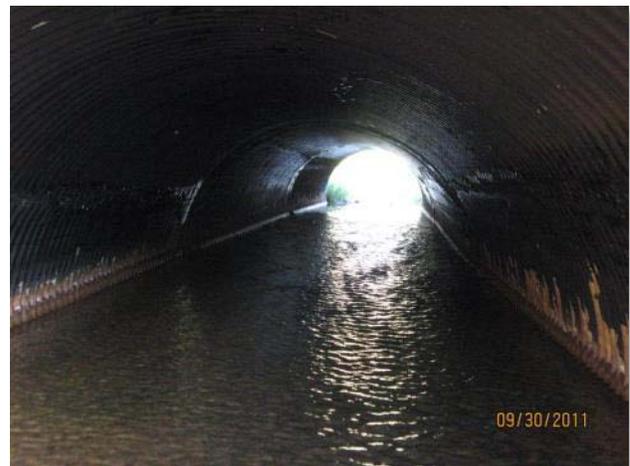
Figure 9: Fish passage conditions in Culverts #3 and #4

All five culverts were examined for fish passage suitability and for evidence of potential debris obstructions. Culverts # 1, 3, and 5 are naturally flooded to a depth that allows fish passage throughout their entire length at all times and contain no potential obstructions (Culvert # 3 shown in Figure 9a). Culvert #2 consists of a low gradient concrete box culvert. Lower flow rates result in shallow sheet flow across the flat floor creating relatively difficult passage conditions. The upstream half of the culvert contained a number of large rocks that helped deepen flows and provided refuge/resting points for fish moving upstream (Figure 5b). Several dozen additional large rocks were manually added to the downstream half of the culvert on July 10. It is believed that this will further facilitate fish passage during all flow conditions. Culvert #4 consists of a bottomless arch culvert with a natural, low gradient streambed (Figure 9b). The culvert is passable at all flows.

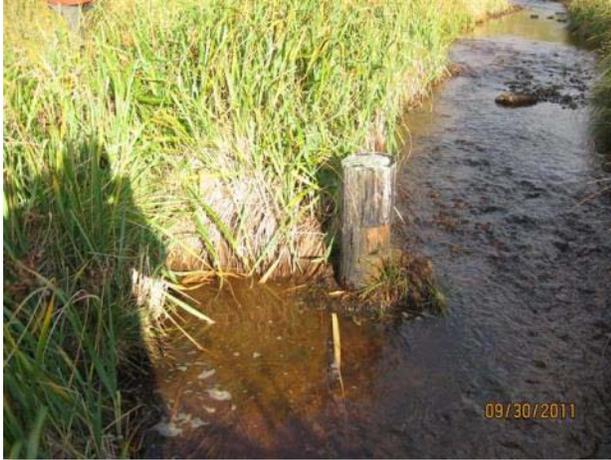
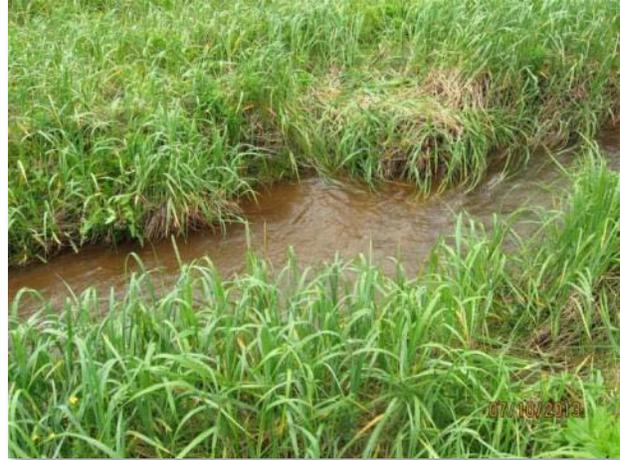
Figure 10: In-stream piling before and after removal

Three pilings located between Culverts #4 and #5 were removed using a backhoe on the adjacent bank (one instream pile) or road (two bank pile) (Figure 10). The pile in the creek broke off approximately 2 to 3 feet below the streambed while it was being removed. The

hole was capped with stream gravel from a nearby gravel bar. The two upland piling were removed in their entirety and the holes filled with topsoil and capped with a vegetation plug.

Monitoring confirmed that seven piles had been removed, the resulting holes filled, and suitable revegetation measures had been applied. This is one more pile than anticipated in the work plan (Figures 10 and 11).

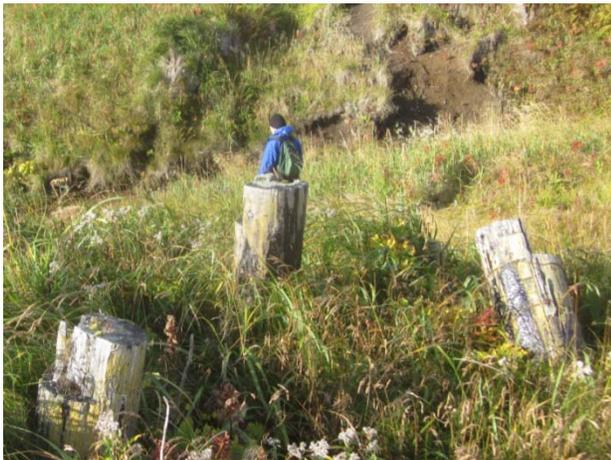
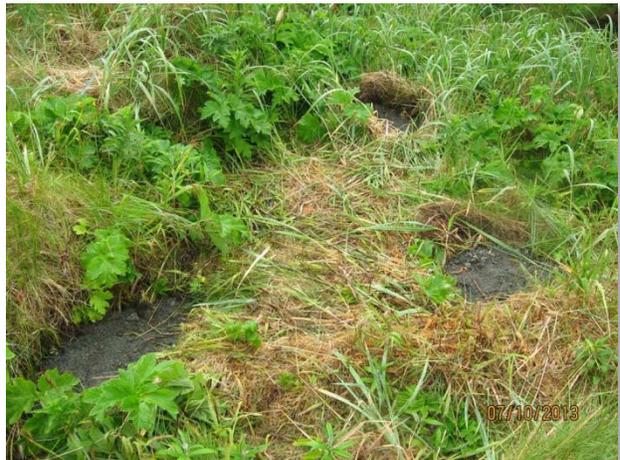
Figure 11: Upper bank pilings before and after removal

Four piling located on the upper bank near the road adjacent to Culvert #5 were removed by a back-hoe operating on the road. The piling were removed in their entirety (extended approximately 4-feet below ground surface) and the surface capped with clean soil and native grass seed (Figure 11).

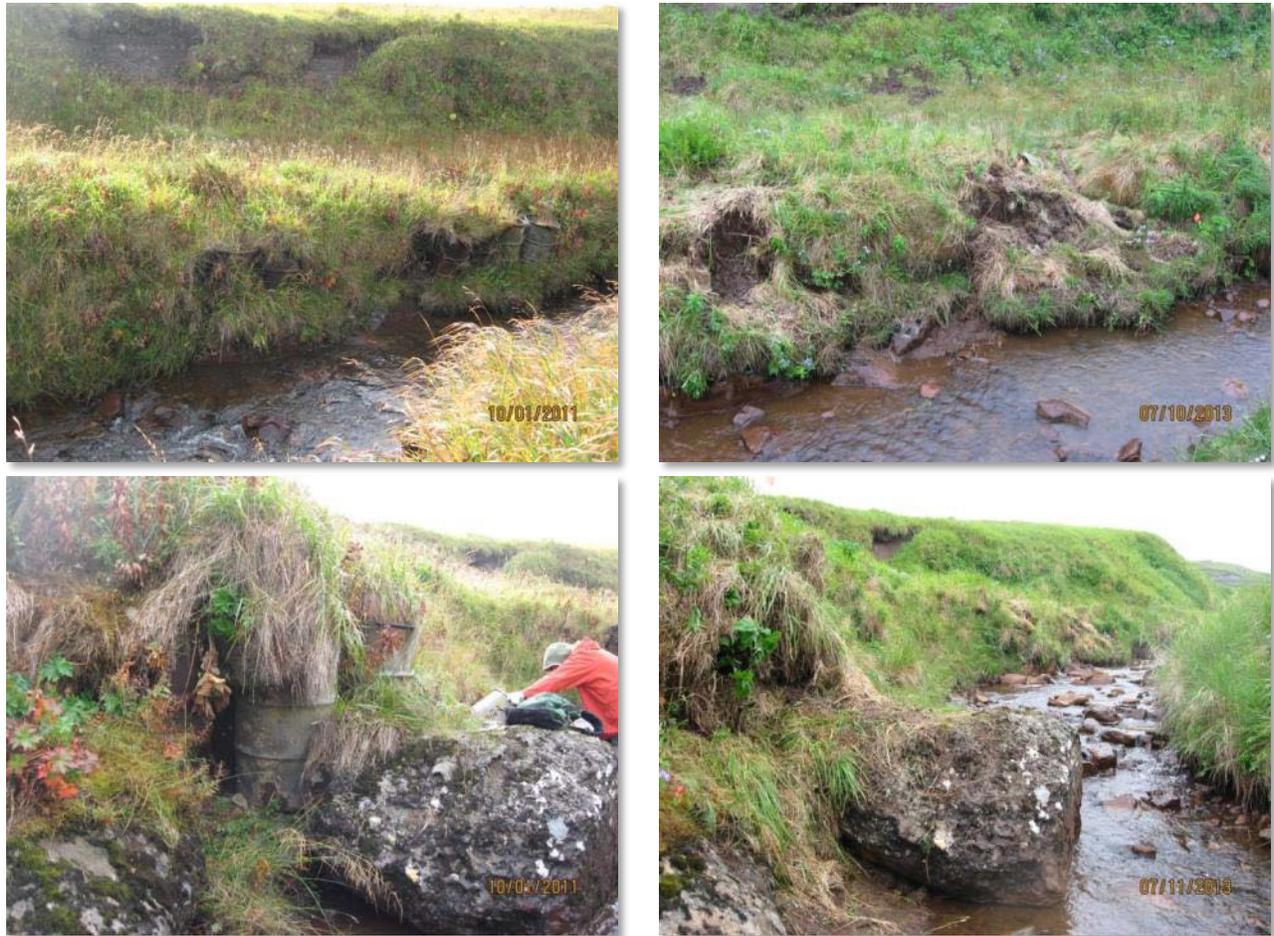
Figure 12: Site #1 before (left) and after (right) barrel removal

The floodplain barrel removal effort resulted in the elimination of eleven (11) whole barrels, plus some pieces of barrels located above ordinary high-water at Site #1 (Figure 12). The barrels

Vegetation mats removed from atop the barrels were replaced in the hole the barrel occupied after first grading the removal location to a stable configuration using soil from the barrels. All mats at risk of being carried away during peak flow events were staked in place using one or more wooden stakes. All disturbed locations were seeded with the *Approved Vegetation Mix* (See Table 4) to supplement the mats. Excess soil removed from the barrels was broadcast around terraces (old building sites) 20 to 75 feet from the channel.

Photo points were established (Figure 12) and a visual assessment of stream bed and stream bank integrity looking downstream and upstream over the area of removal was completed (Figure 20). Stream width was measured through the restoration area (Figure 21). Monitoring frequency for this assessment will be every monitoring year. Vegetation monitoring for this area is covered in Section 6v.

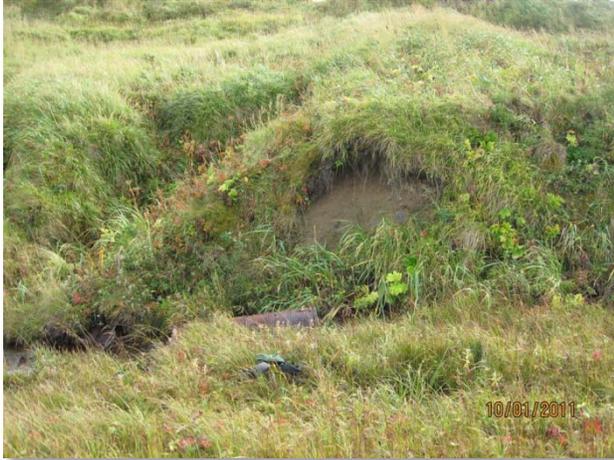
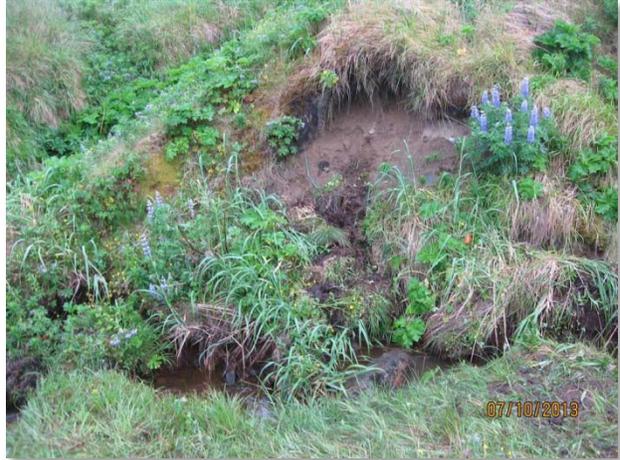
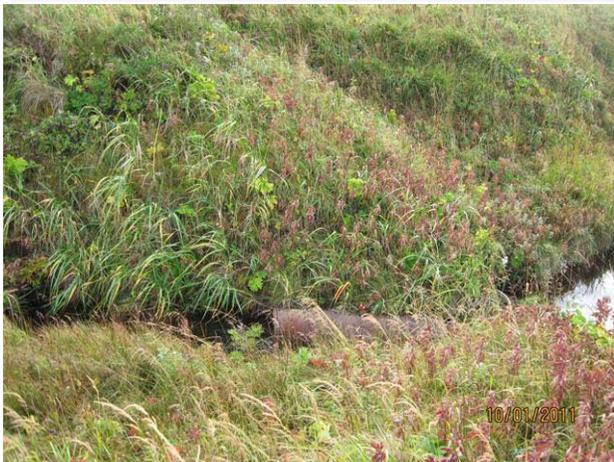
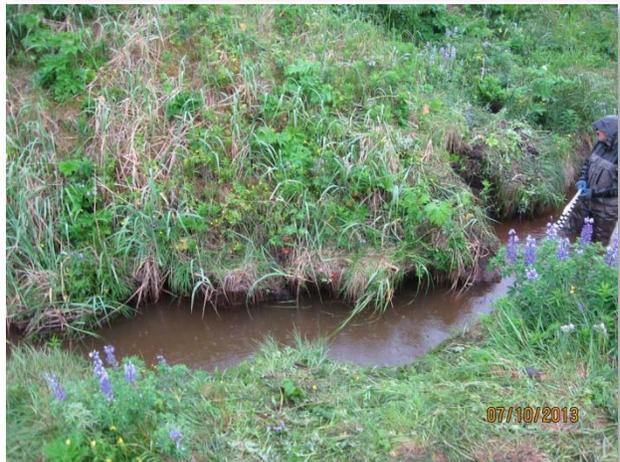
Figure 13: Site #2 before (left) and after (right) barrel removal

Roughly 15 to 18 barrels and portions of barrels were removed from within the active channel (Figure 13). The exact number of barrels was difficult to count because many came out as partial sections and pieces. The barrels and all other man-made debris were hauled away for disposal as described in Section C.1. One or two partial barrel sections were allowed to remain at Site #2, as they supported significant pieces of bank, and were not deemed current or future potential obstructions to fish passage. Both barrels had suffered from significant degradation and were slowly collapsing. This slow collapse allows vegetation mats to settle and re-root and appears to result in a stable situation as evidenced in other sections of the channel where barrels had completely collapsed.

Vegetation mats removed from atop some of the barrels were replaced on disturbed sections after first grading the bank to a stable configuration. All mats at risk of being carried away during peak flow events were staked in place using one or more wooden stakes. All disturbed locations were seeded with the *Approved Vegetation Mix* to supplement the mats. A pre-existing steep unvegetated slope near the work area was also covered with a few leftover mats and seeded. Excess soil removed from around the barrels was broadcast on the upper terraces 25 to 75 feet from the channel. Stream width and depth data were collected to serve as a general reference for future monitoring years.

- Photo points were established (Figure 13 – Site #2; Figure 14 – Site #3) and a visual assessment of stream bed and stream bank integrity looking downstream and upstream over the area of removal was completed (Figure 22 – Site #2; Figure 23 – Site #3). Monitoring frequency for this assessment will be every monitoring year.

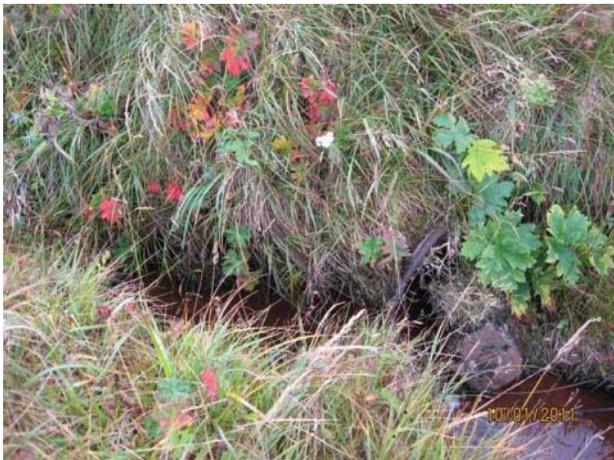
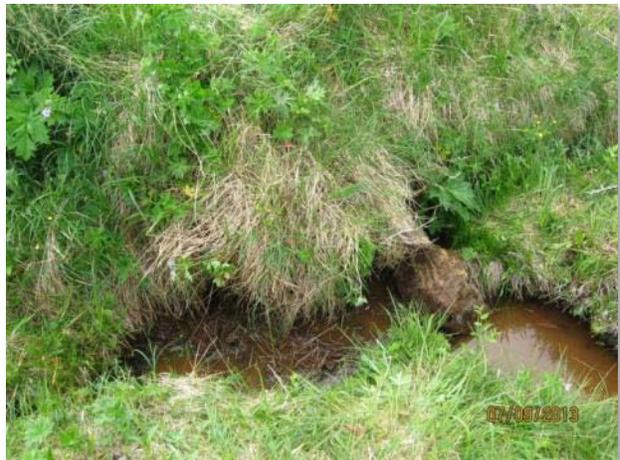
Figure 14: Site #3 before (left) and after (right) barrel removal

Site #3 had a single, partial barrel embedded deeply into the streambank (Figure 14). The vegetation mat atop the barrel was peeled back by hand and held while the underlying barrel was removed. The mat was then allowed to return and cover the bank where the barrel had been removed. No seeding was necessary.

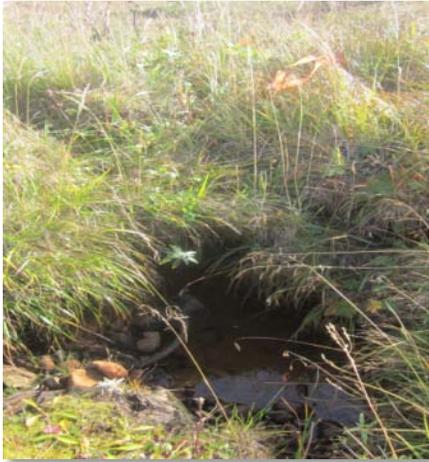
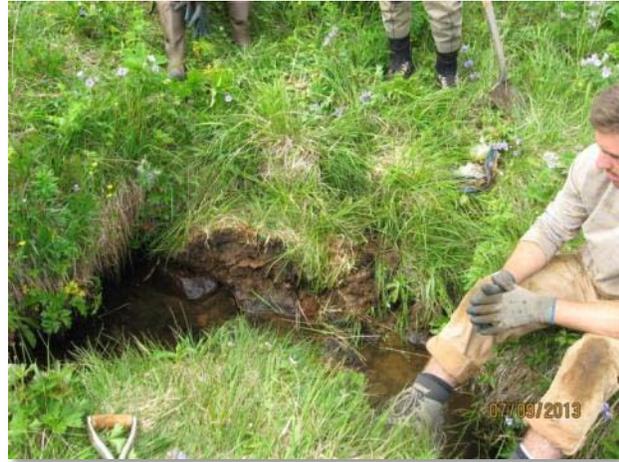
Figure 15: Culvert complex (Site #4) before and after plugging

The upstream end (intake) of the barrel complex was plugged by first filling the mouth of the culvert with large rocks (6-12") and then placing an 18"x24" vegetation mat over the entire area (Figure 15). Wood stakes were driven through the plug and into the underlying soil to hold the plug in place. A small amount of the *Approved Vegetation Mix* was added to supplement the mat. The plug eliminated about 95 percent of the flow coming out of the culvert at the downstream end.

Monitoring confirmed that the mouth of the culvert complex has been plugged (Figure 15). All disturbed areas on the banks have been revegetated.

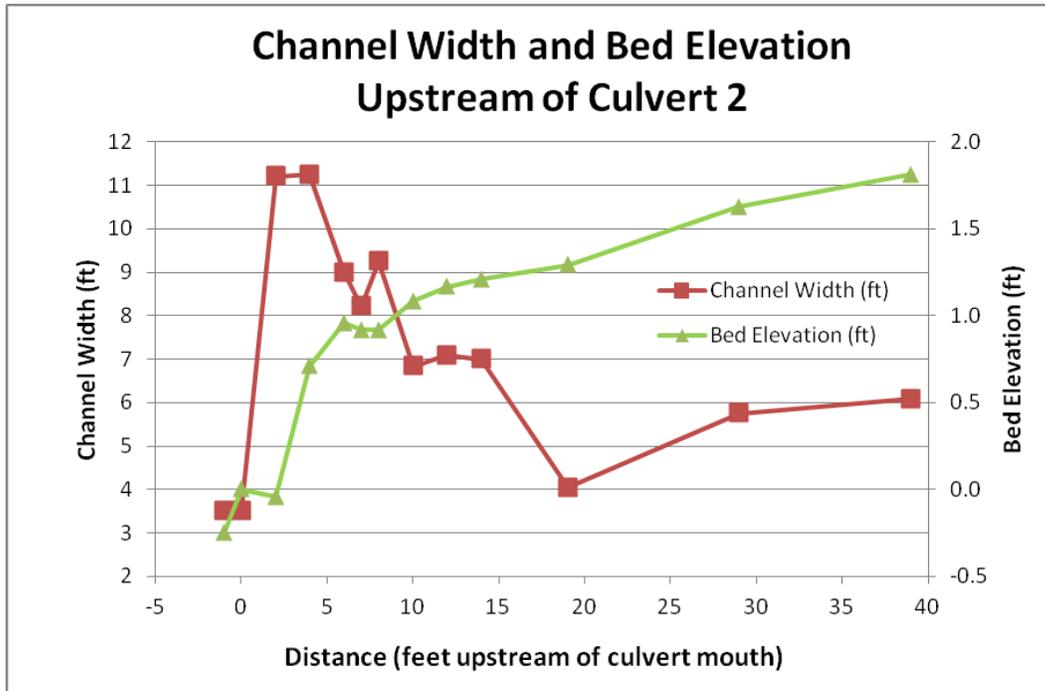
Figure 17: Post-Construction channel measurements (Culvert #2)

- Transect measurements of in-stream parameters including stream width, depth, and grade were collected (See Figure 17 for Culvert #2 and Figure 18 or Culvert #3). Monitoring frequency for this assessment will be every monitoring year.
- Photo points were established (See Figures 5 and 6) and a visual assessment of stream bed and stream bank integrity made looking downstream and upstream over the regraded channel area. Monitoring frequency for this assessment will be every monitoring year.

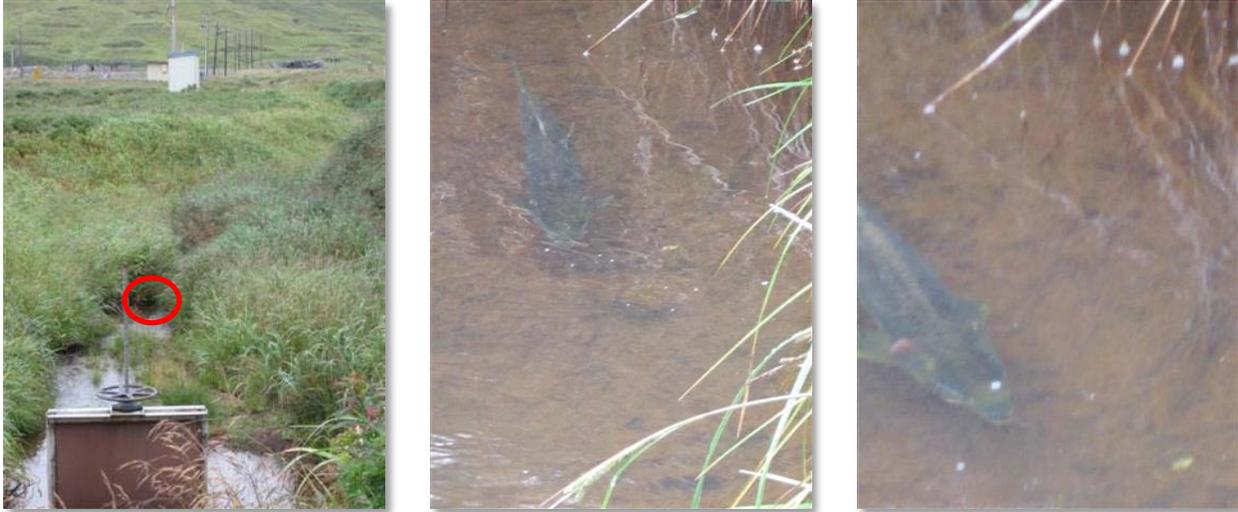
Figure 19: Adult salmon observed near RK 0.3 (8/25/2013)

On August 25, 2013, a single adult salmon was observed in Helmet Creek immediately downstream of Culvert #3 (Figure 19). The fish had successfully negotiated the most significant area of channel disturbance located upstream of Culvert #2 (Figures 4 and 5) where a blockage had been removed as part of this effort. The observation was incidental and not part of a systematic survey. No other locations were searched for fish. Fish species was not reported.

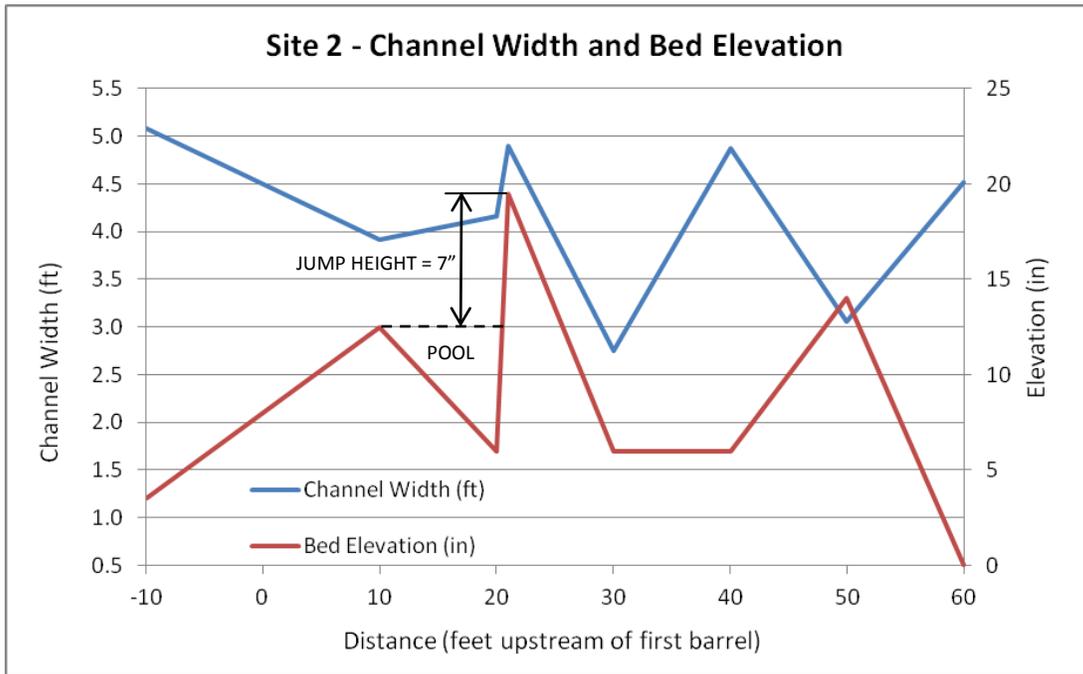
Figure 24: Site #2 – Post Construction channel measurements

- Transect measurements of in-stream parameters including stream width, depth, and grade were completed at Site #2 (Figure 24). Only minimal channel disturbance occurred at Site #3 (Figure 14) and no physical channel measurements were deemed necessary.

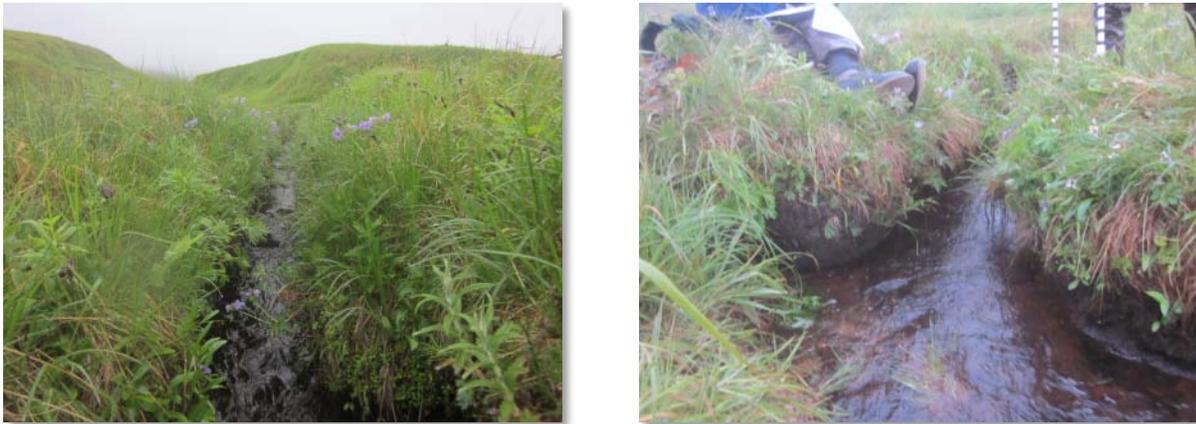
Figure 25: Site #4 – Post Construction looking upstream (L) and downstream (R)

A photo point and visual assessment of stream bed and stream bank integrity was made (Figure 25). Monitoring frequency for this assessment will be every monitoring year.

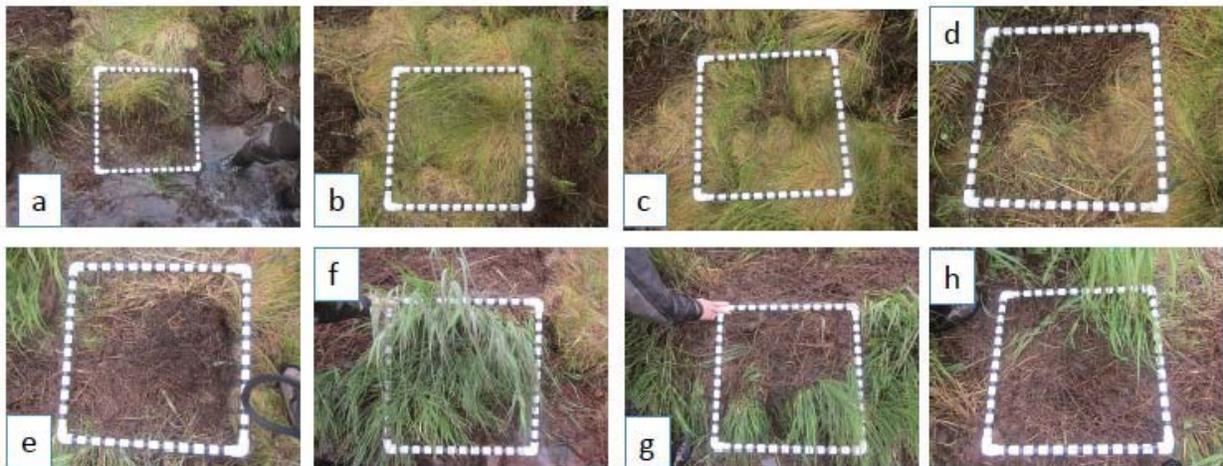
Figure 26: Photo quadrats for Trash Rack #1 streambank

Vegetation makeup: Grasses dominant most likely 'Norcoast' Bering Hairgrass (<http://plants.alaska.gov/publications/pdf/plant-flyers/NorcoastBeringHairgrass.pdf>)

Percent cover by photo: a: 30%, b: 90%, c: 85%, d: 55% (note; dead material was present and placed on mats to keep the underlying soil moist), e: 5% (note; dead material added), f: 90%, g: 10% (note; dead material added), h: 5% (note; dead material added).

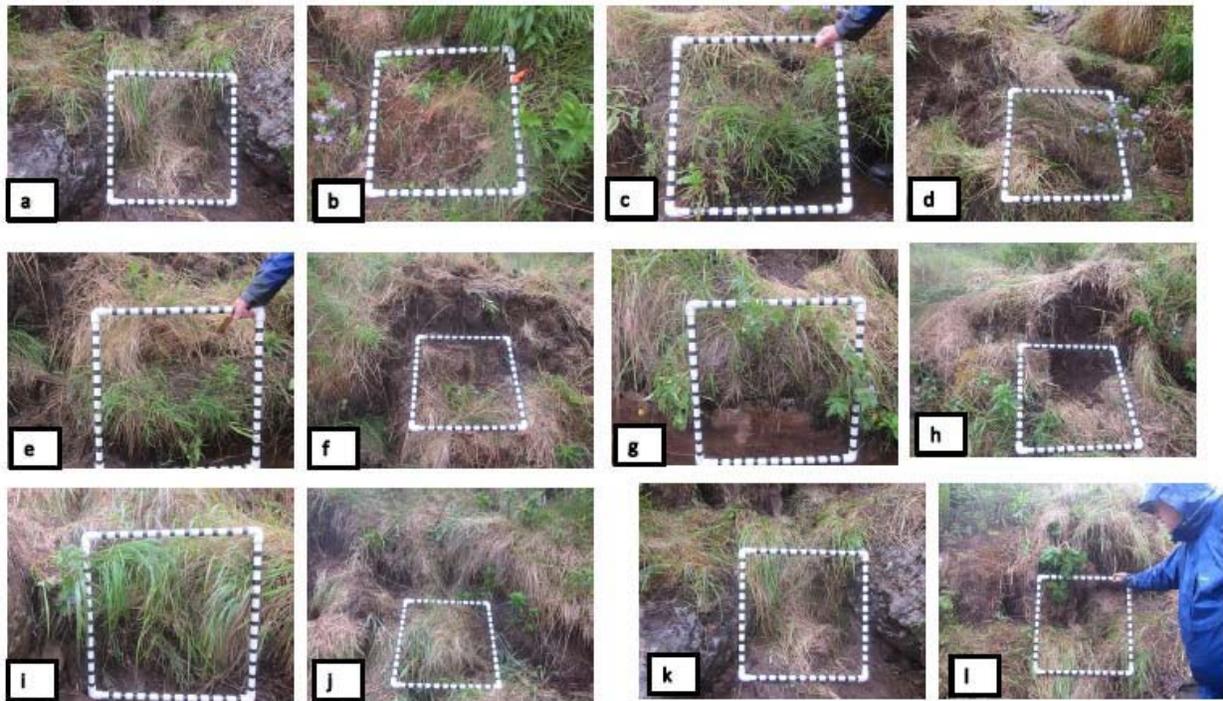
Figure 27: Photo quadrats for Barrel Removal Site #1 streambank

- Photo quadrat and visual assessment of stream bank integrity was conducted. Post-construction bank condition for areas of bank disturbance that occurred during removal of the barrels was recorded for Site #1. In addition to recording percent cover, the photos were taken so that visual comparisons of the bank could be made. Some of the bank instability is natural and preexisting as noted (Figure 27).

Percent cover by photo: a: 6%, b: 4% (note; dead material was present), c: 20% (note; photo includes open space), d: 5% (note; dead material was present and photo includes open space), e: 10% (note; dead material present) f: 2% (note; steep slope aiming for growth at base not on slope), g: 6% (note; photo includes stream), h: 5% (note; dead material and bank slope), i: 15% (note photo includes stream), j: 7% (note; dead material present and open space), k: 7% (note; open space and slope of bank), l: 7% (note; open space and slope of bank).

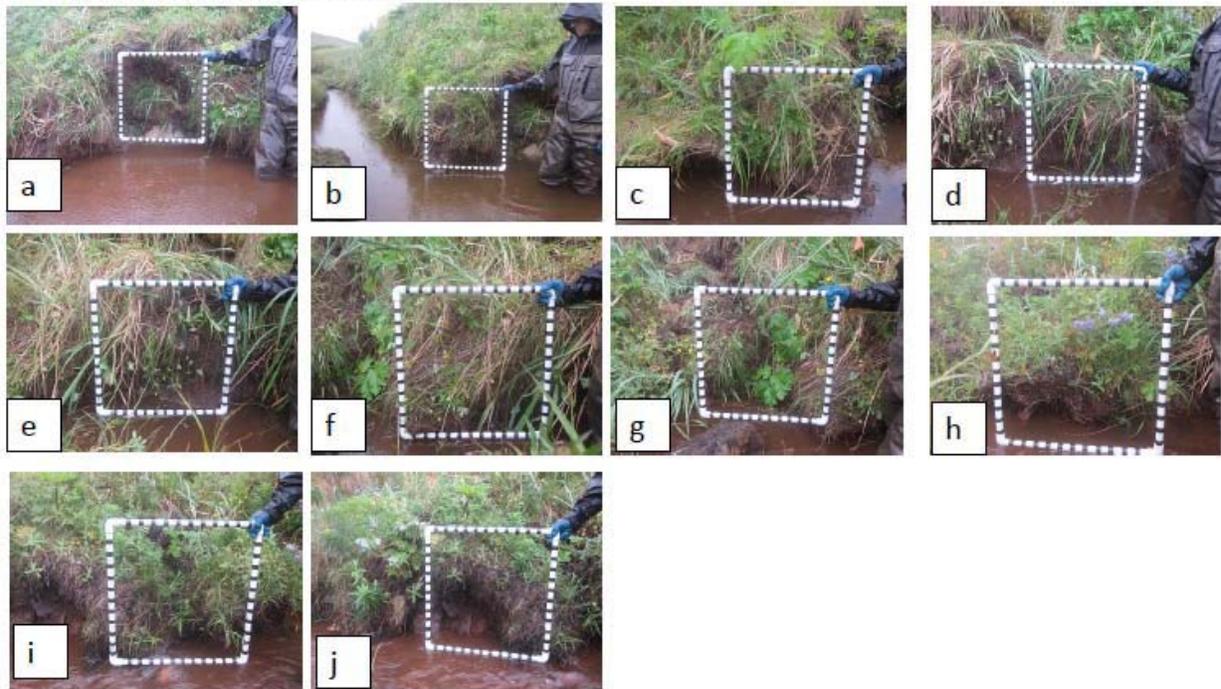
Figure 28: Photo quadrats for Barrel Removal Site #2 streambank

Vegetation makeup: Dominant: Grasses, most likely 'Norcoast' Bering Hairgrass. Non dominant: devils club, wild geranium, Sitka Burnett, Chocolate lily, Cinquefoil, fireweed, lupine, twisted stalk.

Percent cover by photo: a: 10%, b:40%, c: 35%, d: 40%, e: 25%, f: 30%, g: 25%, h: 40%, i: 35%, j: 15%.

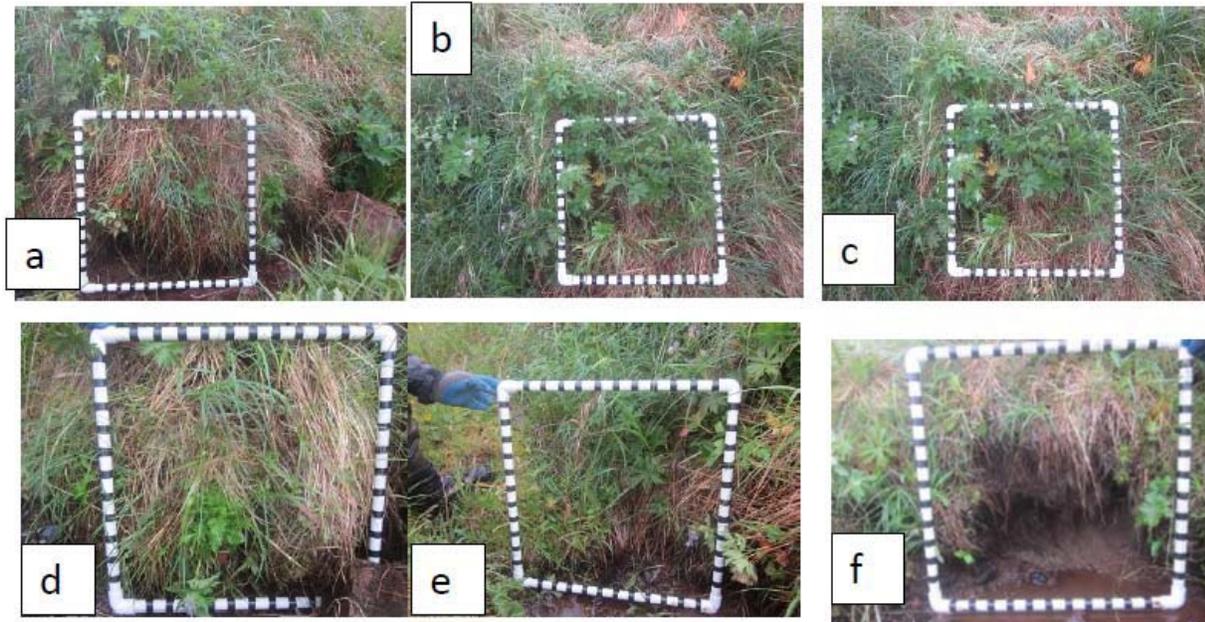
Figure 29: Photo quadrats for Barrel Removal Site #3 streambank.

Vegetation Makeup: Dominant: Grasses, most likely 'Norcoast' Bering Hairgrass. Non dominant: devils club, wild geranium, Sitka Burnett.

Percent cover by photo: a: 25%, b: 30%, c: 40%, d: 20%, e: 35%, f: 15%

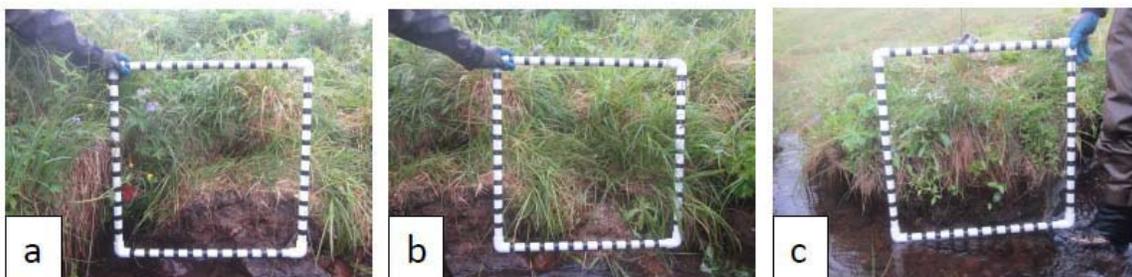
Figure 30: Photo quadrats for Barrel Plug Site #4 streambank.

- Photo quadrat and visual assessment of stream bank integrity was conducted. Post-construction bank condition for areas of bank disturbance that occurred during plugging of the barrel complex was recorded for Site #4 (Figure 30).

- **Vegetation Makeup:** Dominant: Grasses, most likely 'Norcoast' Bering Hairgrass. Non dominant: devils club, wild geranium, Sitka Burnett, equisetum, twisted stalk, non-native veg dandelion.
- **Percent cover by photo:** a: 25%, b: 30%, c: 25%.
