LNG CARRIER *MATTHEW* PRELIMINARY SITE ASSESSMENT PLAN AND EMERGENCY RESTORATION PLAN

March 3, 2009

Introduction

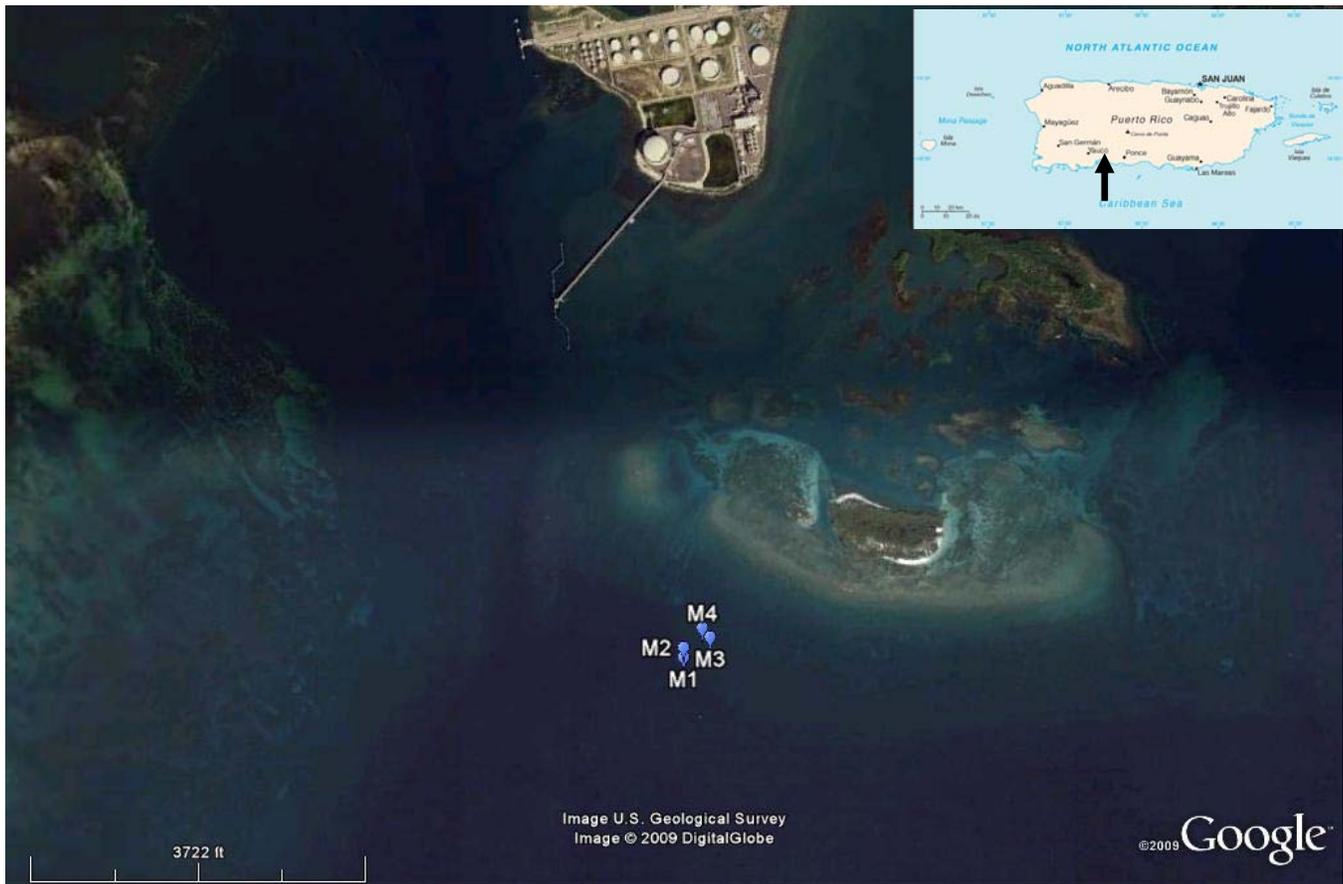
The LNG carrier Matthew, a 920 foot tank vessel was reported to strike bottom on December 15, 2009 on the southern coast of Puerto Rico near the entrance to Guayanilla Bay at approximately 18° 2.781'N, 65° 48.268'W. The natural resource Trustees from the National Oceanic and Atmospheric Administration (NOAA) and the Puerto Rico Department of Natural and Environmental Resources (PRDNER) reported injury to benthic resources bounded by the following 4 locations (**Figure 1**):

Figure 1. Reported grounding position.

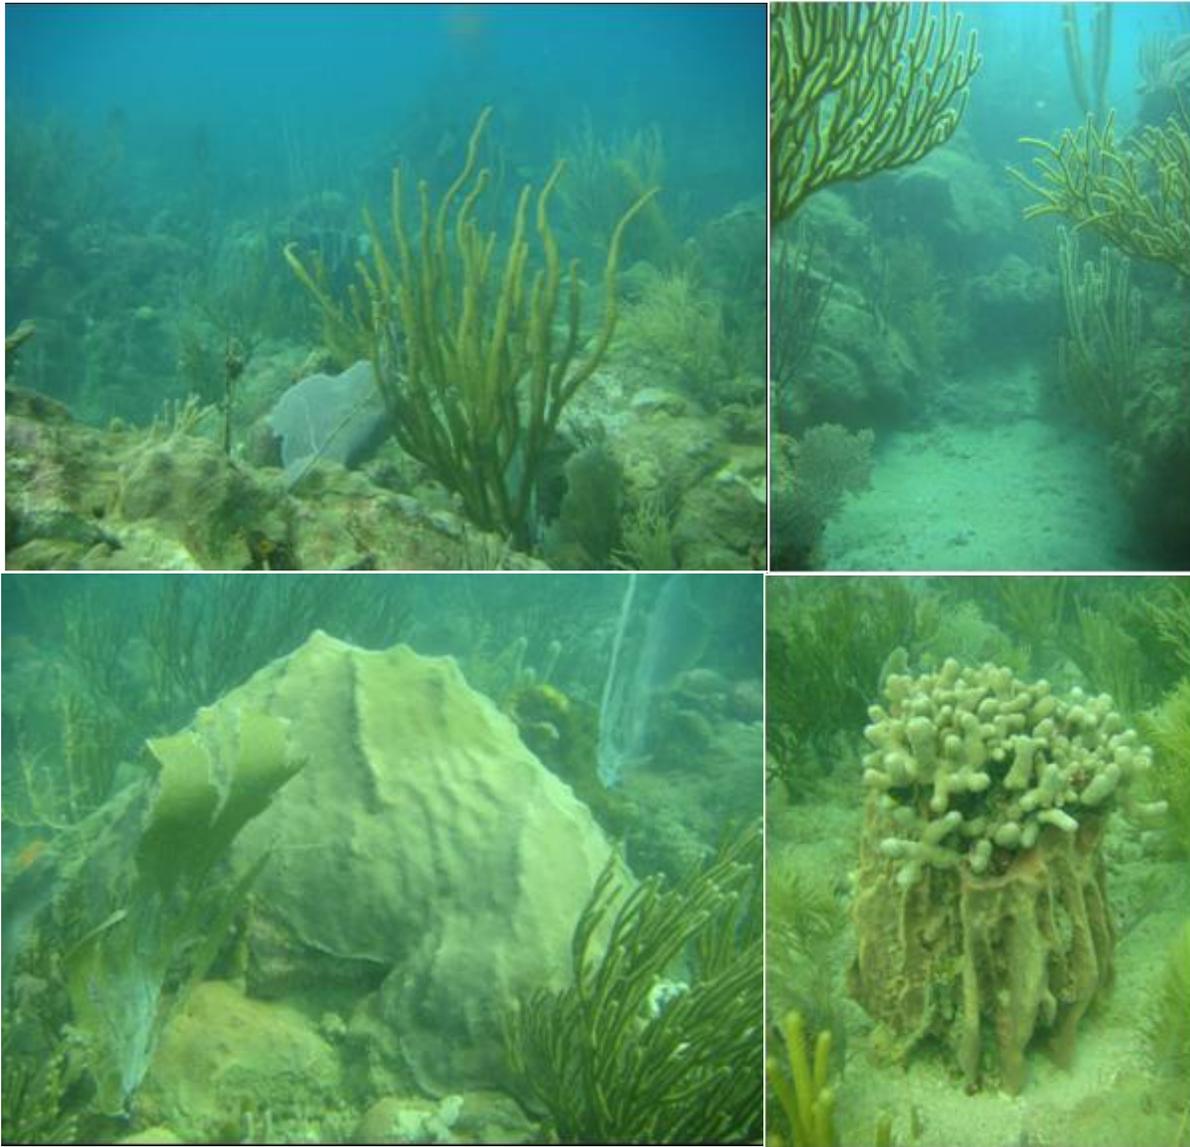
The affected reef area is a hard bottom of underlying limestone formed by reef building organisms in the past and currently supports hard and soft corals as well as numerous other benthic invertebrates (**Figure 2**). The bathymetry varies from 24 feet near the bow to 38 feet with scattered deeper sand, coral and rubble depressions of greater depth at the southern end, where the water quickly drops to several hundred feet beyond the injury area. The reef may be described as a low-lying spur and groove formation with reef spurs projecting 2-6 feet above sand grooves (channels).

The hard bottom seafloor is estimated to have 25% to 35% cover of soft and hard corals among a variety of other benthic organisms (**Figure 2**). Reference data will be analyzed to provide more quantitative estimates of biota during the assessment. The hard corals are dominated by mountainous star coral (*Montastrea annularis*) cavernous star coral (*Montastrea cavernosa*), starlet coral (*Siderastrea* spp), smooth brain coral (*Diploria strigosa*), mustard hill coral (*Porites astreoides*), finger coral (*Porites* sp) and pillar coral (*Dendrogyra cylindricus*). Branching calcareous hydroids (*Millepora* spp) and other subdominant hard corals such as butterprint brain coral (*Meandrina* sp), fungus coral (*Mycetophyllia* sp), grooved brain coral (*Colpolphyllia natans*), elliptical star coral (*Dichocoenia stokesii*), starlet coral (*Isophyllia* sp) and sparse colonies of staghorn coral (*Acropora cervicornis*) a federally threatened species were observed in a few locations. There are also numerous branching soft corals at the site including the sea fan (*Gorgonia flabellum*), and several species of sea rods and sea plumes (*Pseudopterogorgia* sp, *Pterogorgia* sp, *Plexaura* sp, *Plexaurella* sp, *Muricea* sp, *Eunicia* sp).

Figure 2. Unaffected hard bottom area showing the community composition of soft corals and hard corals (upper left). Reef groove (upper right). Large *Montastrea annularis* colony (lower left), and finger coral (*Porites* sp) growing out of a barrel sponge (*Xestospongia muta*).

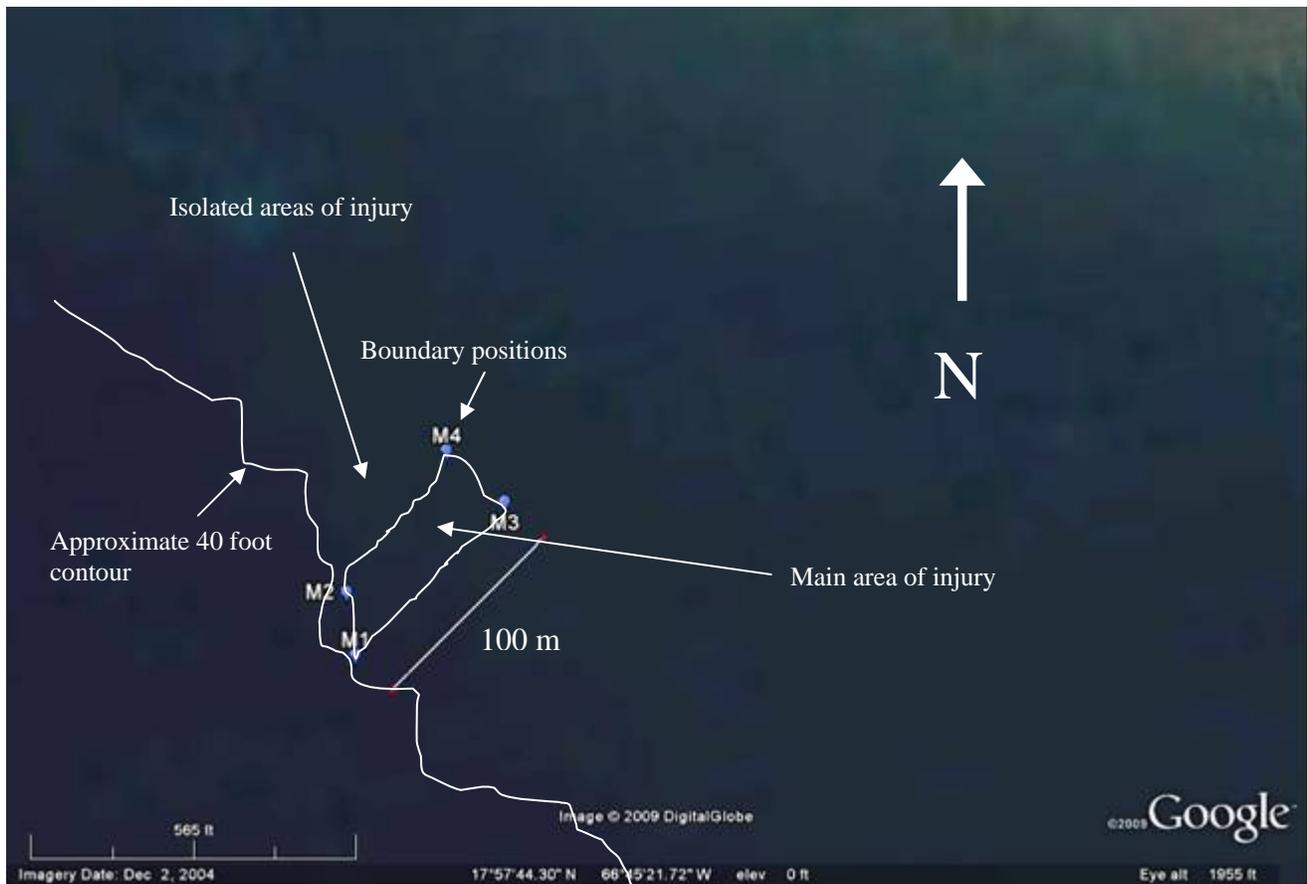
GPS boundary positions indicate the site lies within approximately 4,000 square meters (**Figure 3**). There are also isolated areas of injured reef on coral outcroppings to the west of the main.

Figure 3. Boundary positions of the injury site.

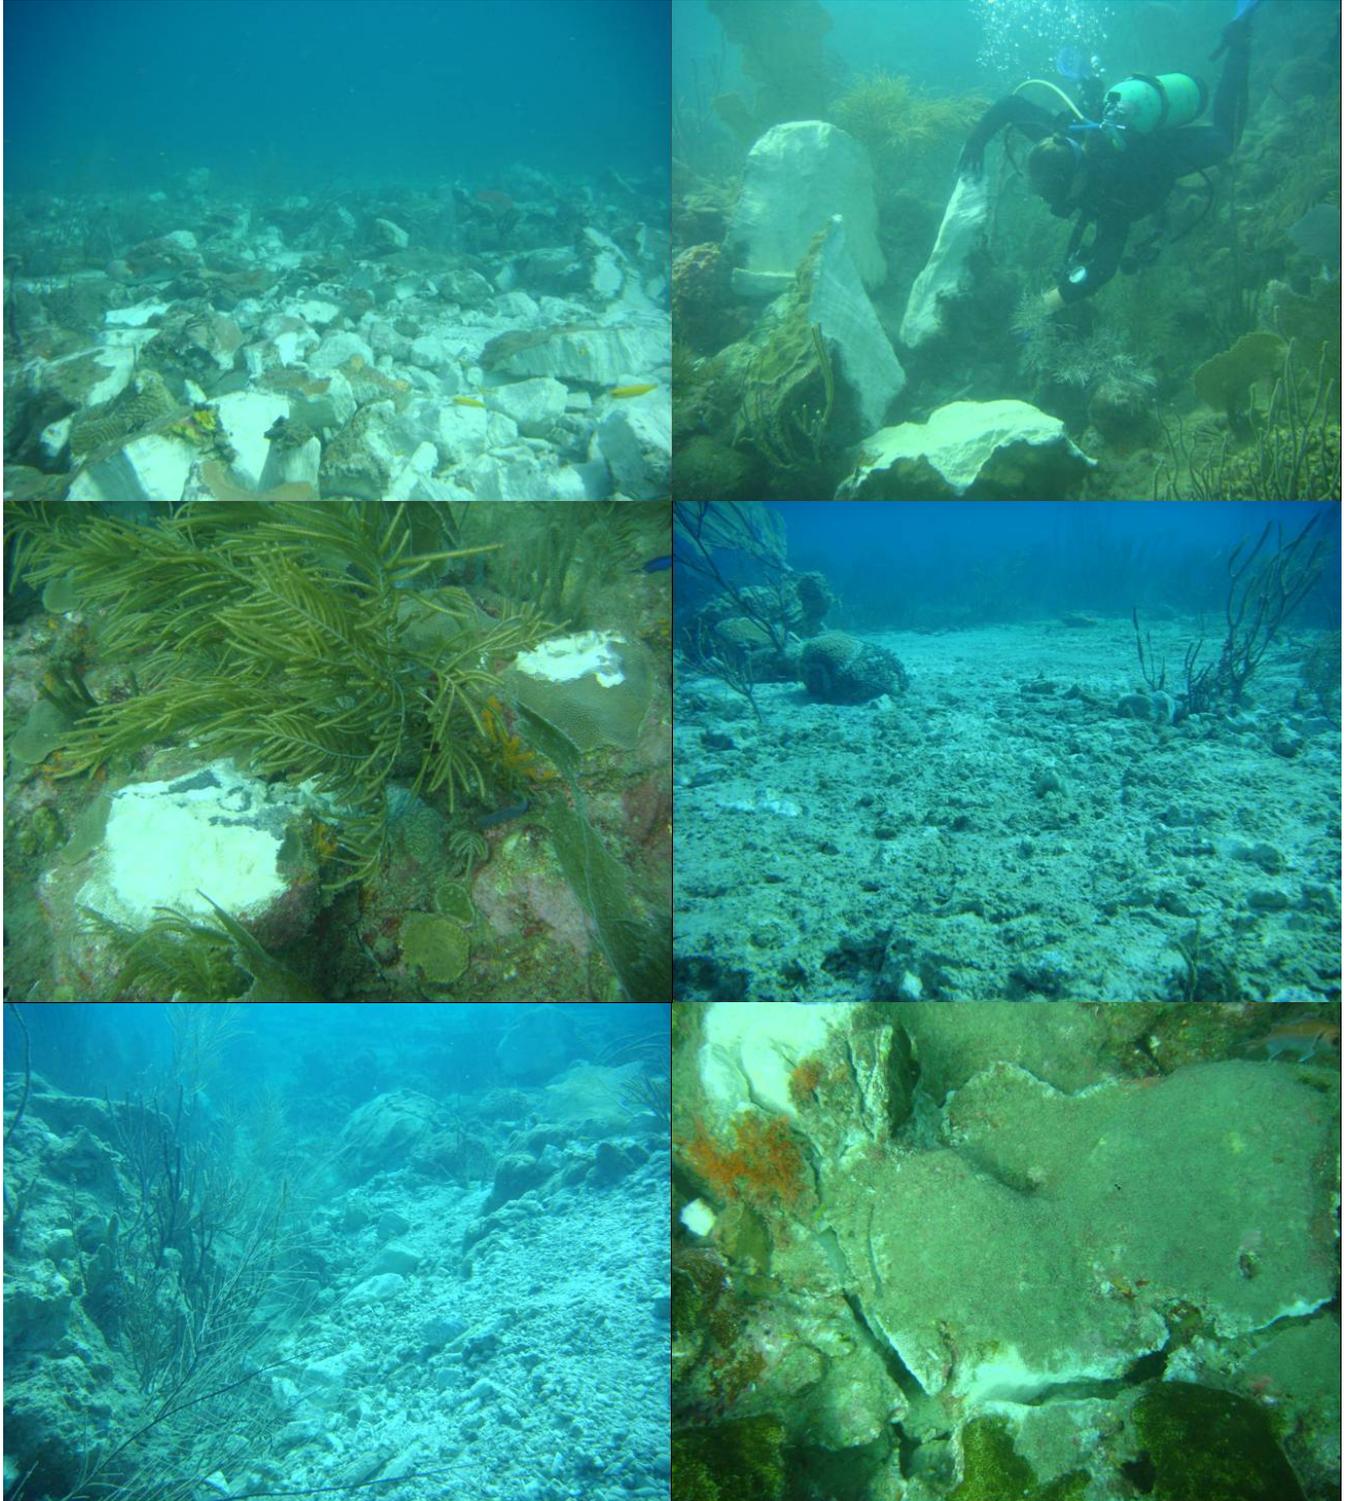
The injured site is variable and includes flat scarring, toppled, broken and crushed rock and corals, scattered rubble, burial, broken or slumped ledge outcrops as well as substantial structural fracturing in the underlying substrata (**Figure 4**). There is also bottom paint in chips and embedded into cracks and crevices. Although there are no large deposits of paint, there is considerable large rubble created by crushing. There are no large berms of rubble though many of the grooves were infilled with

rubble. Nonetheless, the large-sized rubble at the site is substantial and will likely constitute the majority of effort to stabilize and re-create structure during emergency/primary restoration. It appears the majority of injury occurred within one continuous area with some additional isolated injury along the periphery (primarily to the West and Southwest) as depicted in a schematic of the injury features (**Figure 5**). The areas of isolated injury, mostly of less than 5 square meters each, comprise an additional area of approximately 100-200 square meters (**Figure 6**). The main flattened area (100% loss of biota and structure) has been initially mapped by the RP representatives as approximately 1,325 square meters. Areas not flattened have been scarred, fractured, buried or otherwise partly affected.

Figure 4. Clockwise from upper left; 1) Large pieces of fractured rubble, 2) Large broken *Montastrea annularis* colony, 3) Flattened area with fine sediment, 4) fractured reef substrate, 5) Burial in reef groove with small rubble, and 6) Isolated injury area to the west of the main injury site.

Areas of re-attachment will be the main flat areas (**Figure 4**). Concrete placement will avoid covering existing live biota. The structures will be arranged to present a variety of sizes and shapes (**Figure 9**) with special consideration of the following:

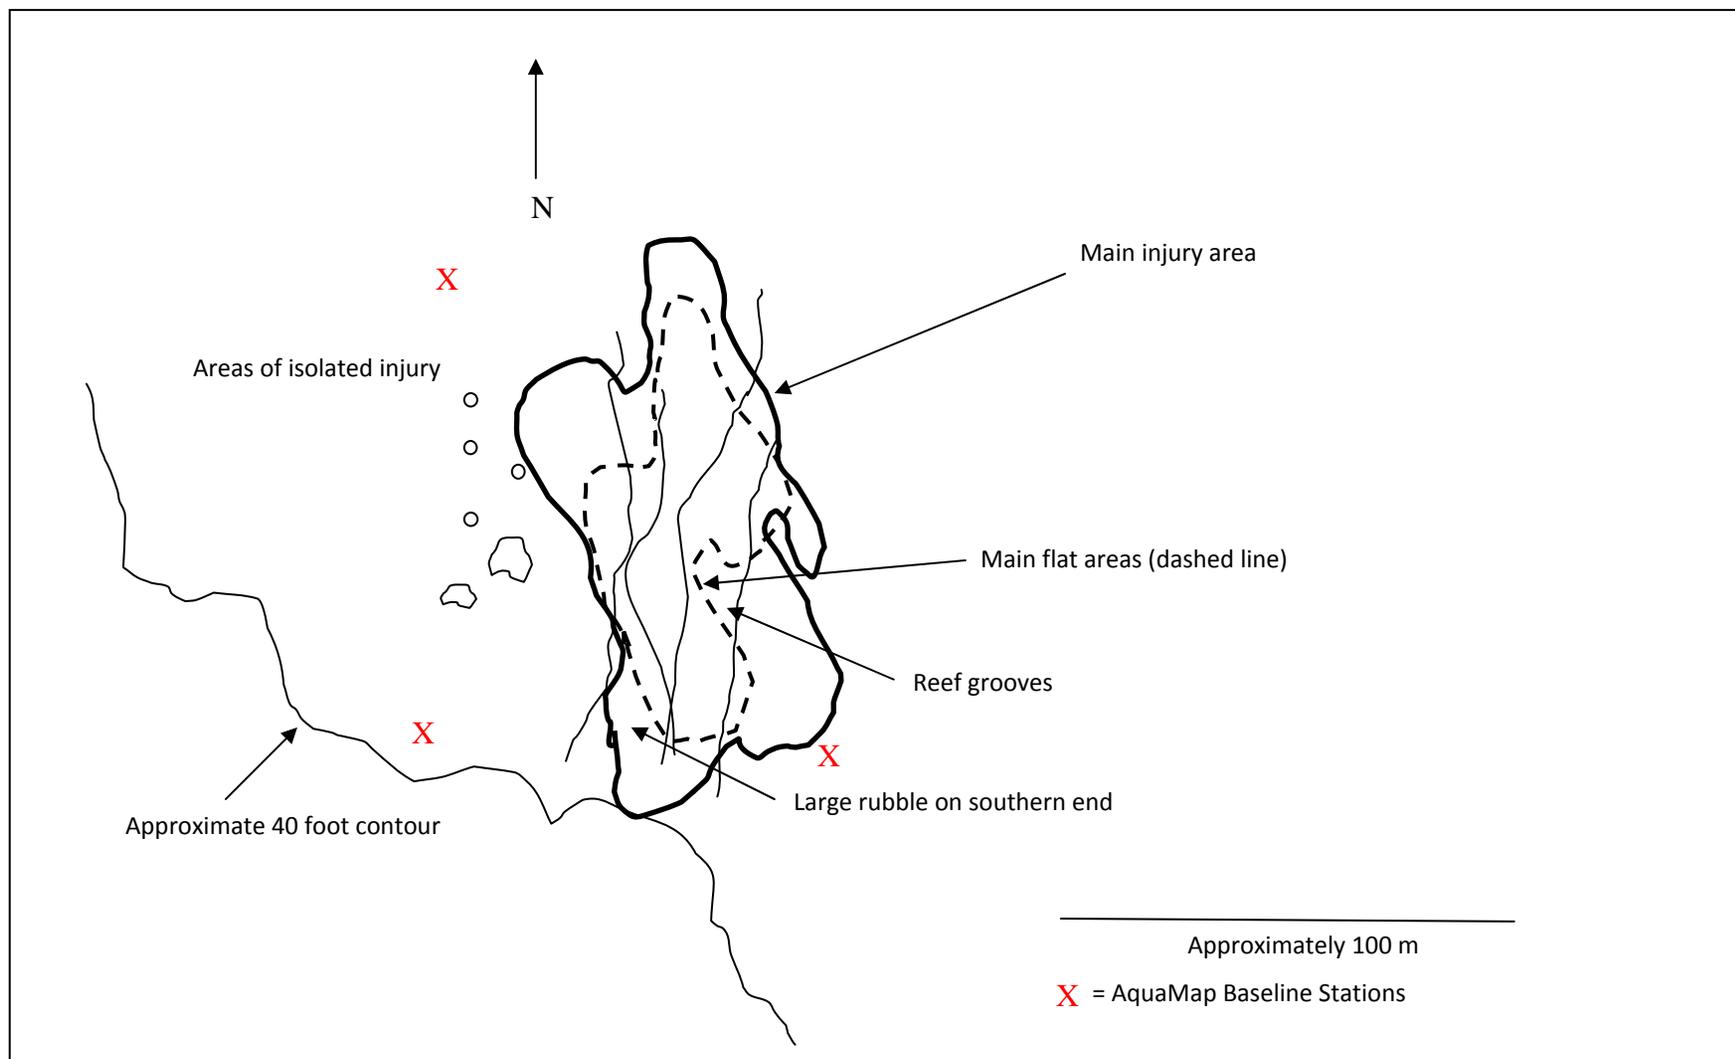
Figure 5. Schematic of injury features. Diagram not to scale and for planning purposes only. AquaMap will create an accurate diagram of the area for restoration planning purposes.

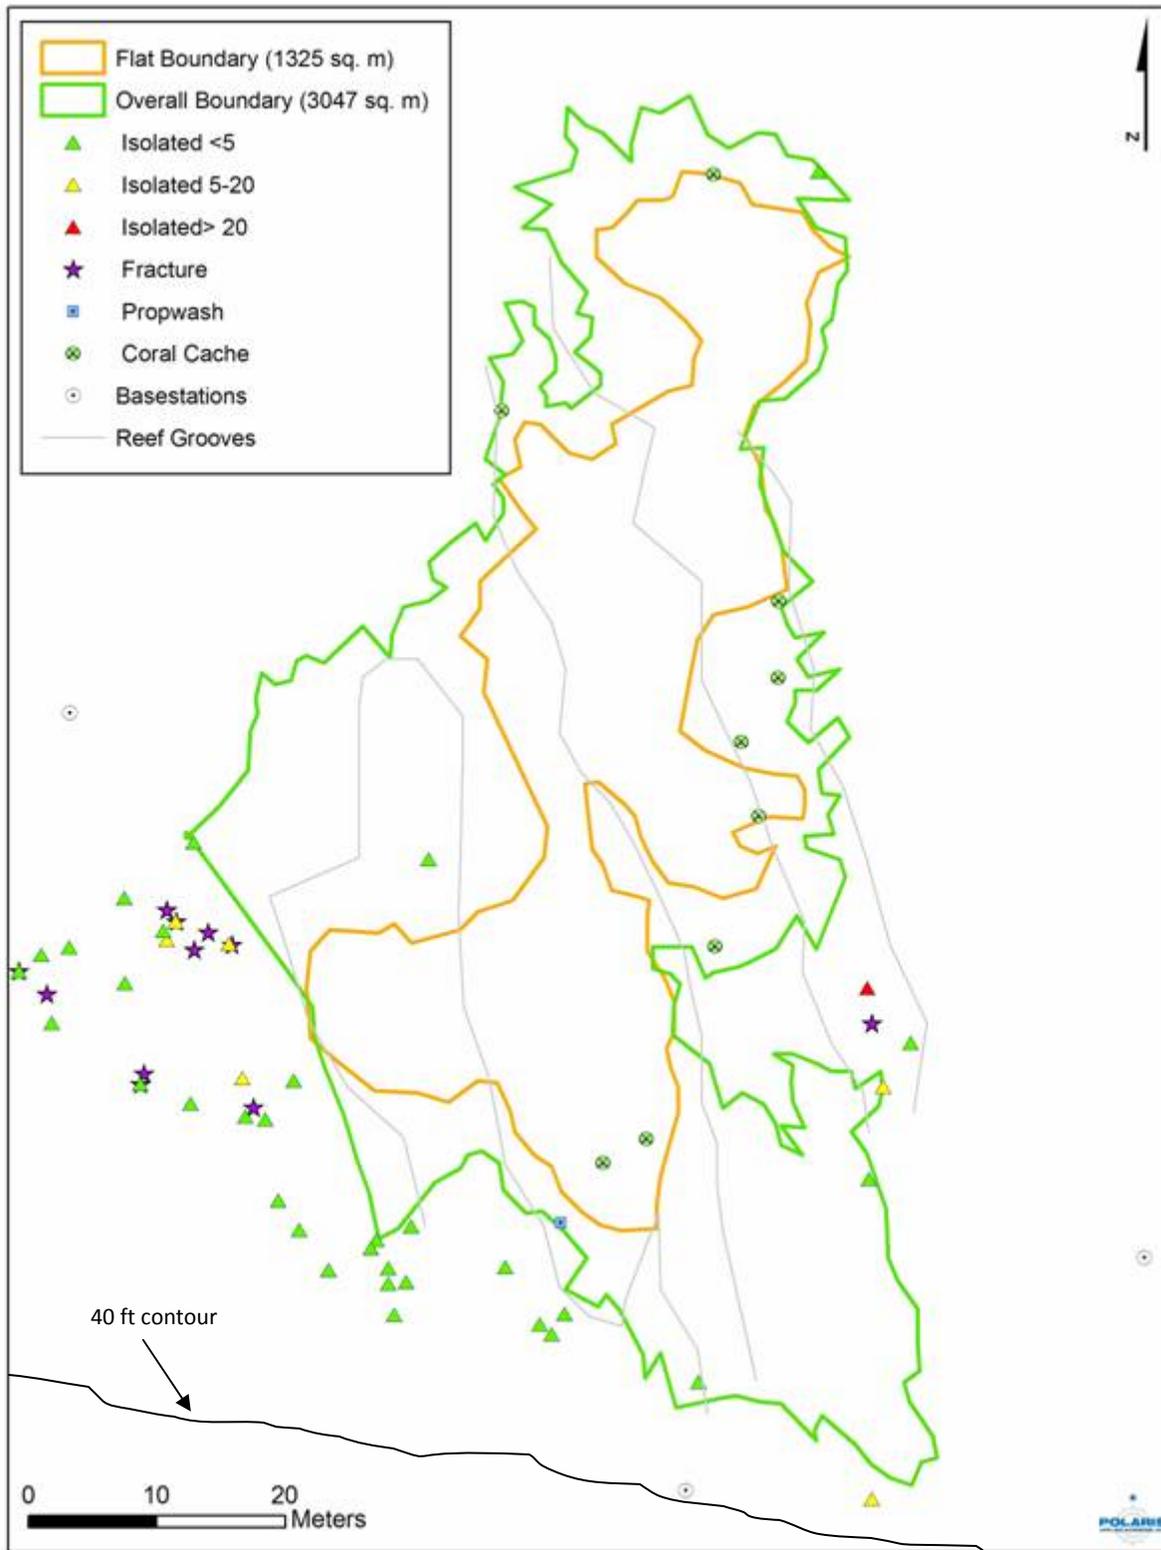
Figure 6. AquaMap of injury areas.

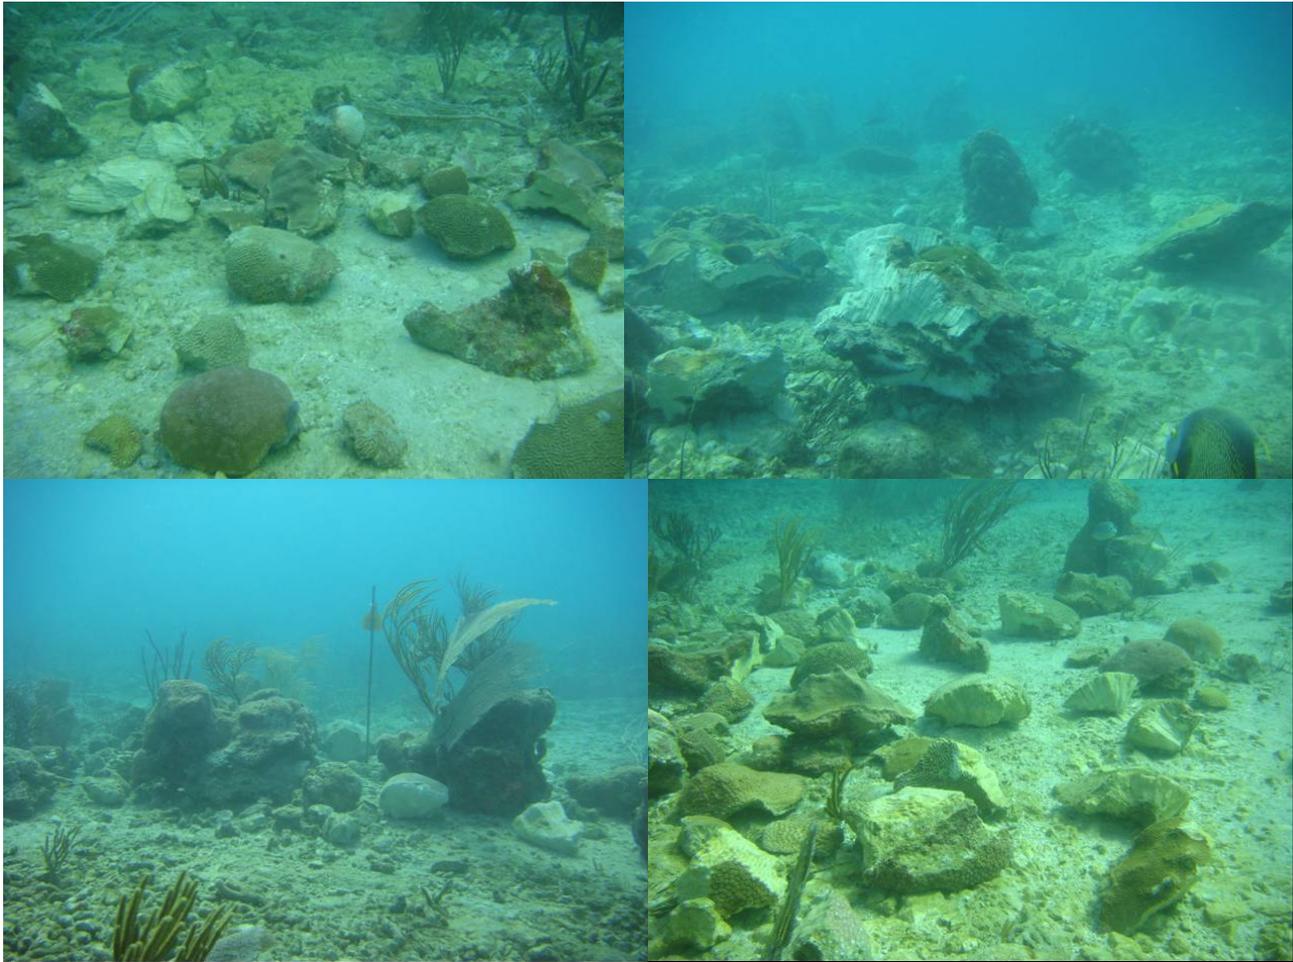
Figure7. Small and large corals temporarily re-located on top of flattened areas for pending restoration.

Collect and store as many re-attachable coral fragments as can be located (**Figure 7**). This is defined as corals or coral tissue of a size that can be easily manipulated by divers and is in good condition. This is generally a size of greater than 10 centimeters. Smaller corals will be re-attached if in good condition. Small fragments in less than good condition generally have a very low survival rate. Good condition refers to dislodged coral with a large portion of the tissue intact, and sponges and soft corals dislodged with basal structures intact.

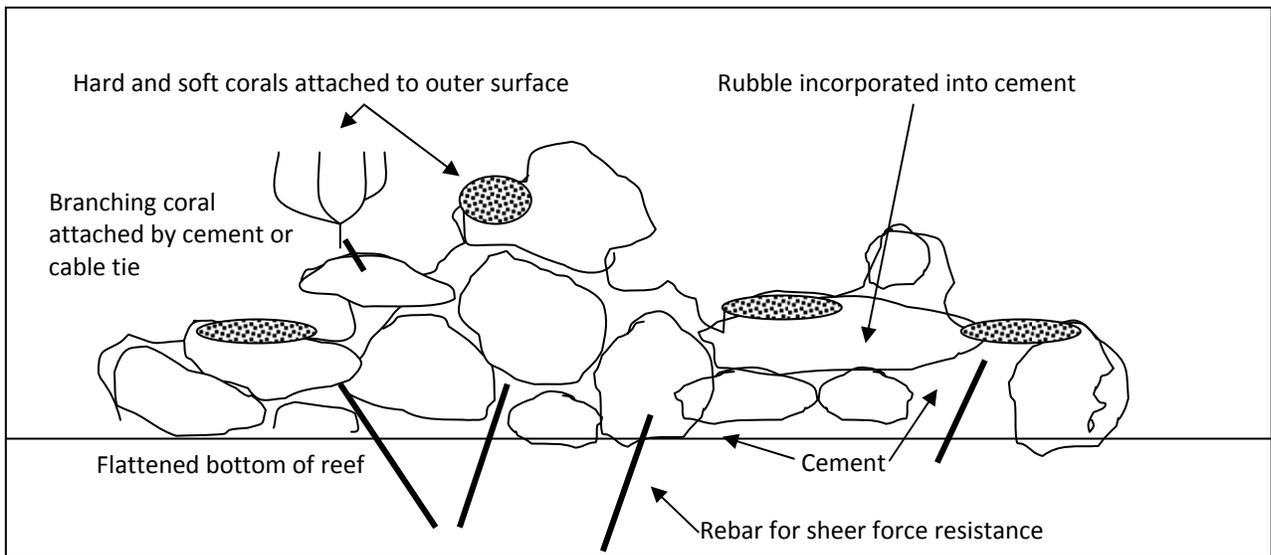
Figure 8. Schematic of rubble/concrete and coral structure.

Material used to restore structure at the site will be secured with Marine Portland (Type II if available) cement with a 50% mix of clean silica sand. The concrete will be mixed in a

cement mixer or drill on the vessel to a thick consistency to avoid dissolution and sedimentation underwater. While small material can and should be placed directly into cement, larger material will require that rebar is driven into a void space and cement is poured between boulders. When building the foundation of larger limestone structures, divers will work to ensure, to the maximum extent practical, that cement is poured prior to directly adjacent concrete becoming dry. If it is not practical to pour all cement within a structure's foundation at the same time, horizontal rebar shall be placed sticking out of the poured cement into the area remaining to be poured.

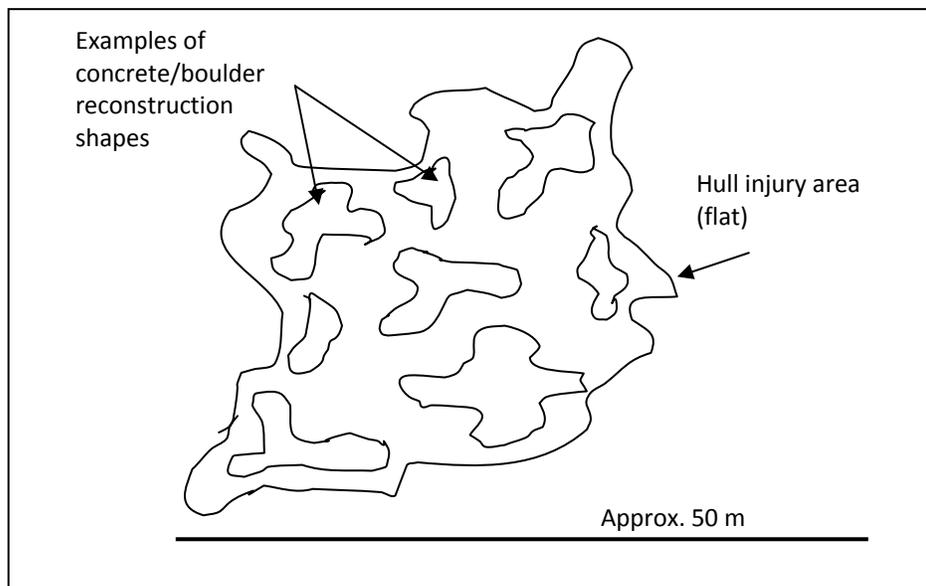
Figure 9. Example schematic overview of proposed primary restoration area.

- Where practical, structures should be close to the existing edges at some point since it will help decrease chances of site erosion and/or expansion and may aid recruitment and recovery (edge effect).

- In areas with sufficient hard structure exposed, a minimum structure size of ~2 square meters will ensure structures are resistant to movement in swells. Increased sheer force resistance will be accomplished by placing cut-nails or rebar into the subsurface prior to cementation.

- In areas of the site where significant structural damage has occurred and it is not feasible or possible to expose sufficient hard stable substrate, the minimum structure size will be increased to a minimum of ~14 square meters and a minimum weight of 2 tons. These structures should be built around a minimum of one large (> 1m) piece of limestone to further enhance stability. The larger structures will ensure that even if further site erosion takes place, the structures will have sufficient weight to remain on their own, absent being structurally tied to the bottom. Increased sheer force resistance will be accomplished by driving rebar to resistance into the subsurface prior to cementation.

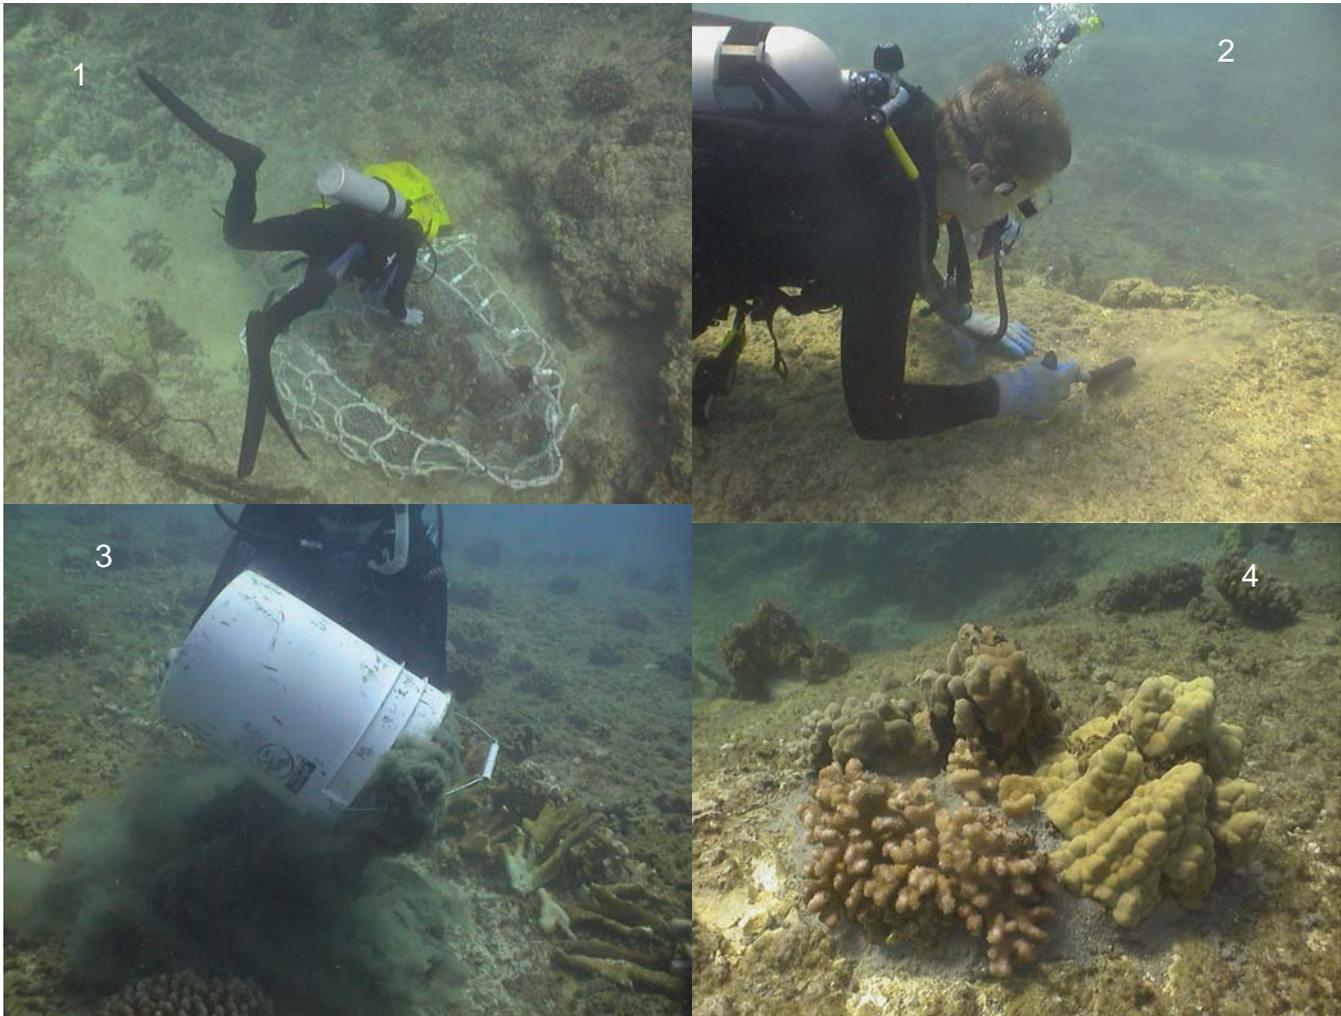
Figure 10. 1) Collecting corals. 2) Preparing the surface. 3) Pouring cement. 4) Re-attached group of corals.

Surface preparation will include “cleaning” algae from the limestone substratum and underside of object being re-attached such that cement re-attachment will not fail (**Figure 10**). Wire brushes could be used to clear the surface of algae. All reef surfaces for re-attachment will include previously injured areas with clear and stable surfaces

Corals and other biota will be re-attached with Marine Portland (Type II if available) cement with a 50% mix of clean silica sand. The cement will be mixed on the vessel to a thick consistency to avoid dissolution and sedimentation underwater. Cement will be placed in 5-gallon buckets with lids and lowered carefully to the bottom directly over the work site. Smaller corals may be also attached utilizing a two part underwater epoxy. No adhesive material other than the minimum amount of cement or epoxy to secure a fast position will be deposited on-site.
