Appendix H3: Macroinvertebrate Report 2012

MICHIGAN DEPARTMENT OF ENVIRONMENTAL QUALITY
WATER RESOURCES DIVISION
APRIL 2013

STAFF REPORT

A BIOLOGICAL SURVEY OF SITES ON THE KALAMAZOO RIVER AND TALMADGE CREEK
NEAR THE ENBRIDGE OIL SPILL IN MARSHALL
CALHOUN COUNTY, MICHIGAN
SEPTEMBER 2012

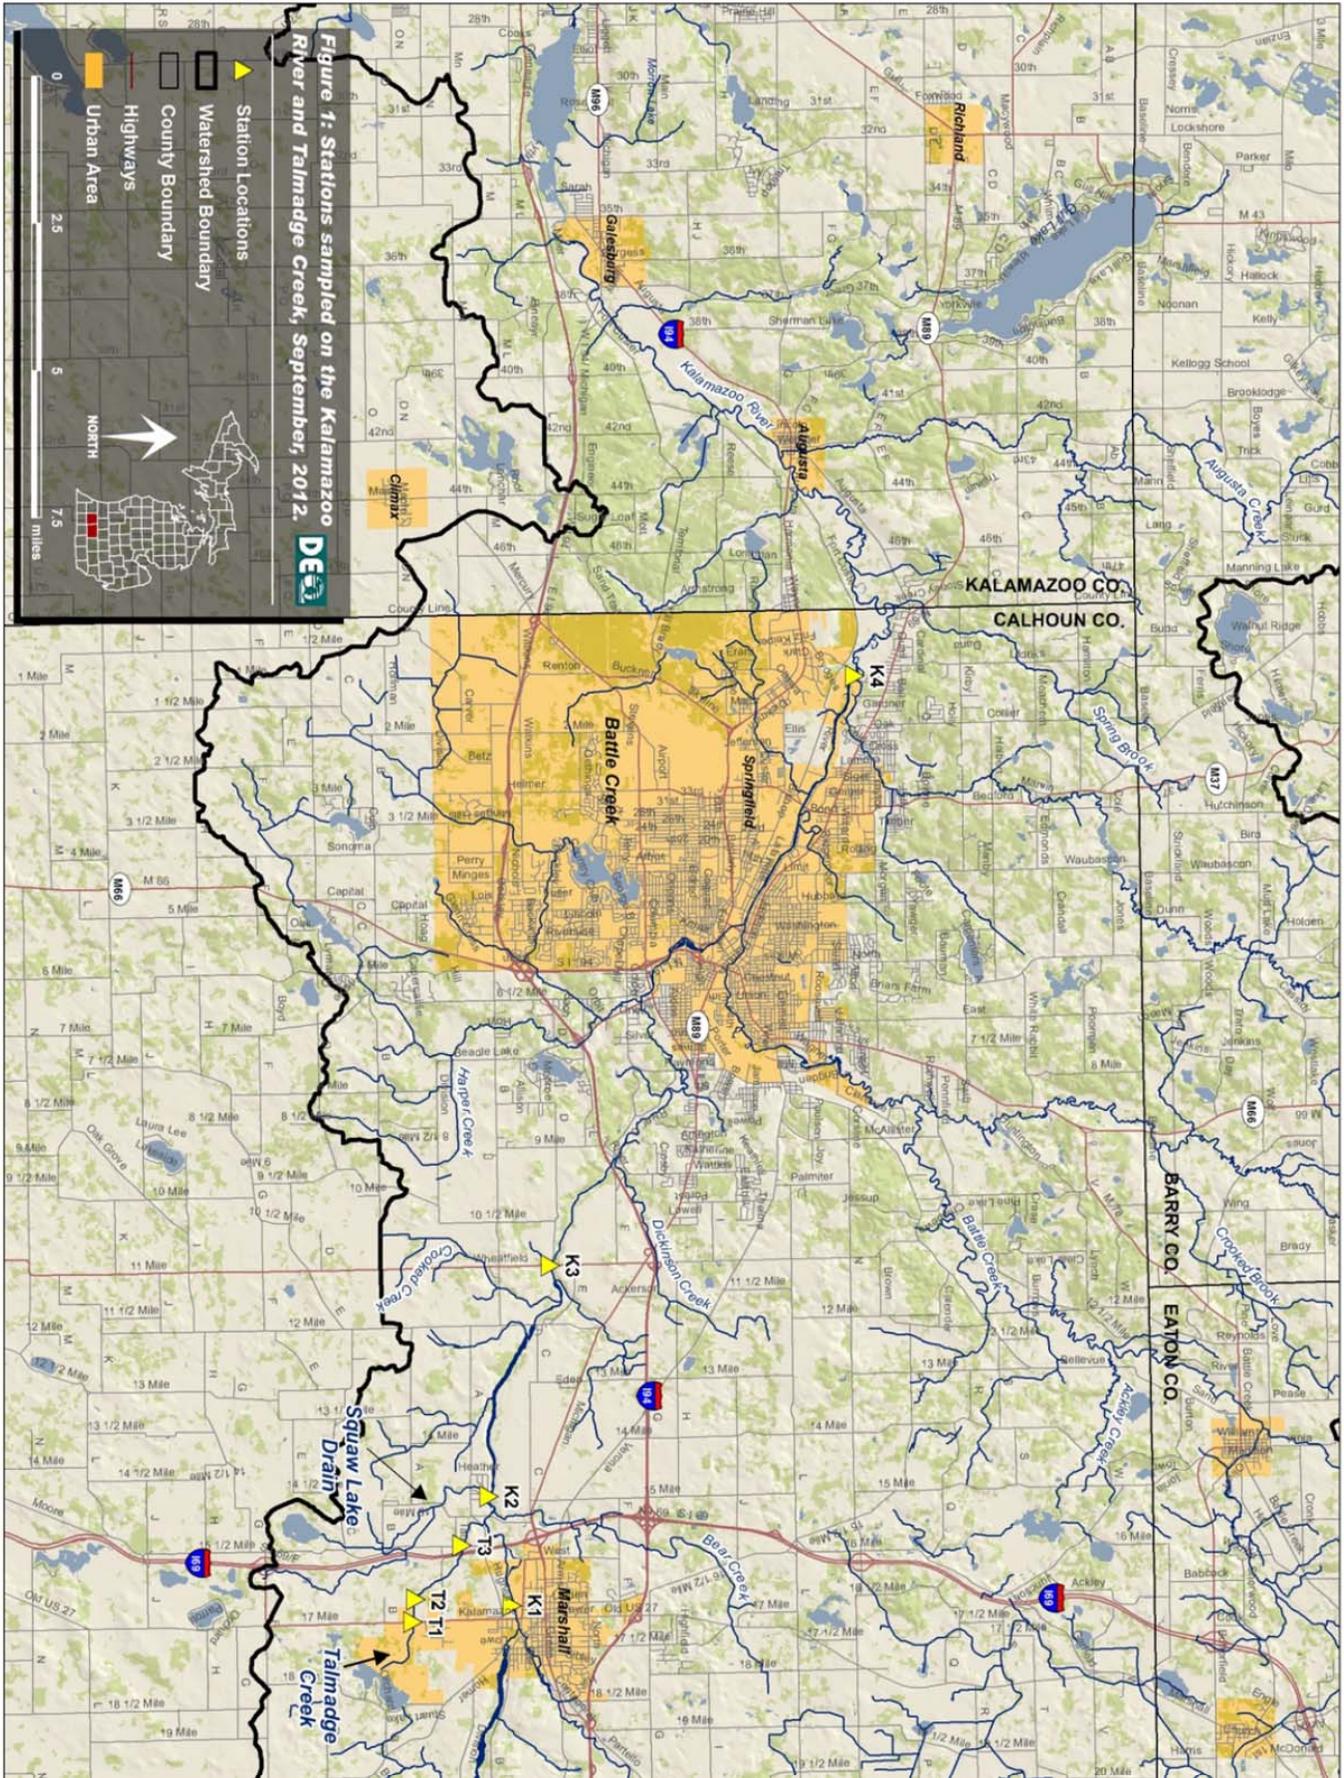
Figure 1. Stations sampled on the Kalamazoo River and Talmadge Creek, September 2012.

Sampling locations are shown in Figure 1.

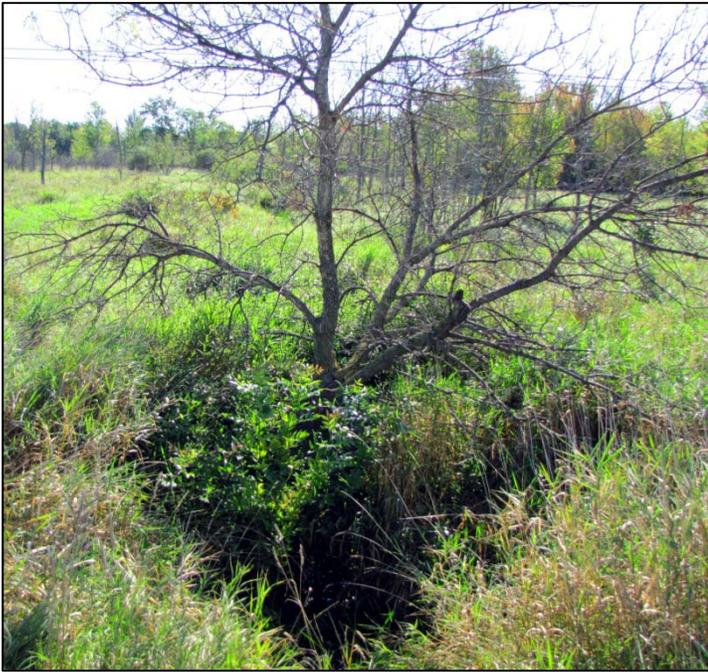
Figure 2. Site T1 upstream reference site. This site is more of a wetland site than the more downstream locations (T2 and T3). T1 was unable to be sampled in 2012 due to low water levels. Photo taken by William Taft, 2011.

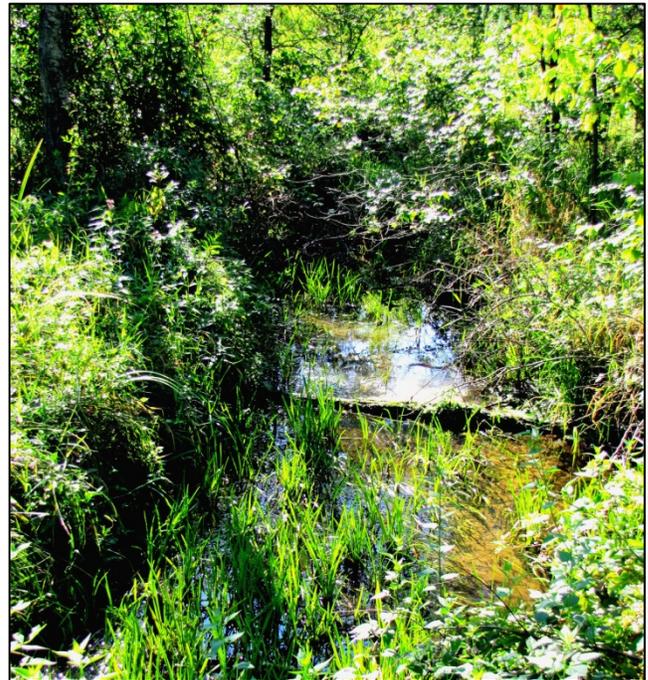
Figure 4. Site T2 upstream reference location. This site was sampled as a reference location in 2010, 2011, and 2012. T2 is heavily vegetated and comparable in flow to T3 (impacted site). Photo by William Taft, 2011.

Riffle habitat at Station T2 was lacking and sand was the predominant substrate, but some gravel and cobble were present along with an abundance of in-stream cover. The riparian corridor was a wide, undisturbed scrub/shrub wetland.

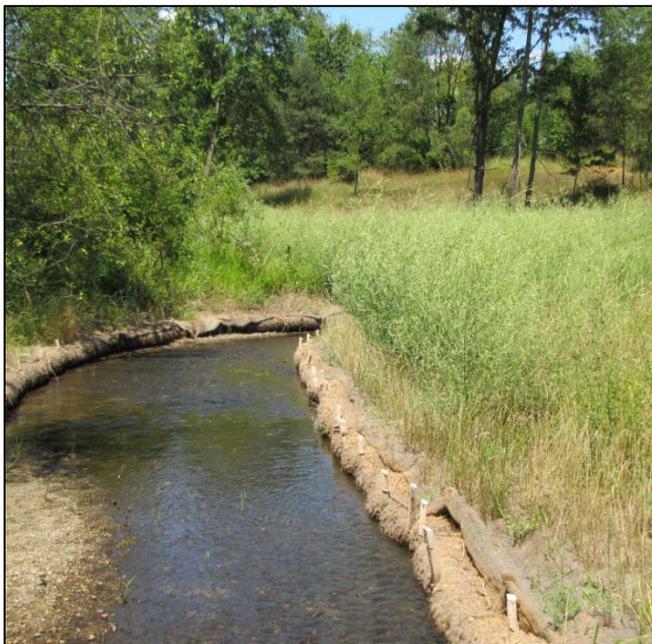
Figure 3. Site T3 on Talmadge Creek. Image shows open canopy and artificial structure along stream bank. Photo by William Taft, 2011.

In 2010, the in-stream habitat, stream banks, and adjacent riparian corridor at Station T3 were highly disturbed due to the cleanup activities and were rated as marginal. In 2011, after the August 2011 survey, additional cleanup operations were conducted on Talmadge Creek that involved dredging the stream banks and channel. The overall 2012 habitat score was slightly higher than in 2011, but still on the lower end of “good.” The stream banks and riparian zone were stabilized with vegetative cover and various structures. The stream channel remains narrower than in 2010. Riffle habitat was present, but in-stream cover was still extremely limited. The substrate was primarily sand and small gravel with a limited amount of cobble still present. The disturbance from cleanup activities has effectively created a clean channel that is silt free.

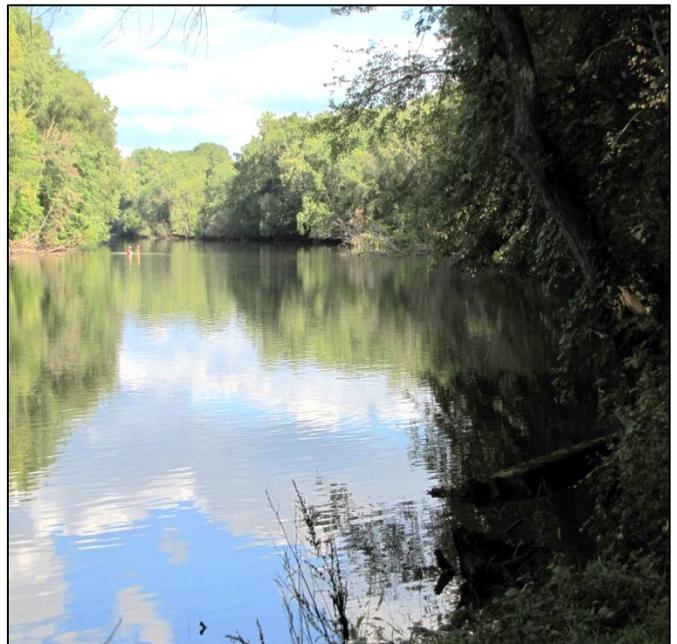
Figure 5. Site K4, Upstream of Custer Drive on the Kalamazoo River. This site is much wider and slower than any of the upstream Kalamazoo River or Talmadge Creek Sites. Photo by William Taft, 2011.

Station K4 (Upstream of Custer Road), is substantially larger in average width and depth than the other sites surveyed (Figure 5). This station was rated “good;” the same as in 2011. The in-stream habitat suitable for colonization is limited at this site, but the wide, forested floodplain helps to increase its habitat score. Sand and silt make up approximately 85 percent of the

substrate at this site, with only small, scattered patches of gravel present. Large woody debris resulting from dead trees and wind storms make up the majority of in-stream habitat. Aquatic vegetation, overhanging vegetation, and undercut banks are also present in limited quantities at this location.
