APPENDIX A

Figures & Tables

Concord River Diadromous Fish Restoration Feasibility Study

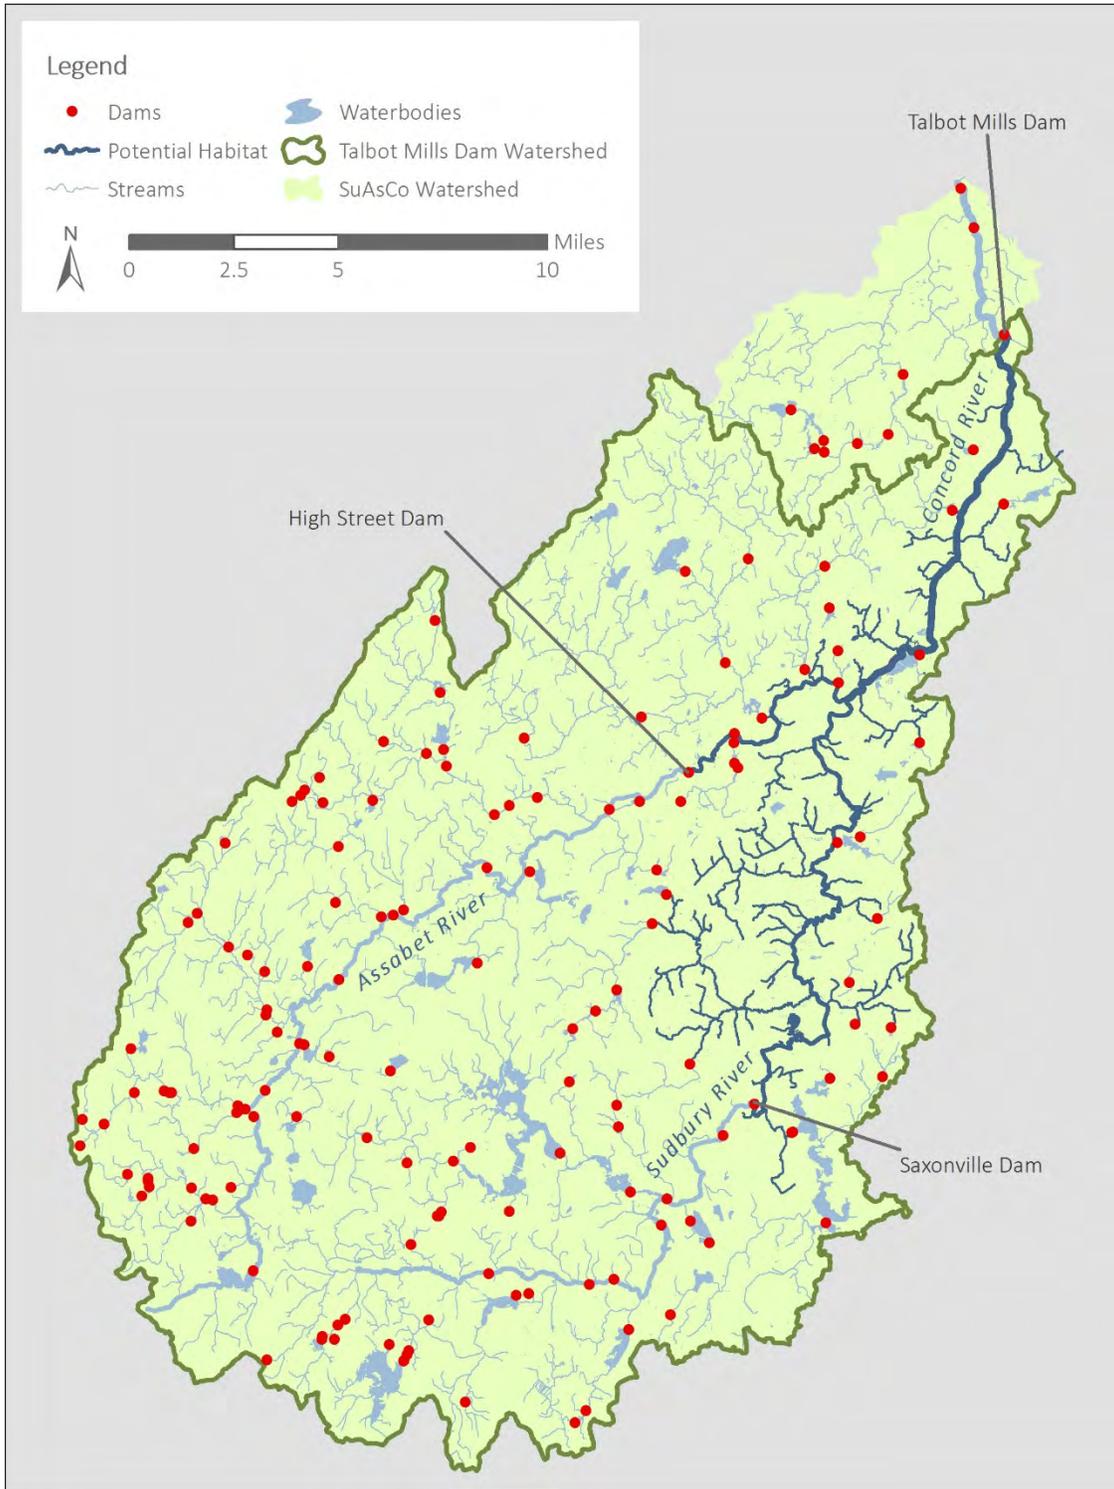
Figure 2.1.1-6: Potential Diadromous Fish Habitat upstream of Talbot Mills Dam

Note: This analysis included available habitat between the Talbot Mills Dam and the next upstream dam on the Assabet River, Sudbury River, and tributaries. It did not consider other potential barriers to fish passage such as culverts. Data Sources: Streams, waterbodies, and SuAsCo watershed from the USGS National Hydrography Dataset (NHD); dams from a database maintained by the ODS available from MassGIS; Talbot Mills Dam watershed delineated from the USGS StreamStats program.

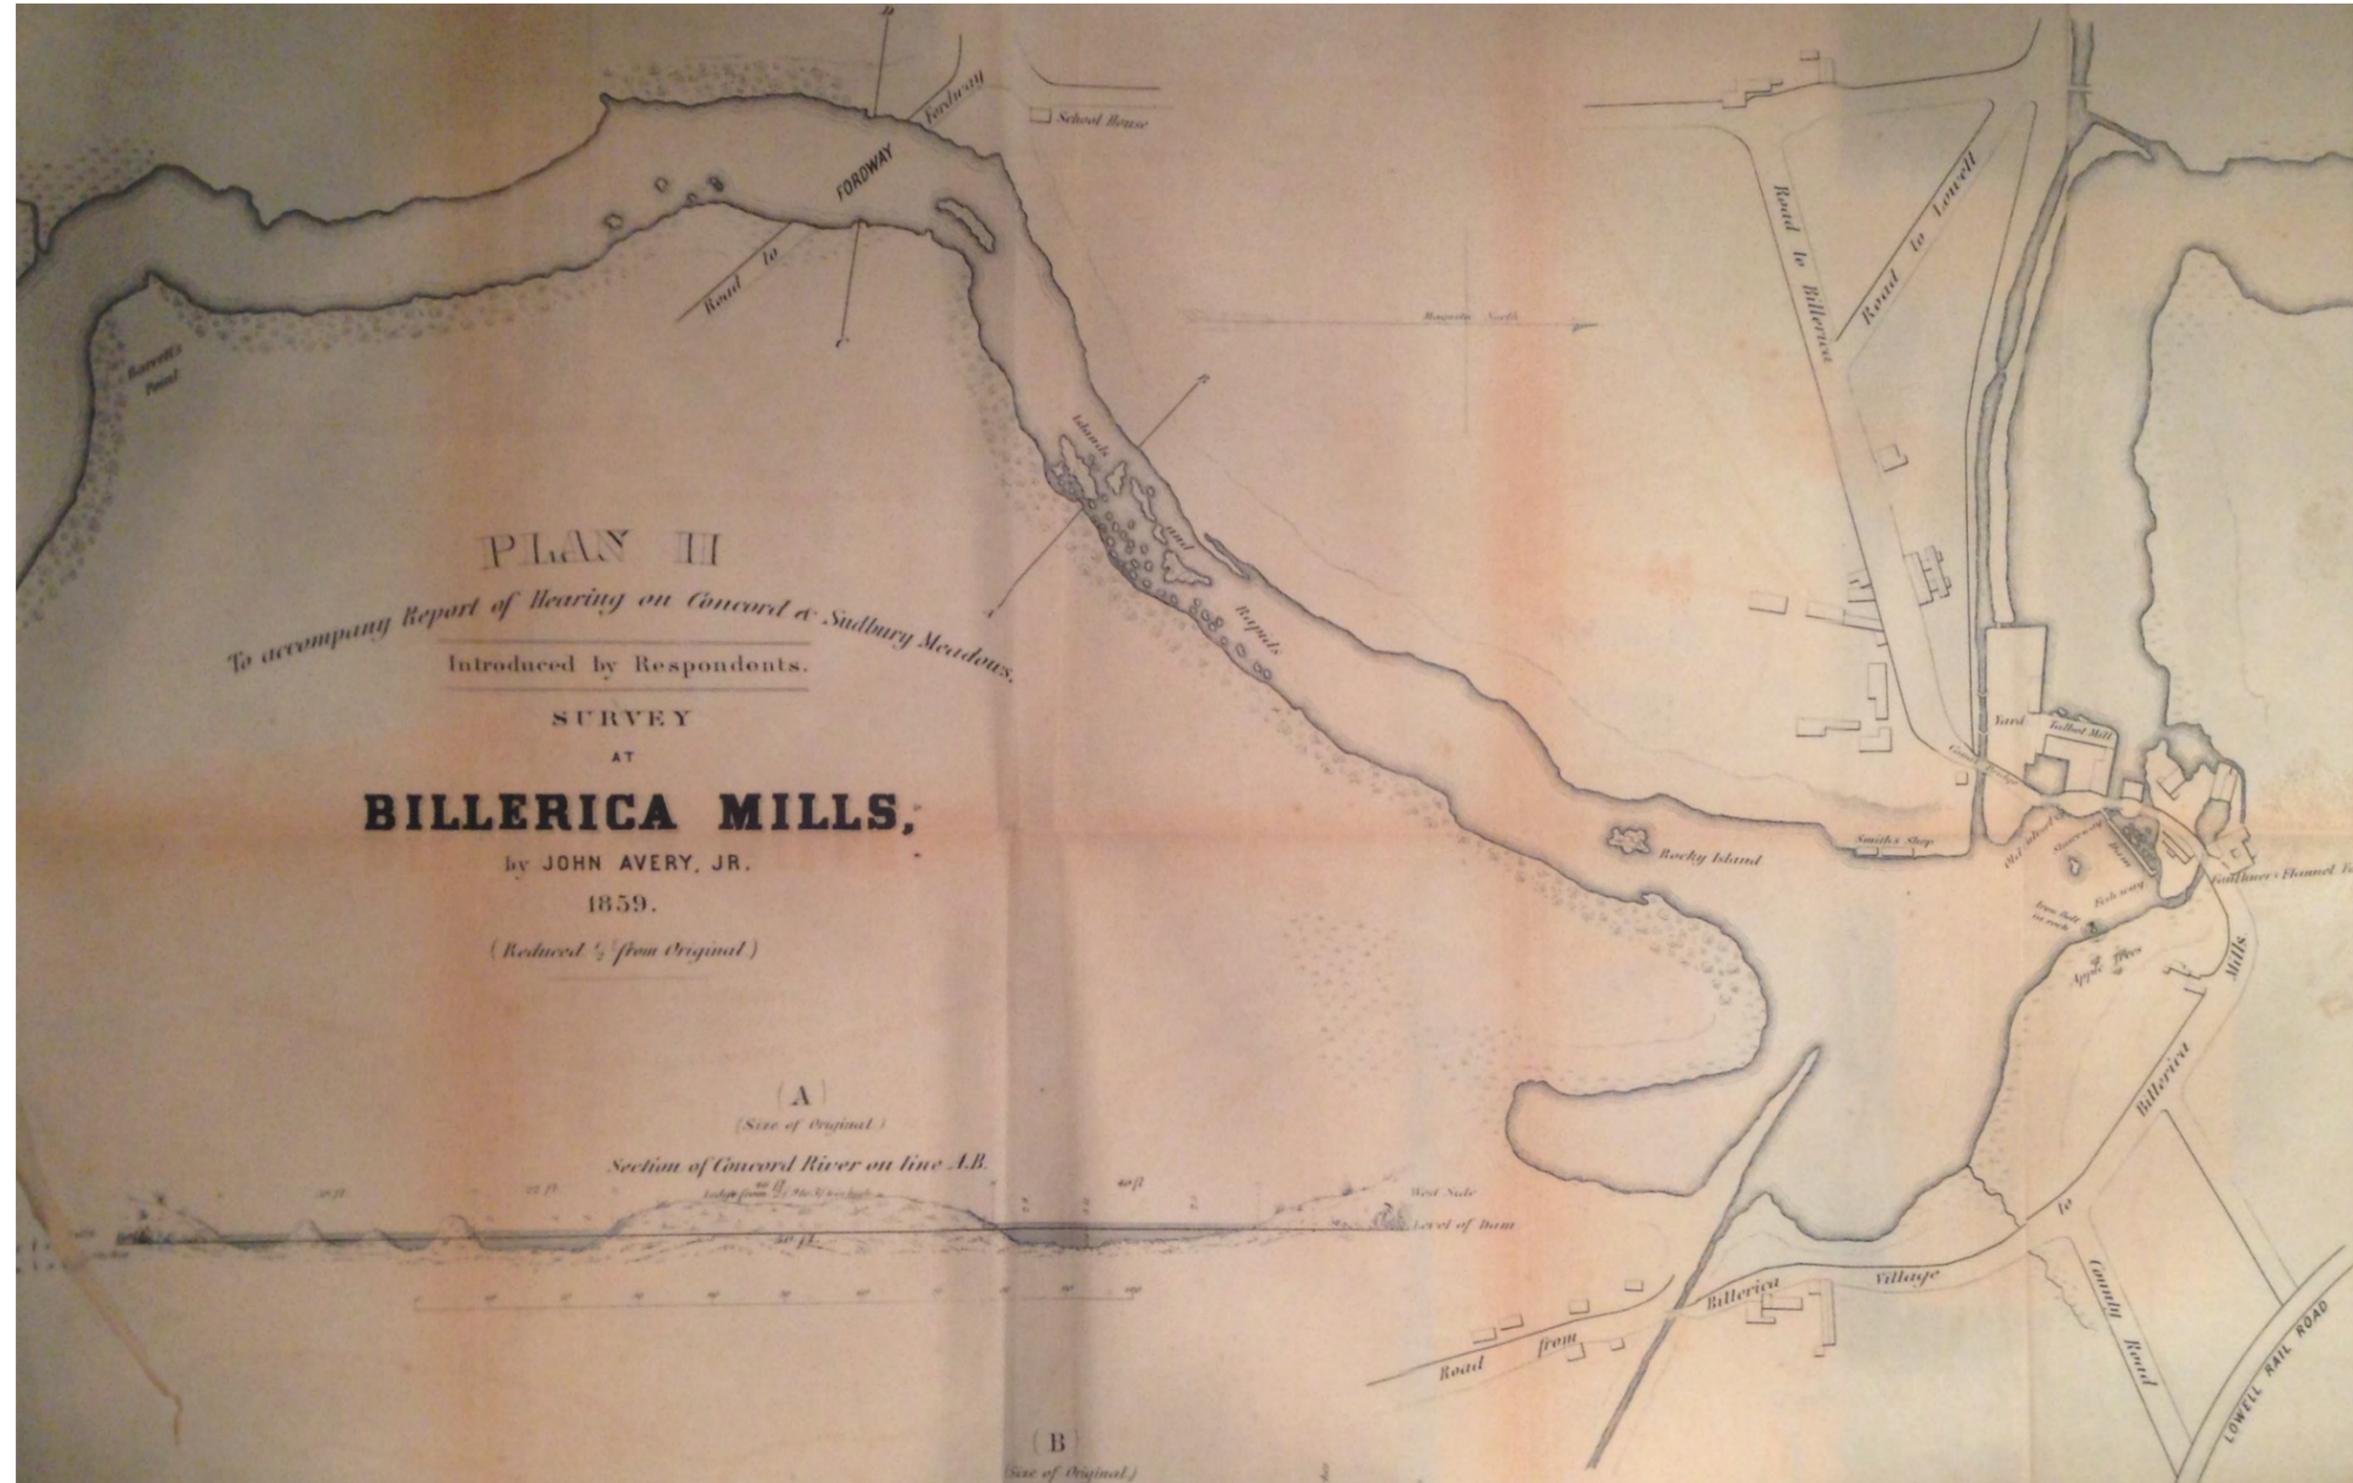
Figure 2.1.2-2: Historical Plan of Billerica Mills Showing Cross-Section of Rapids below Fordway Bar

Source: On display at the Middlesex Canal Museum in North Billerica. Note locations of the Fordway Bar and rapids downstream. Detail [B] showing the cross-section through the Fordway Bar was not included on the copy of the plan obtained for this report. Also note the location of the former fishway at the dam, and the iron bolt used as a benchmark.

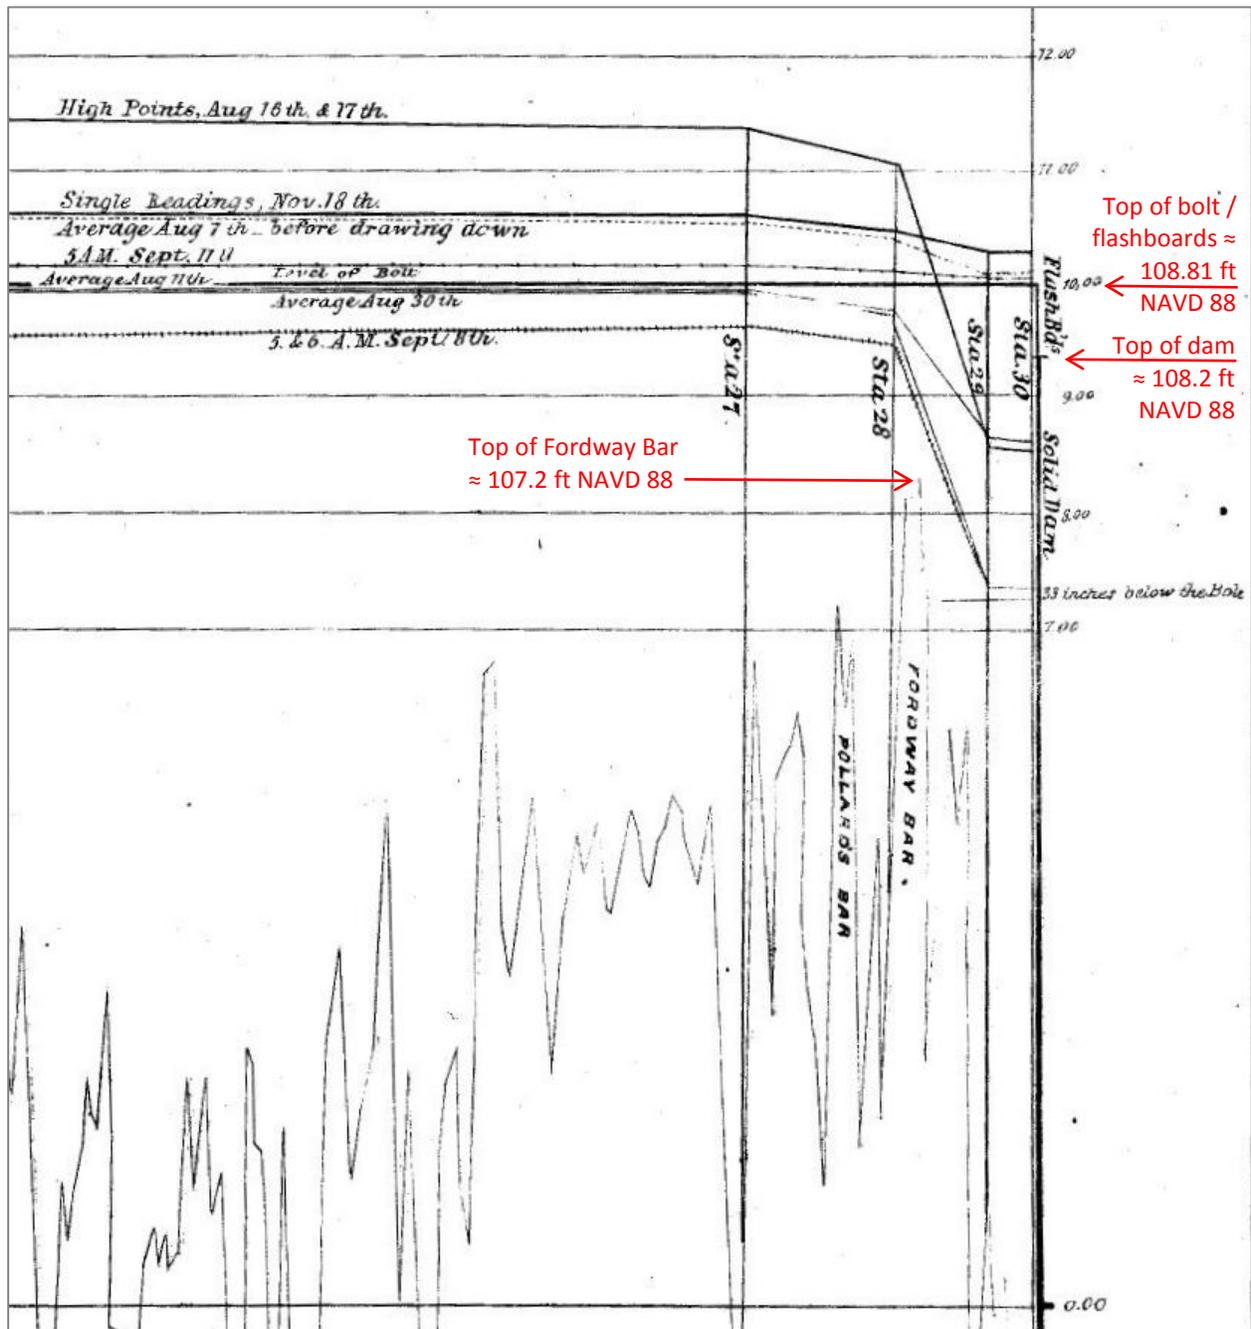
Figure 2.1.2-3: Historical Profile of the Concord River showing the Fordway Bar

Cropped from "Profile of the Concord & Sudbury Rivers, 1861" (Alvord et al., 1862). The 1861 survey used a zero datum 10.00 feet below the top of an iron bolt that had been placed in 1825 at an elevation equal to the top of the flashboards at the dam. In the 1861 study, the elevation of the bolt top was reported as 115.35 feet above the Boston base datum (or mean low water in Boston Harbor), which is 5.65 feet above NVGD 29 and 6.477 feet above NAVD 88, which would make it 108.87 feet NAVD 88. The bolt still exists today and in 2013 its top elevation was re-measured as 108.81 feet NAVD 88 from a temporary benchmark set in 2000 from the 1965 US monument MY0308 (Breen, 2013). Using this reference, elevations for the spillway crest (108.2 feet NAVD 88) and top of the Fordway Bar (107.2 feet) were estimated by scaling from the above profile.

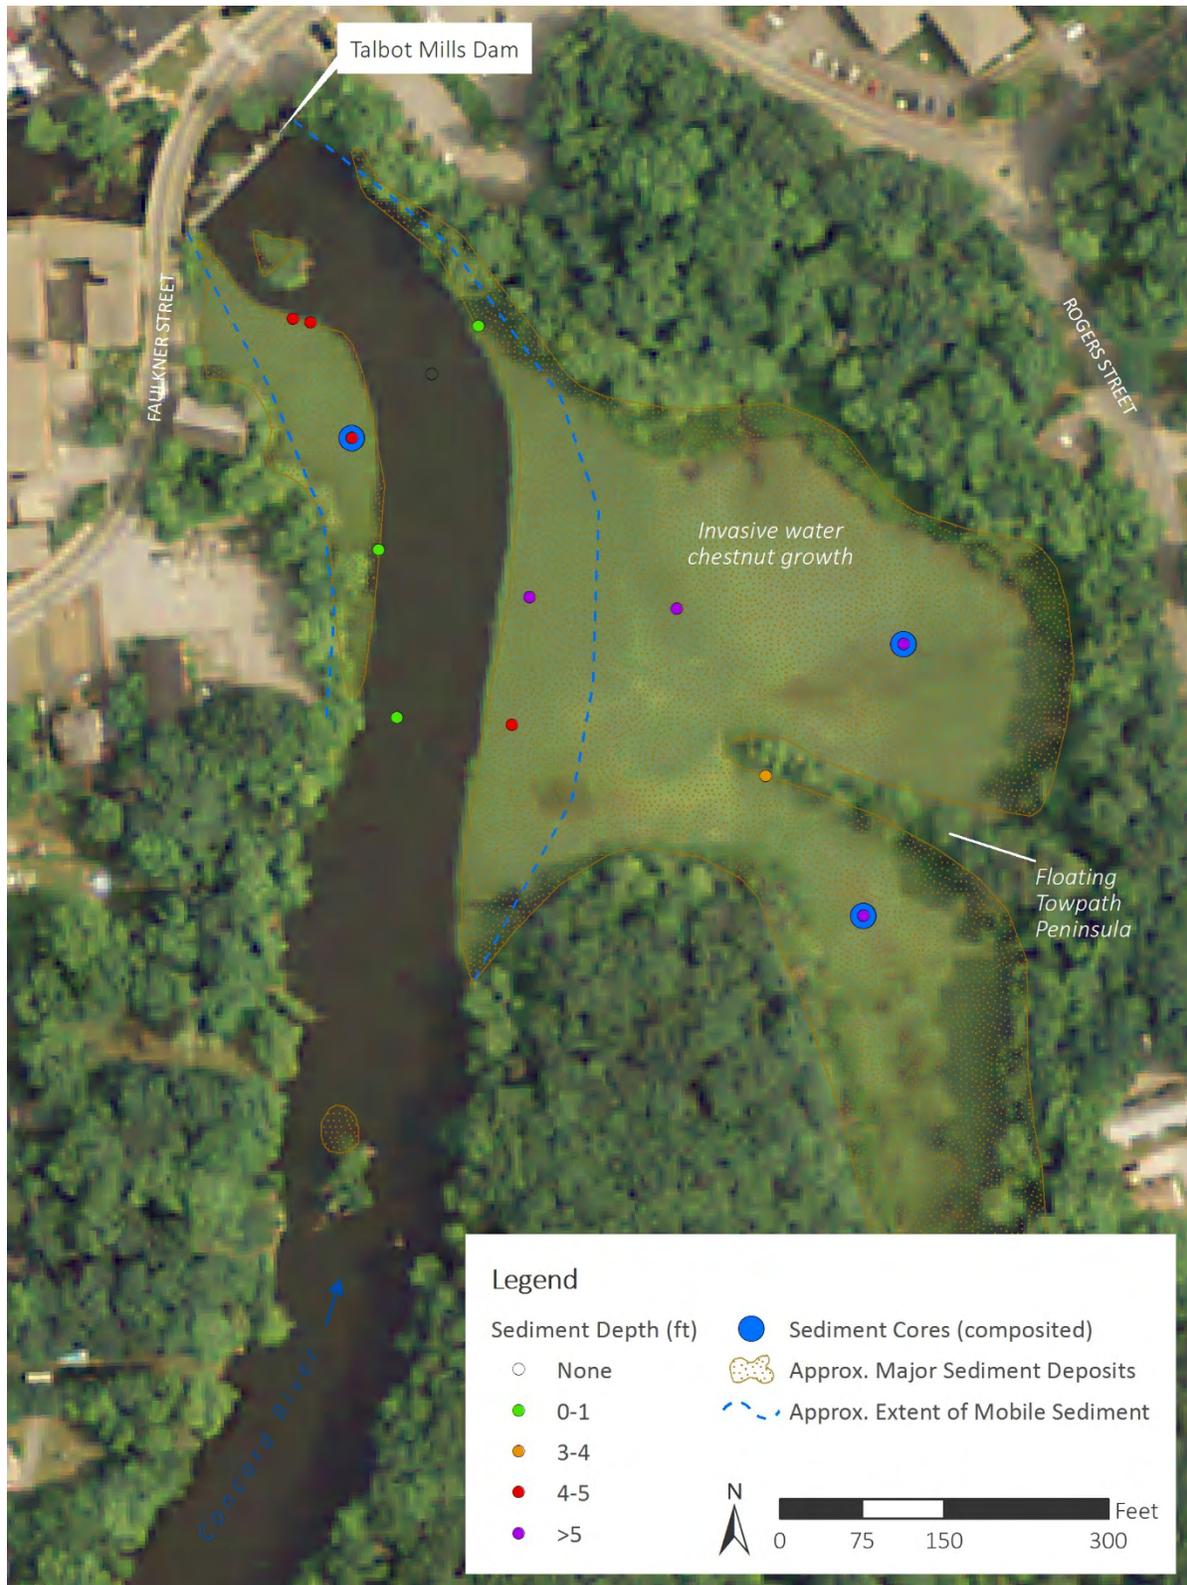
Figure 2.1.5-2: Map of Talbot Mills Dam Impoundment Sediment Probes & Cores (2005)

Source: Breault et al., 2013 (data provided by J. Sorenson). Delineation of approximate edge of major sediment deposits and extent of mobile sediment discussed in **Section 3.2.1**.

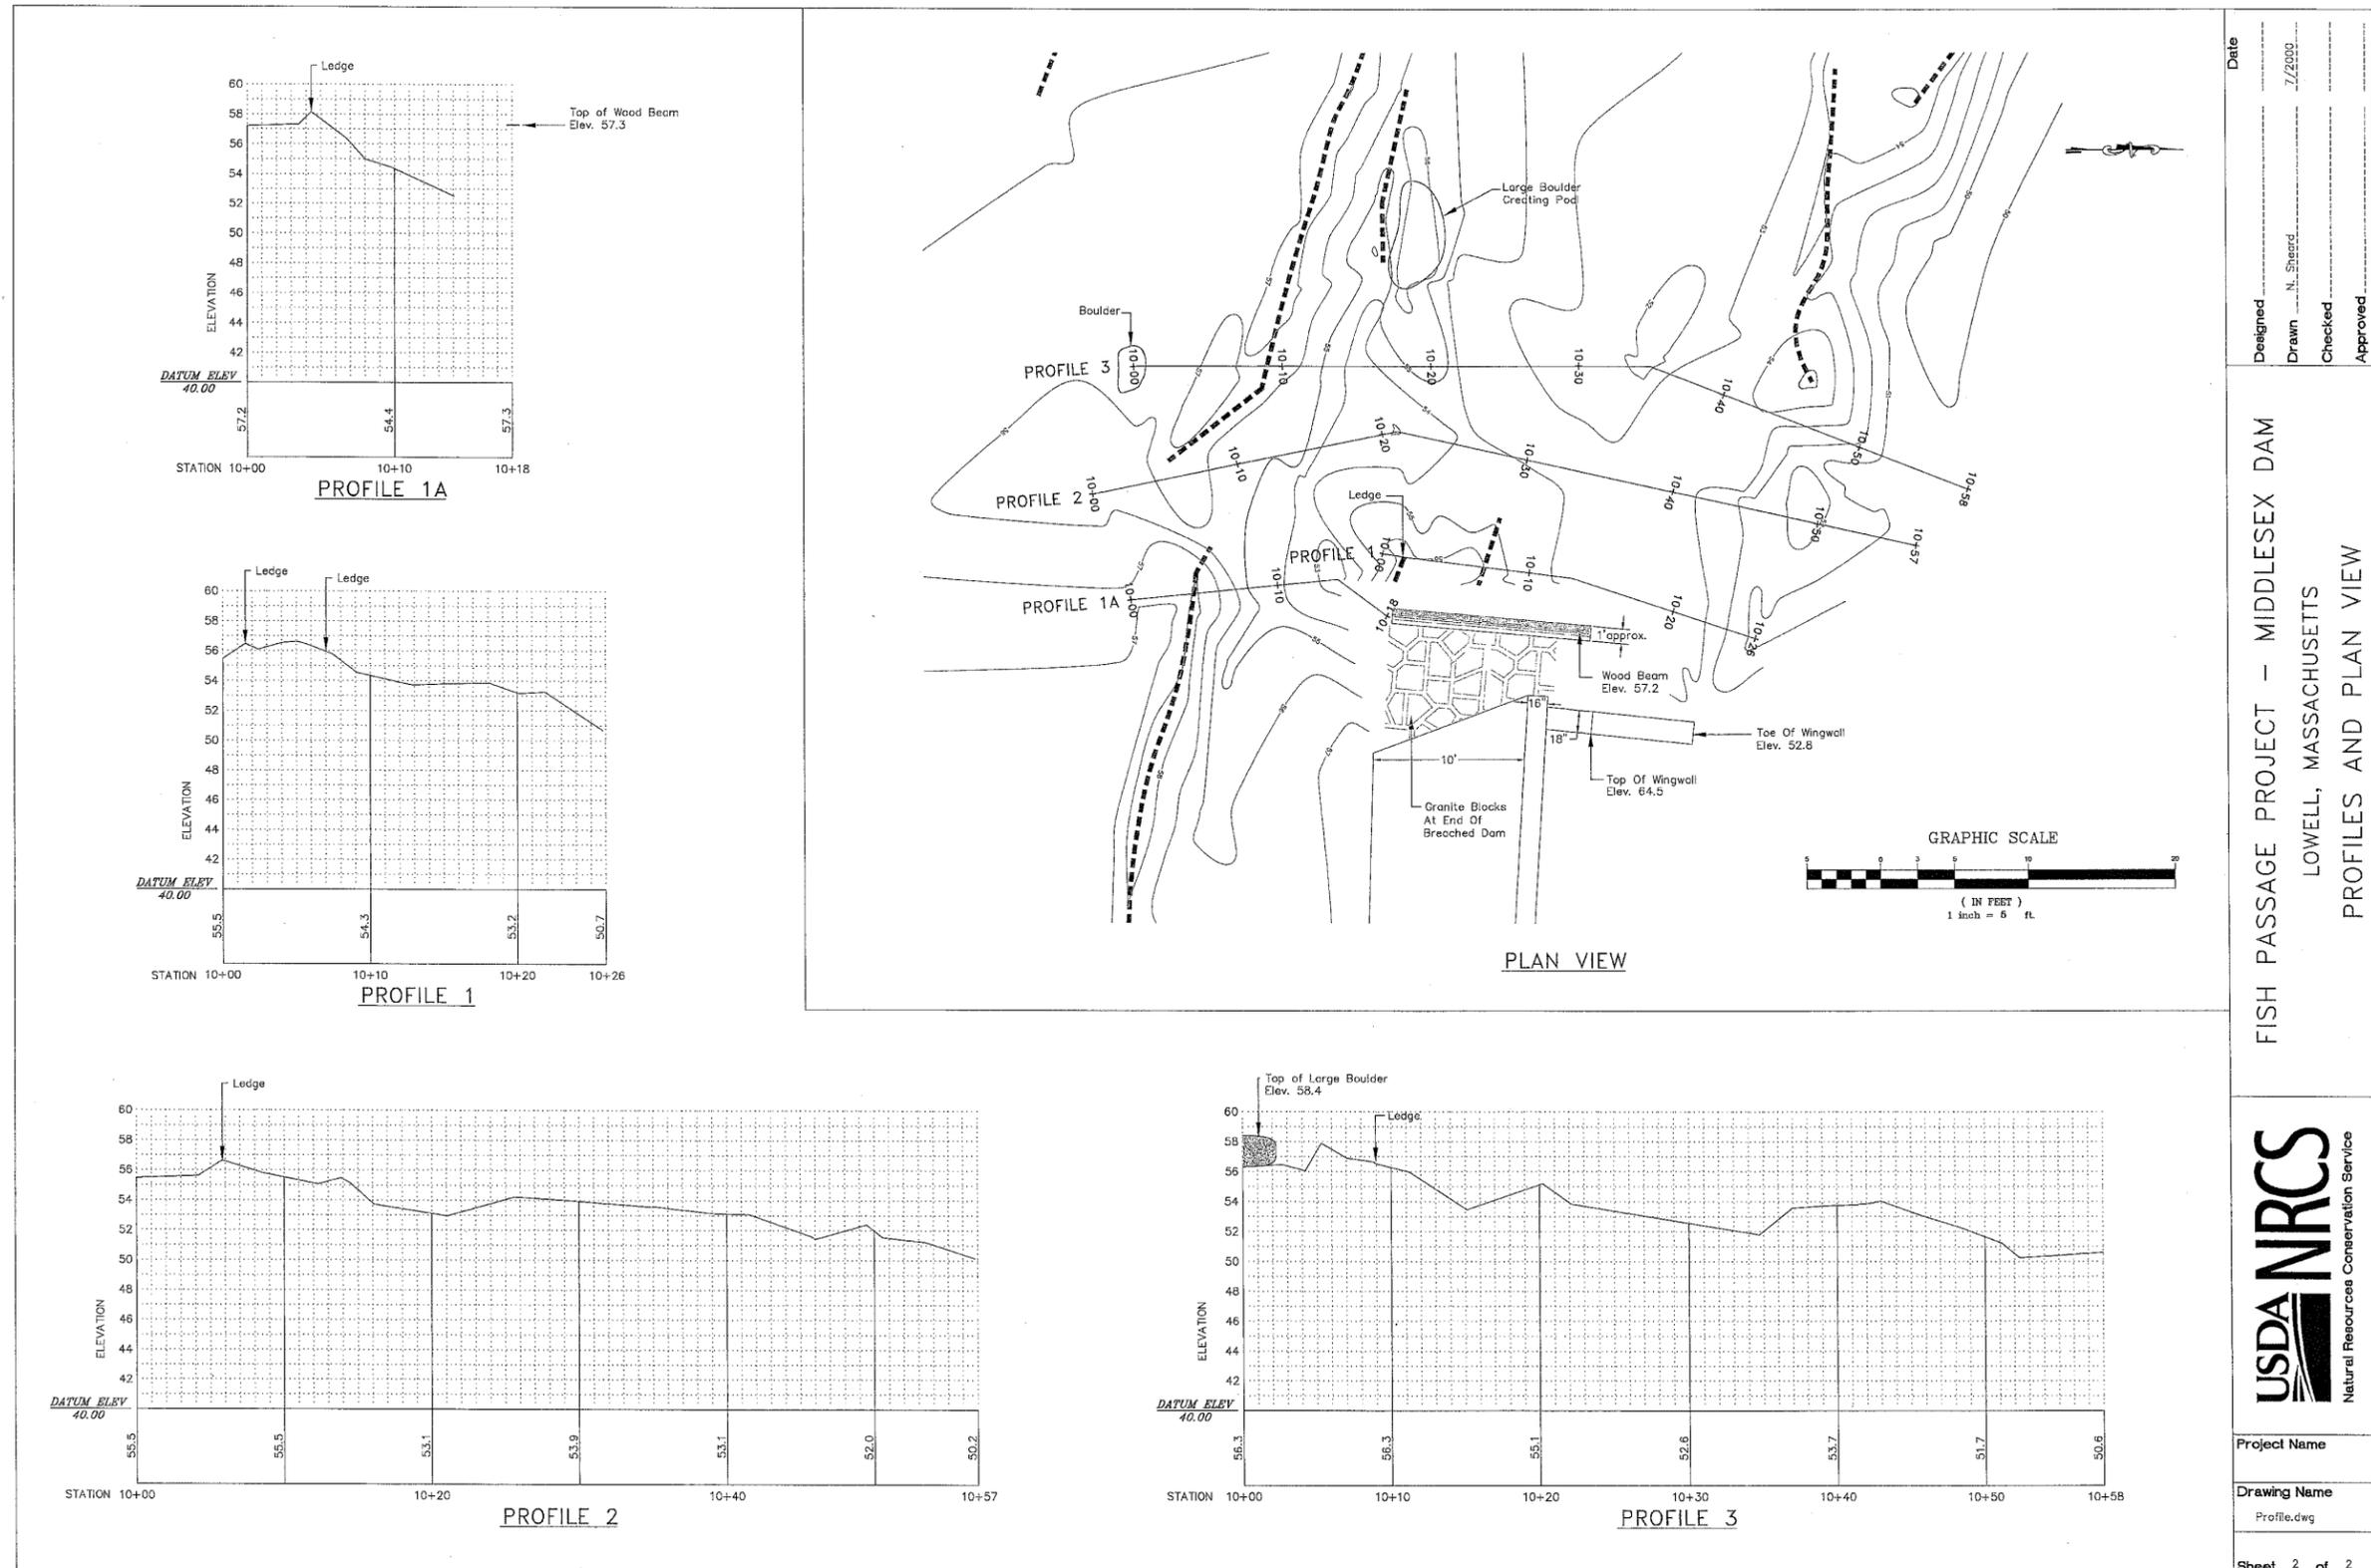
Figure 2.2.1-3: Middlesex Falls Existing Topographic Plan and Sections

FISH PASSAGE PROJECT - MIDDLESEX DAM
LOWELL, MASSACHUSETTS
PROFILES AND PLAN VIEW

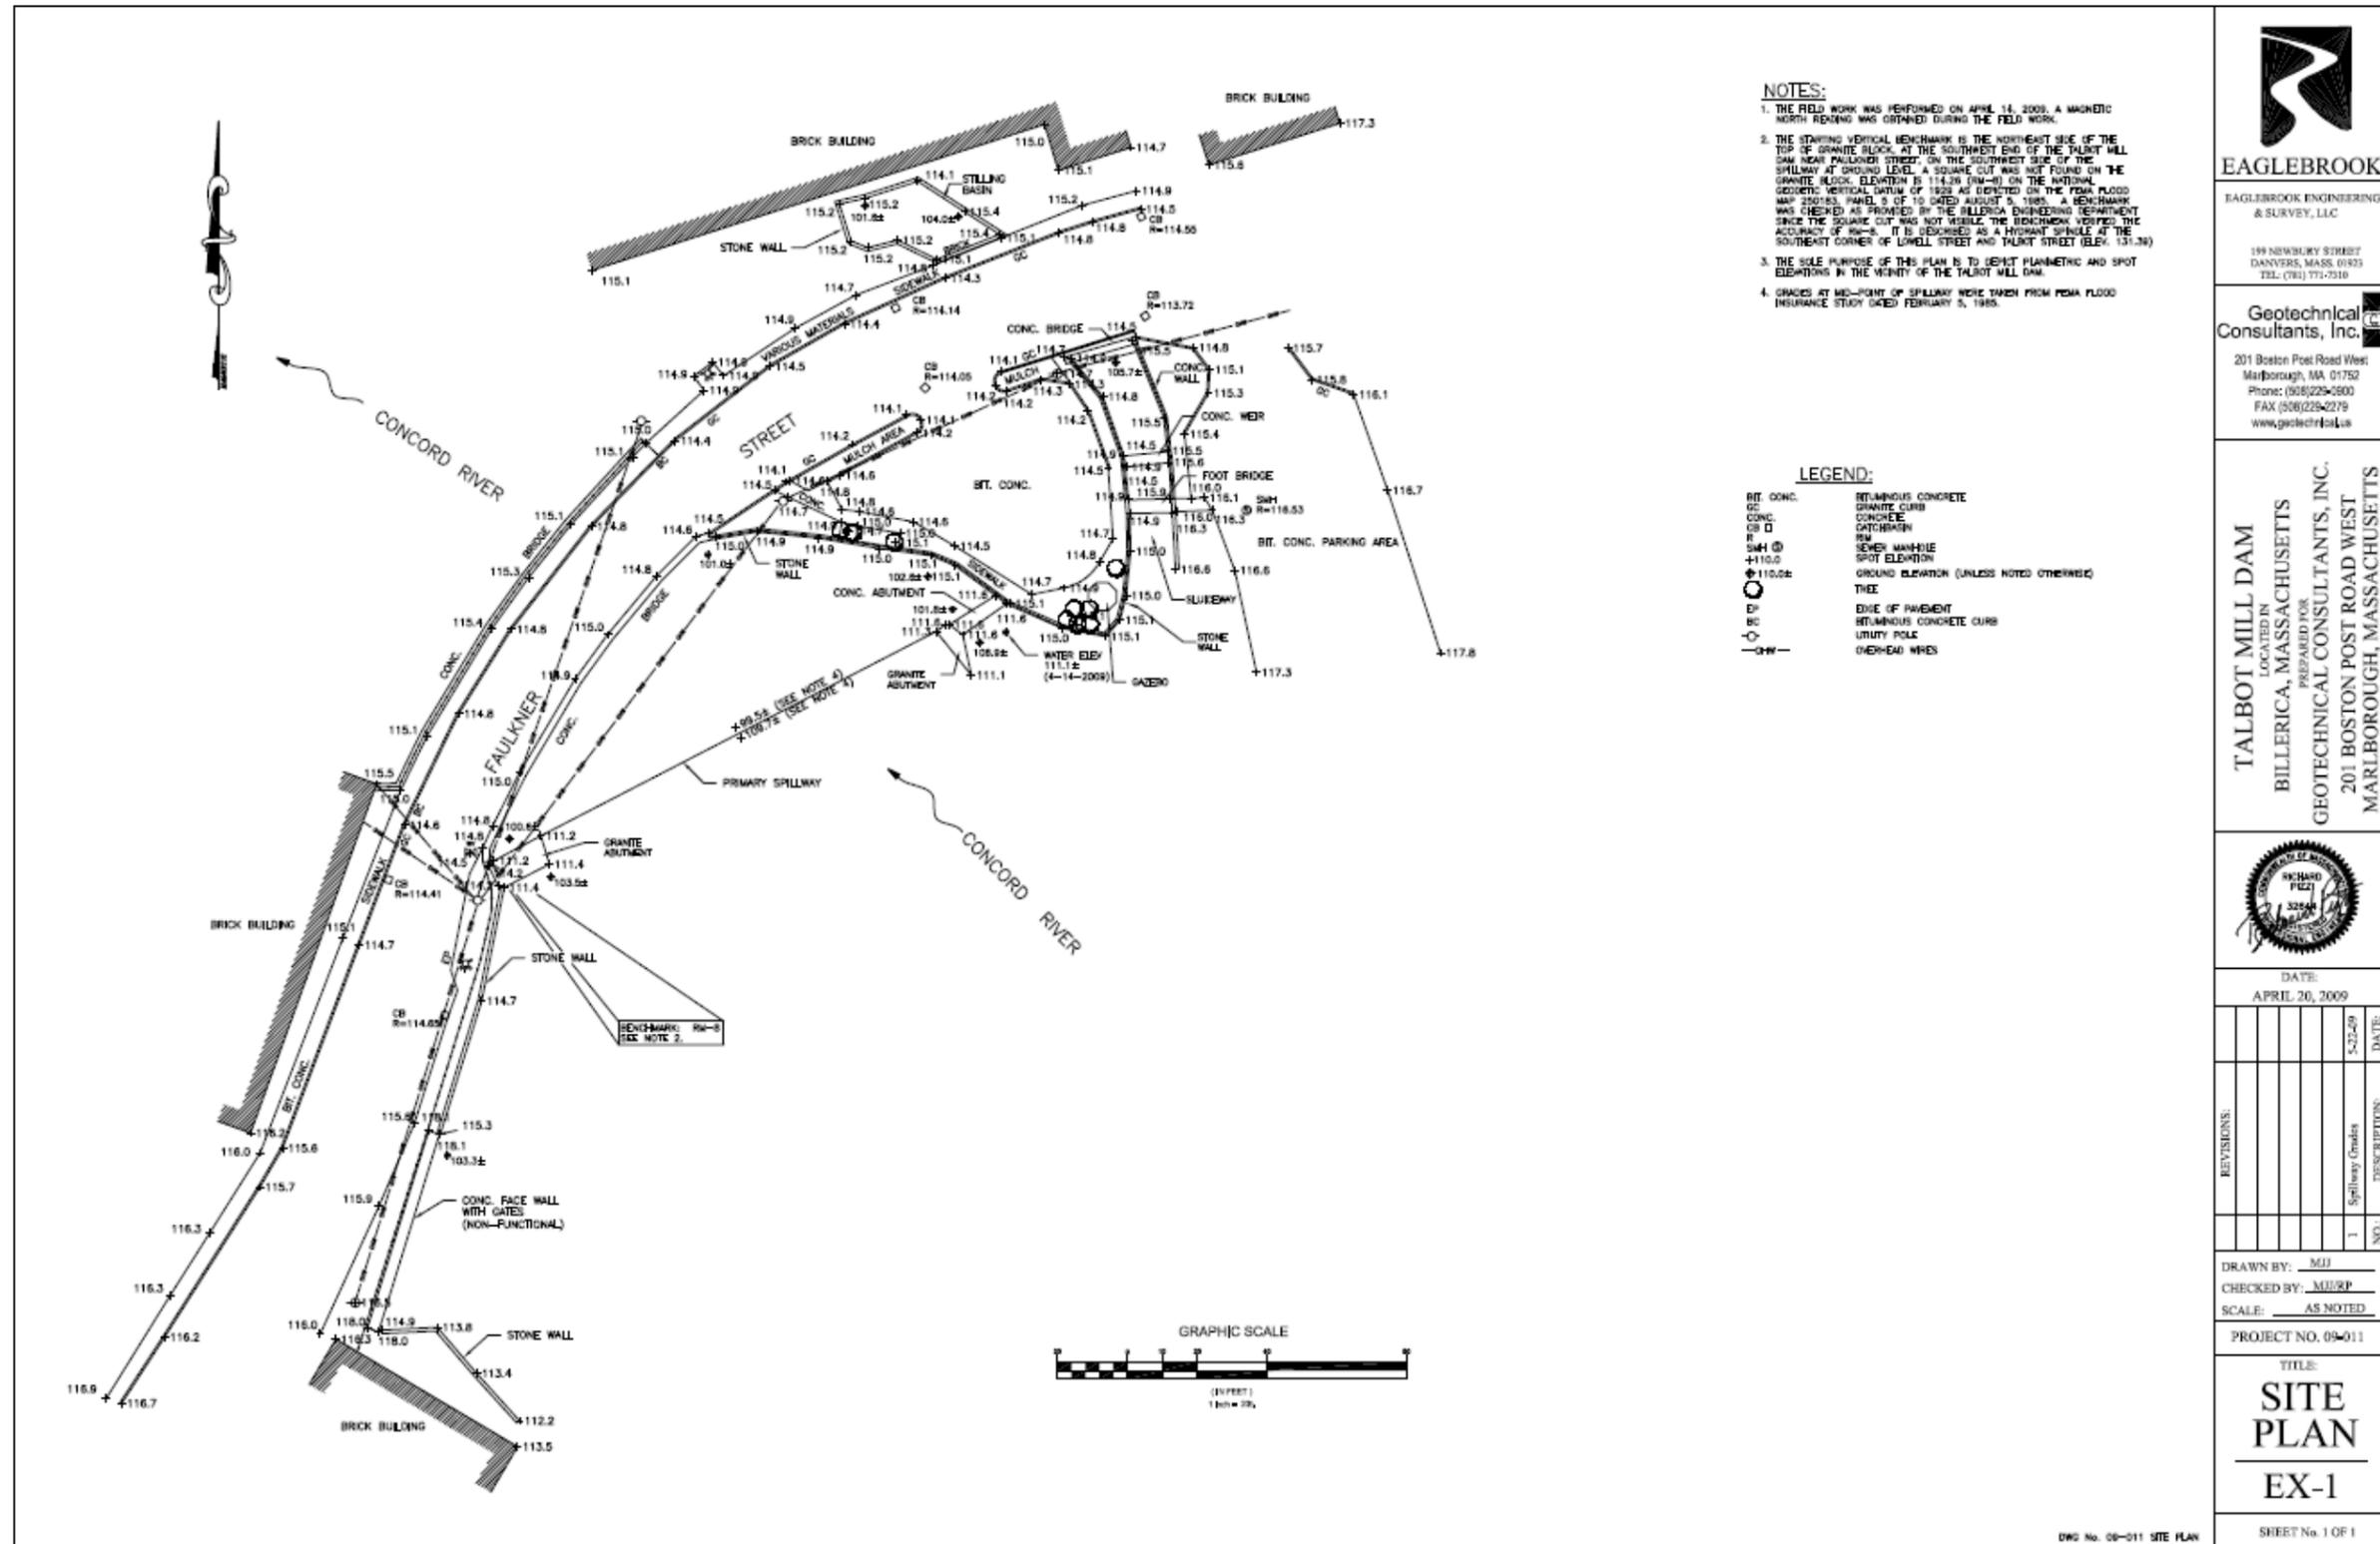
Figure 2.2.3-3: Existing Survey Plan of Talbot Mills Dam

Note: Elevations in NGVD 29. The datum shift to convert to NAVD 88 for the coordinates at Talbot Mills Dam (the conversion is location specific) is -0.827 feet (with NGVD 29 being the higher elevation). Source: Geotechnical Consultants, 2015.

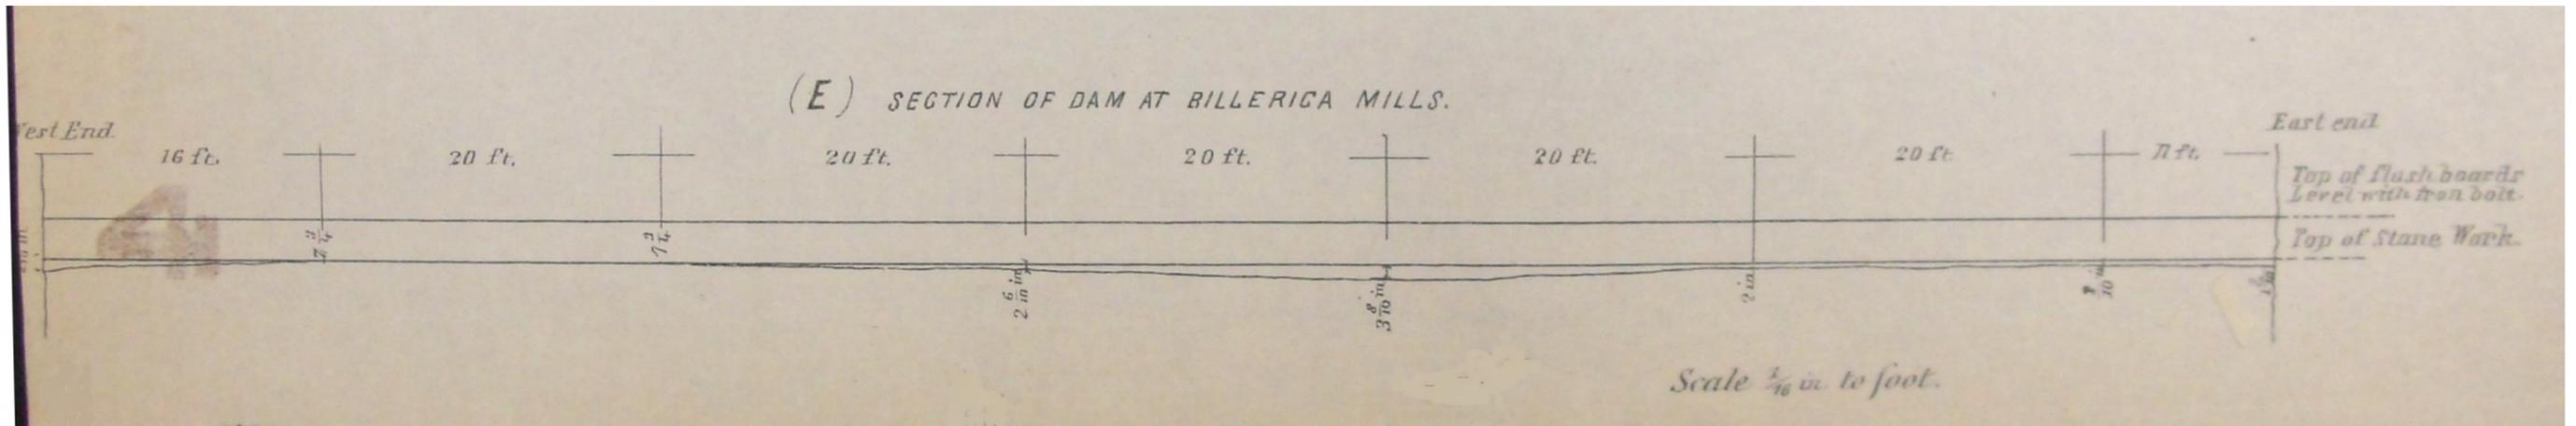
Figure 2.2.3-4: Historical Section of Dam at Billerica Mills

Note: Obtained from MCA; source unknown. Although a date is not specified, this appears to be a section of the current (1828) structure due to the note on the right referring to "stone work," as the previous dams were of wood construction.

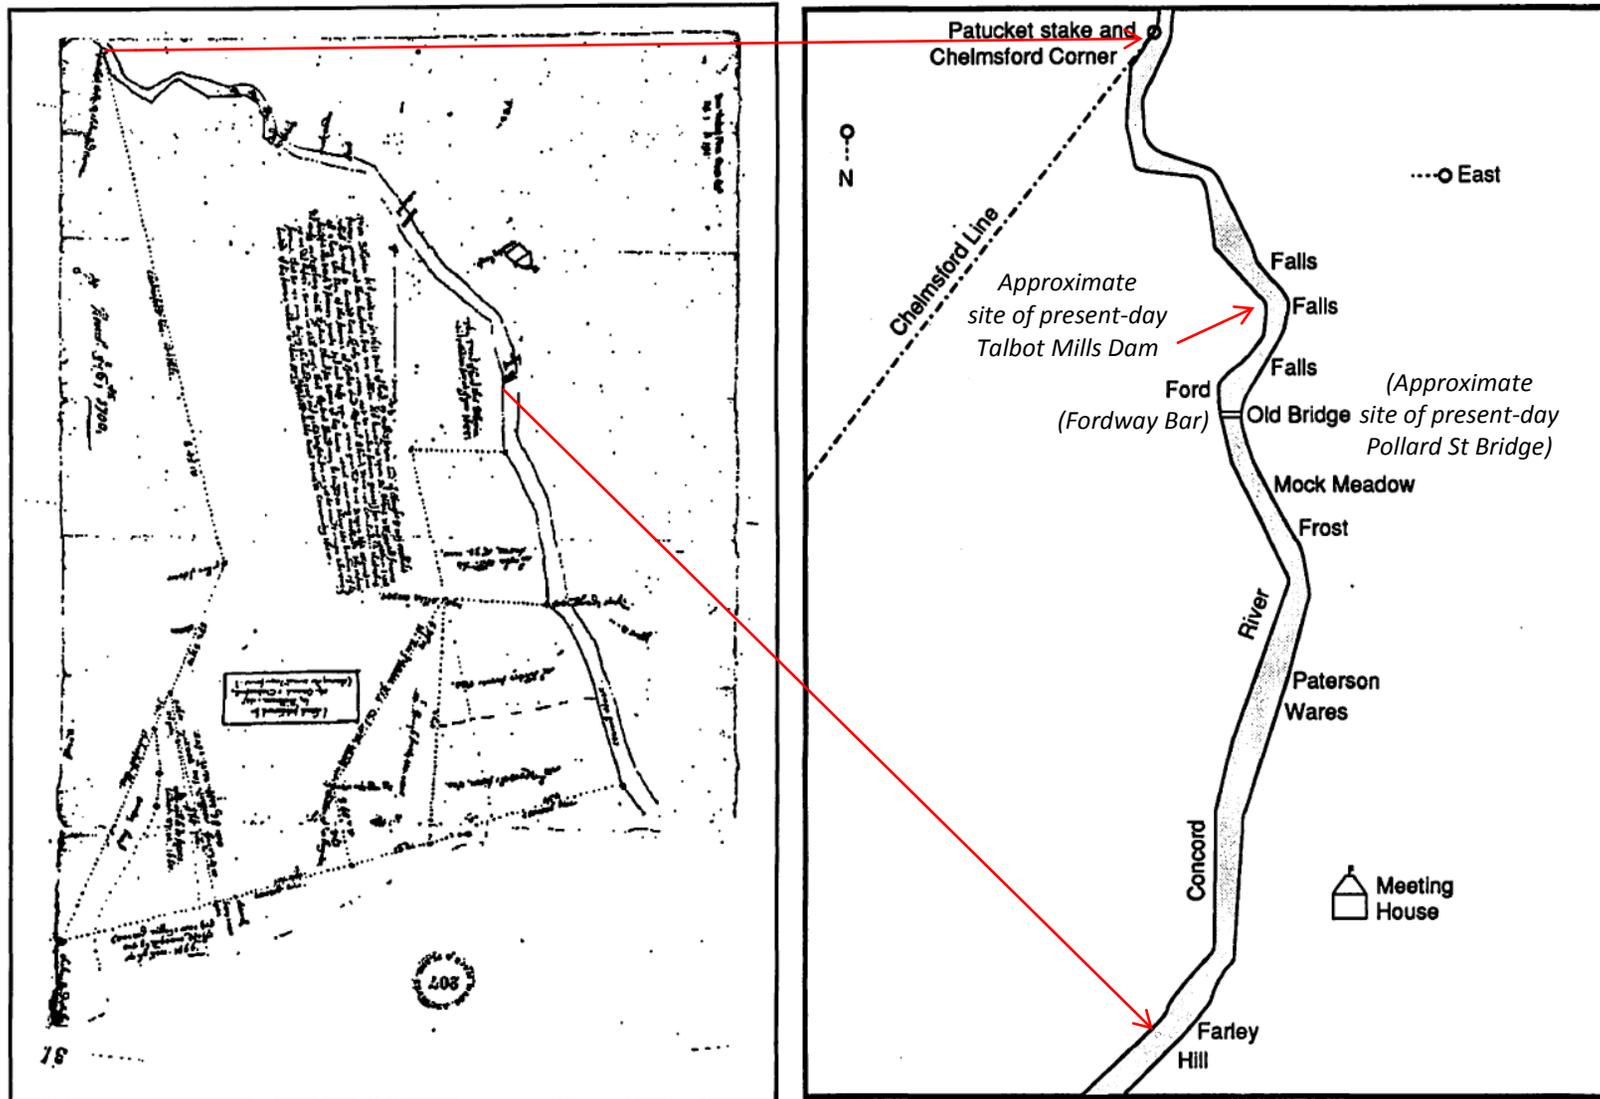
Figure 2.2.3-7: Historical Map Showing Falls Prior to Damming of Concord River

This early map of Billerica (left), prepared in 1700, indicates the existence of a series of falls in the Concord River between the present-day Pollard Street and Faulkner Bridges, as shown in the reproduced extract at right (Ingraham, 1995).

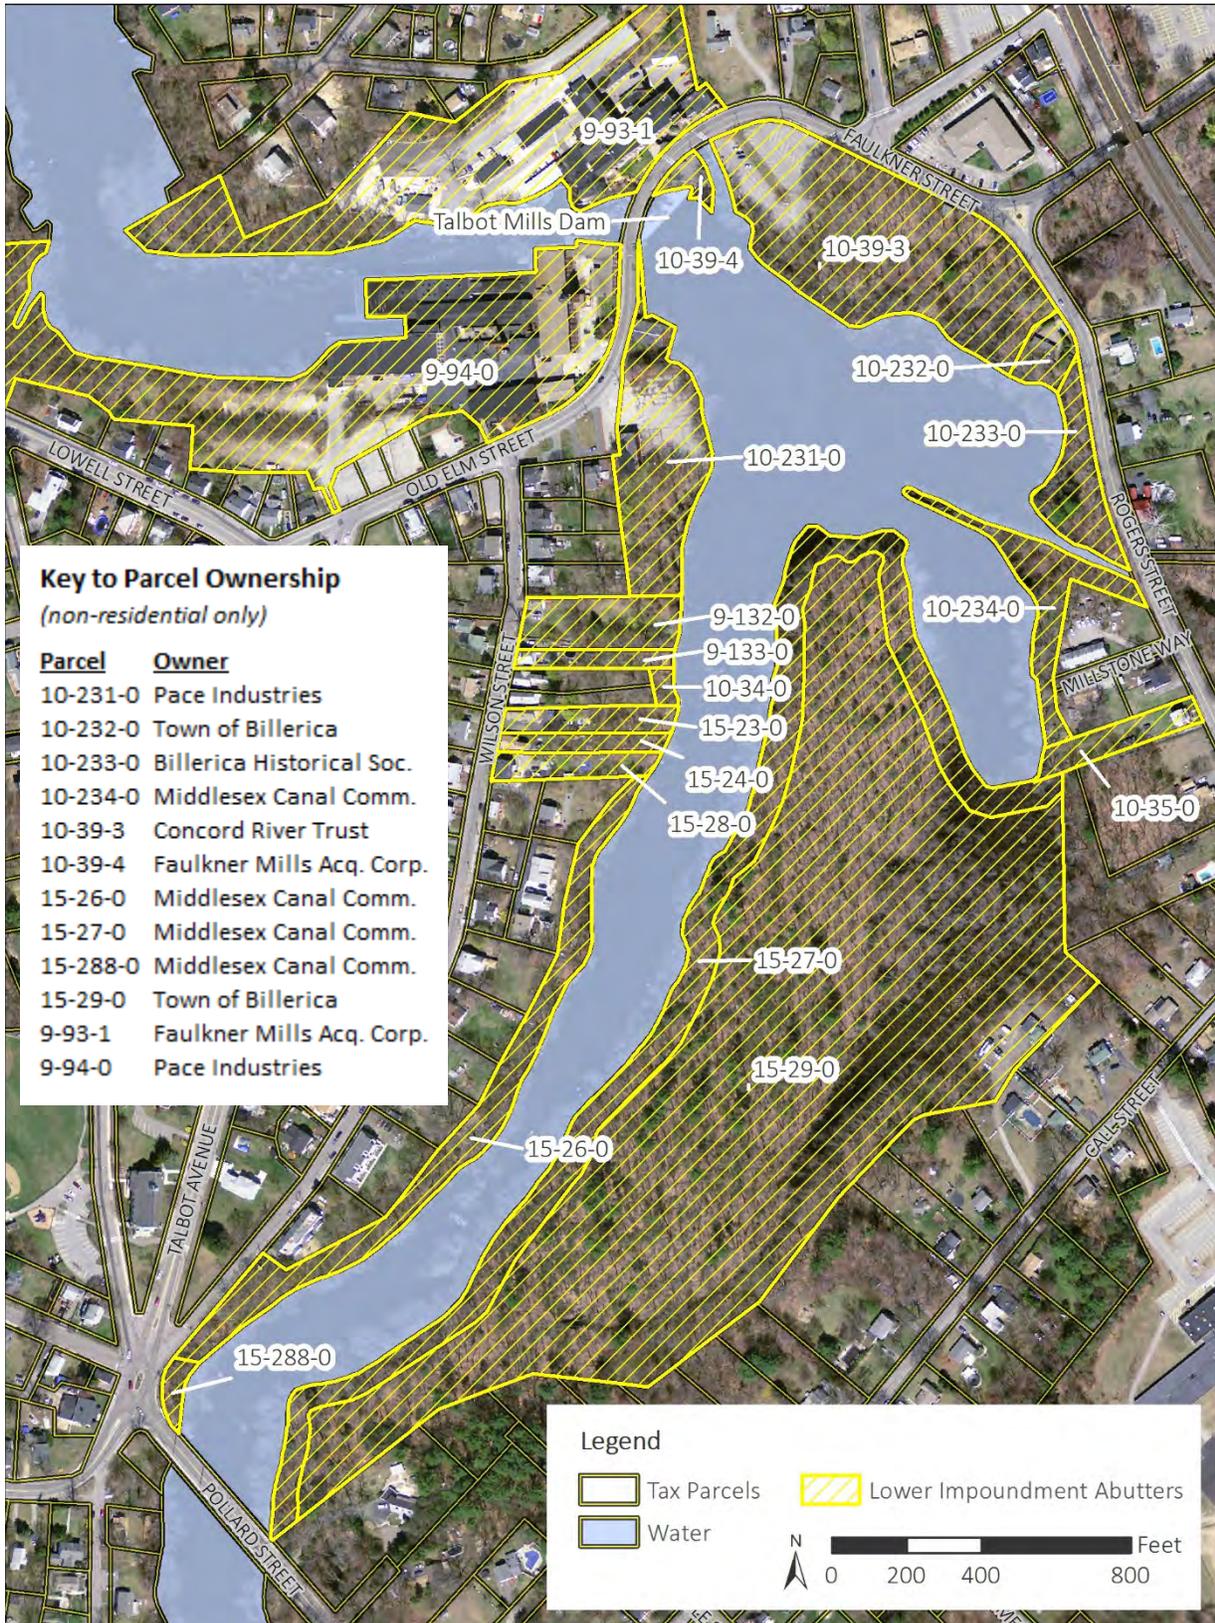
Figure 2.2.3-8: Property Ownership in the Vicinity of Talbot Mills Dam and Lower Impoundment

Note: Former Talbot cloth warehouse building on parcel 10-231-0 granted to the MCA in 2014.
