APPENDIX A

Figures & Tables

Concord River Diadromous Fish Restoration Feasibility Study

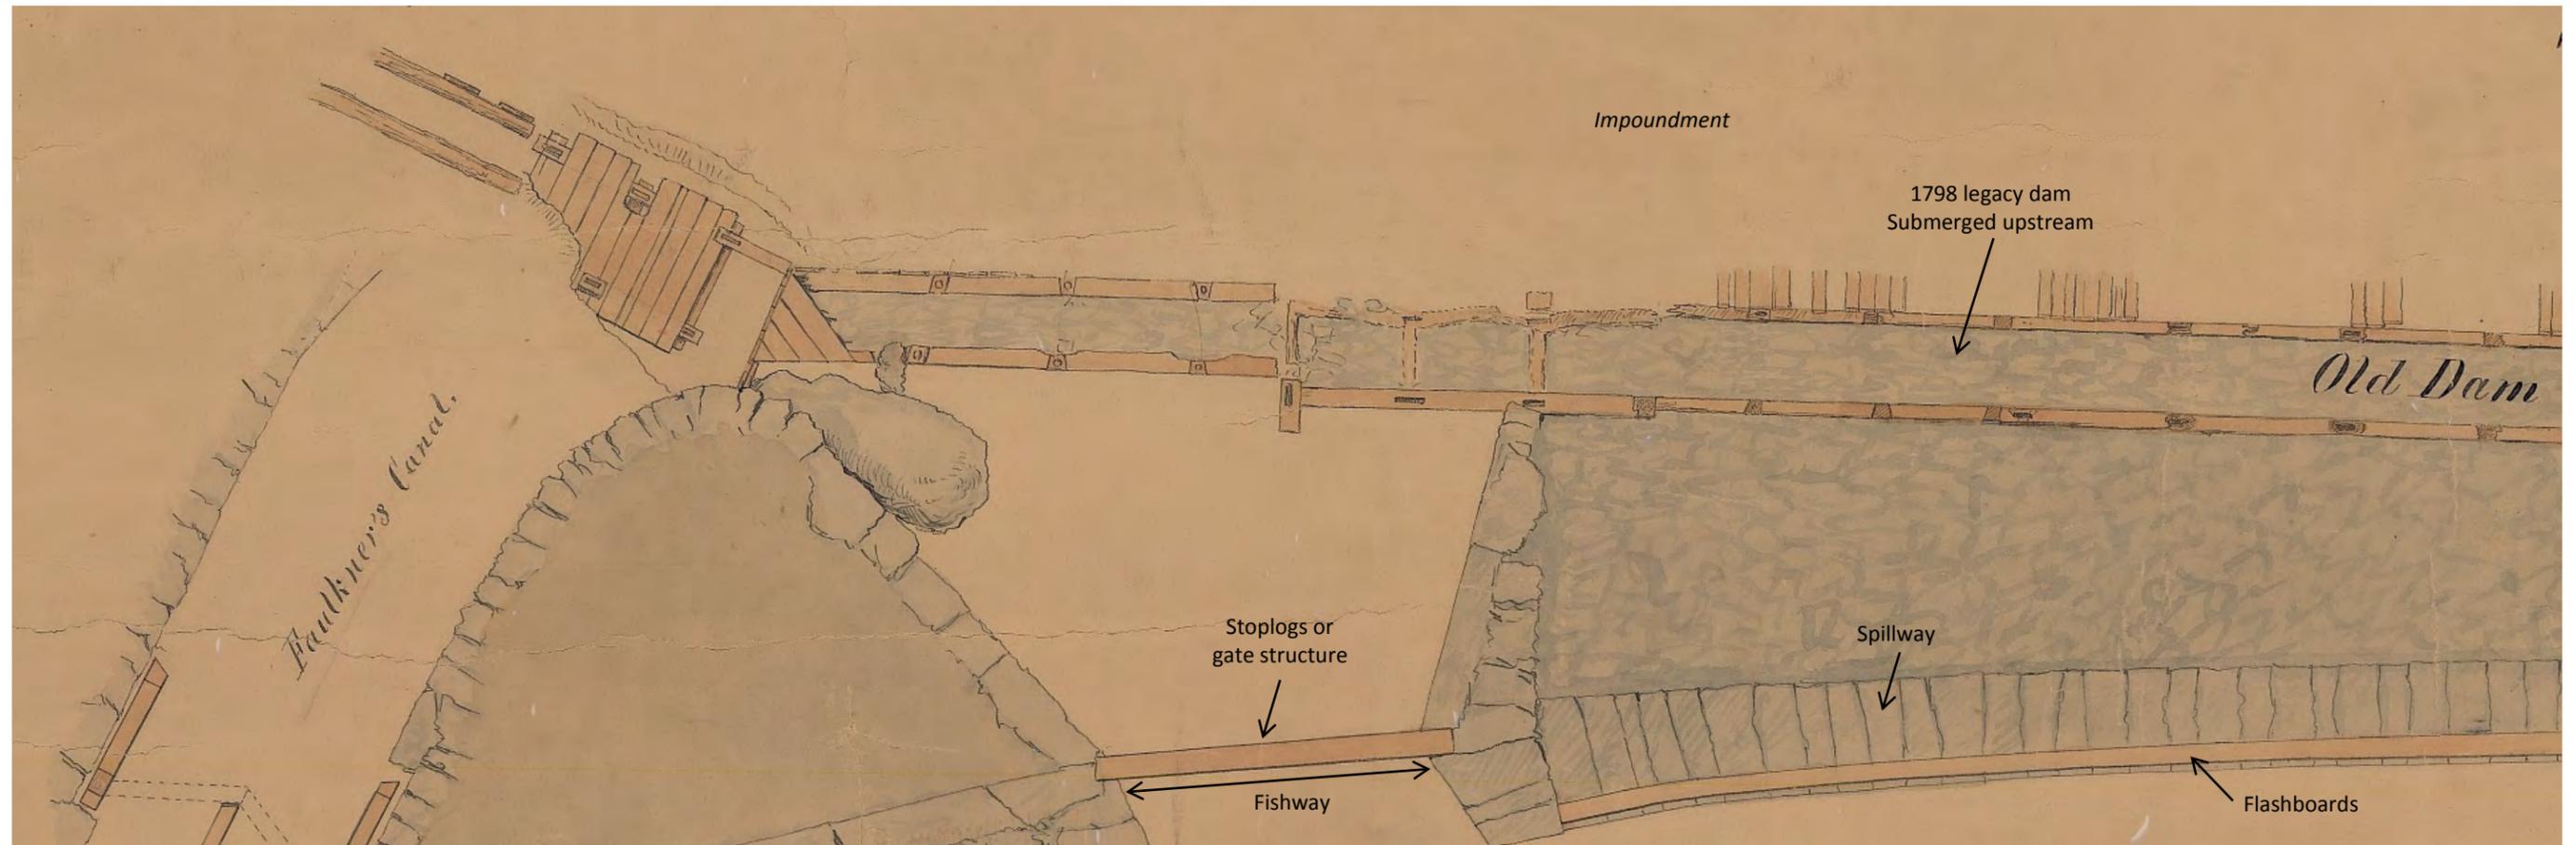
Figure 2.2.3-10: Historical Plan Detail Showing Fishway Location

Note: Obtained from MCA; source unknown. Note the location of the former (1798) wooden dam, which was submerged when the stone dam was built in 1828 (pictured at bottom edge of detail).

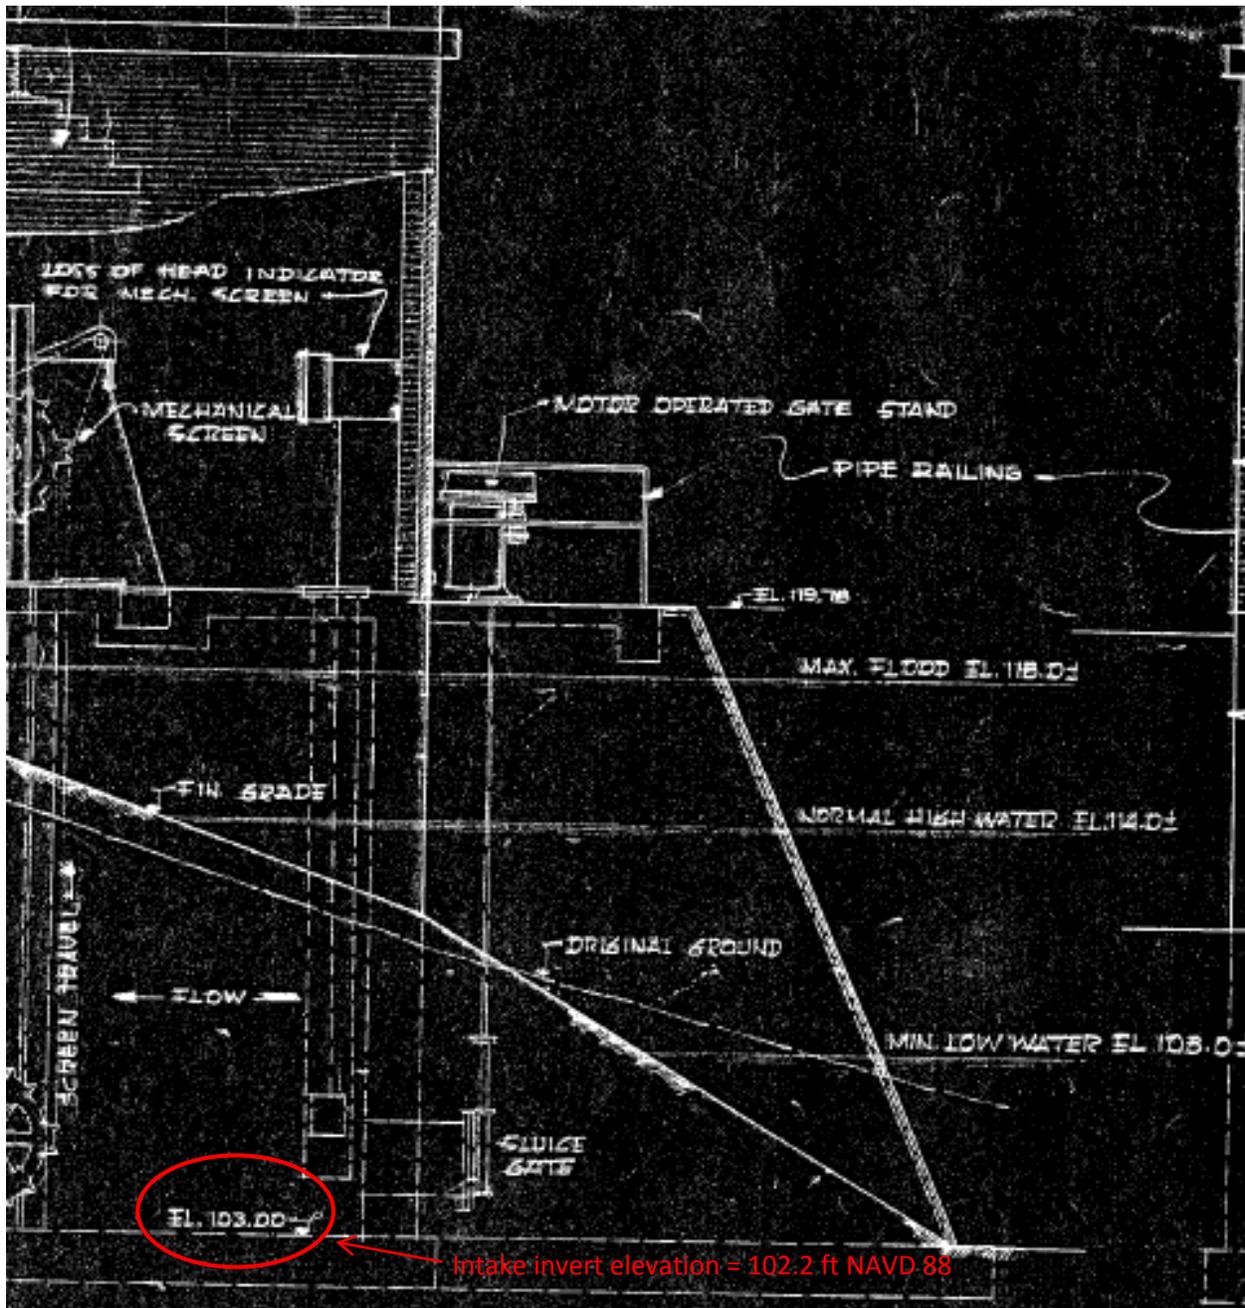
Figure 2.3.2-1: Billerica Water Supply Intake Elevation Detail

TOWN OF BILLERICA, MASSACHUSETTS PUBLIC WORKS DEPARTMENT		
WATER WORKS IMPROVEMENTS		
WATER TREATMENT PLANT INTAKE STATION		
ARCHITECTURAL DETAILS		
Drawn by: FS	Checked by: AJP	SHEET NO.
Approved: [Signature]		44
Date: May 1, 1934		ARCHITECTURE
Scale: As Noted		52-194
Camp, Dresser & McKee Consulting Engineers Boston, Mass.

Note: Elevations assumed to be in feet NGVD 29. Conversion factor to feet NAVD 88 is -0.827.

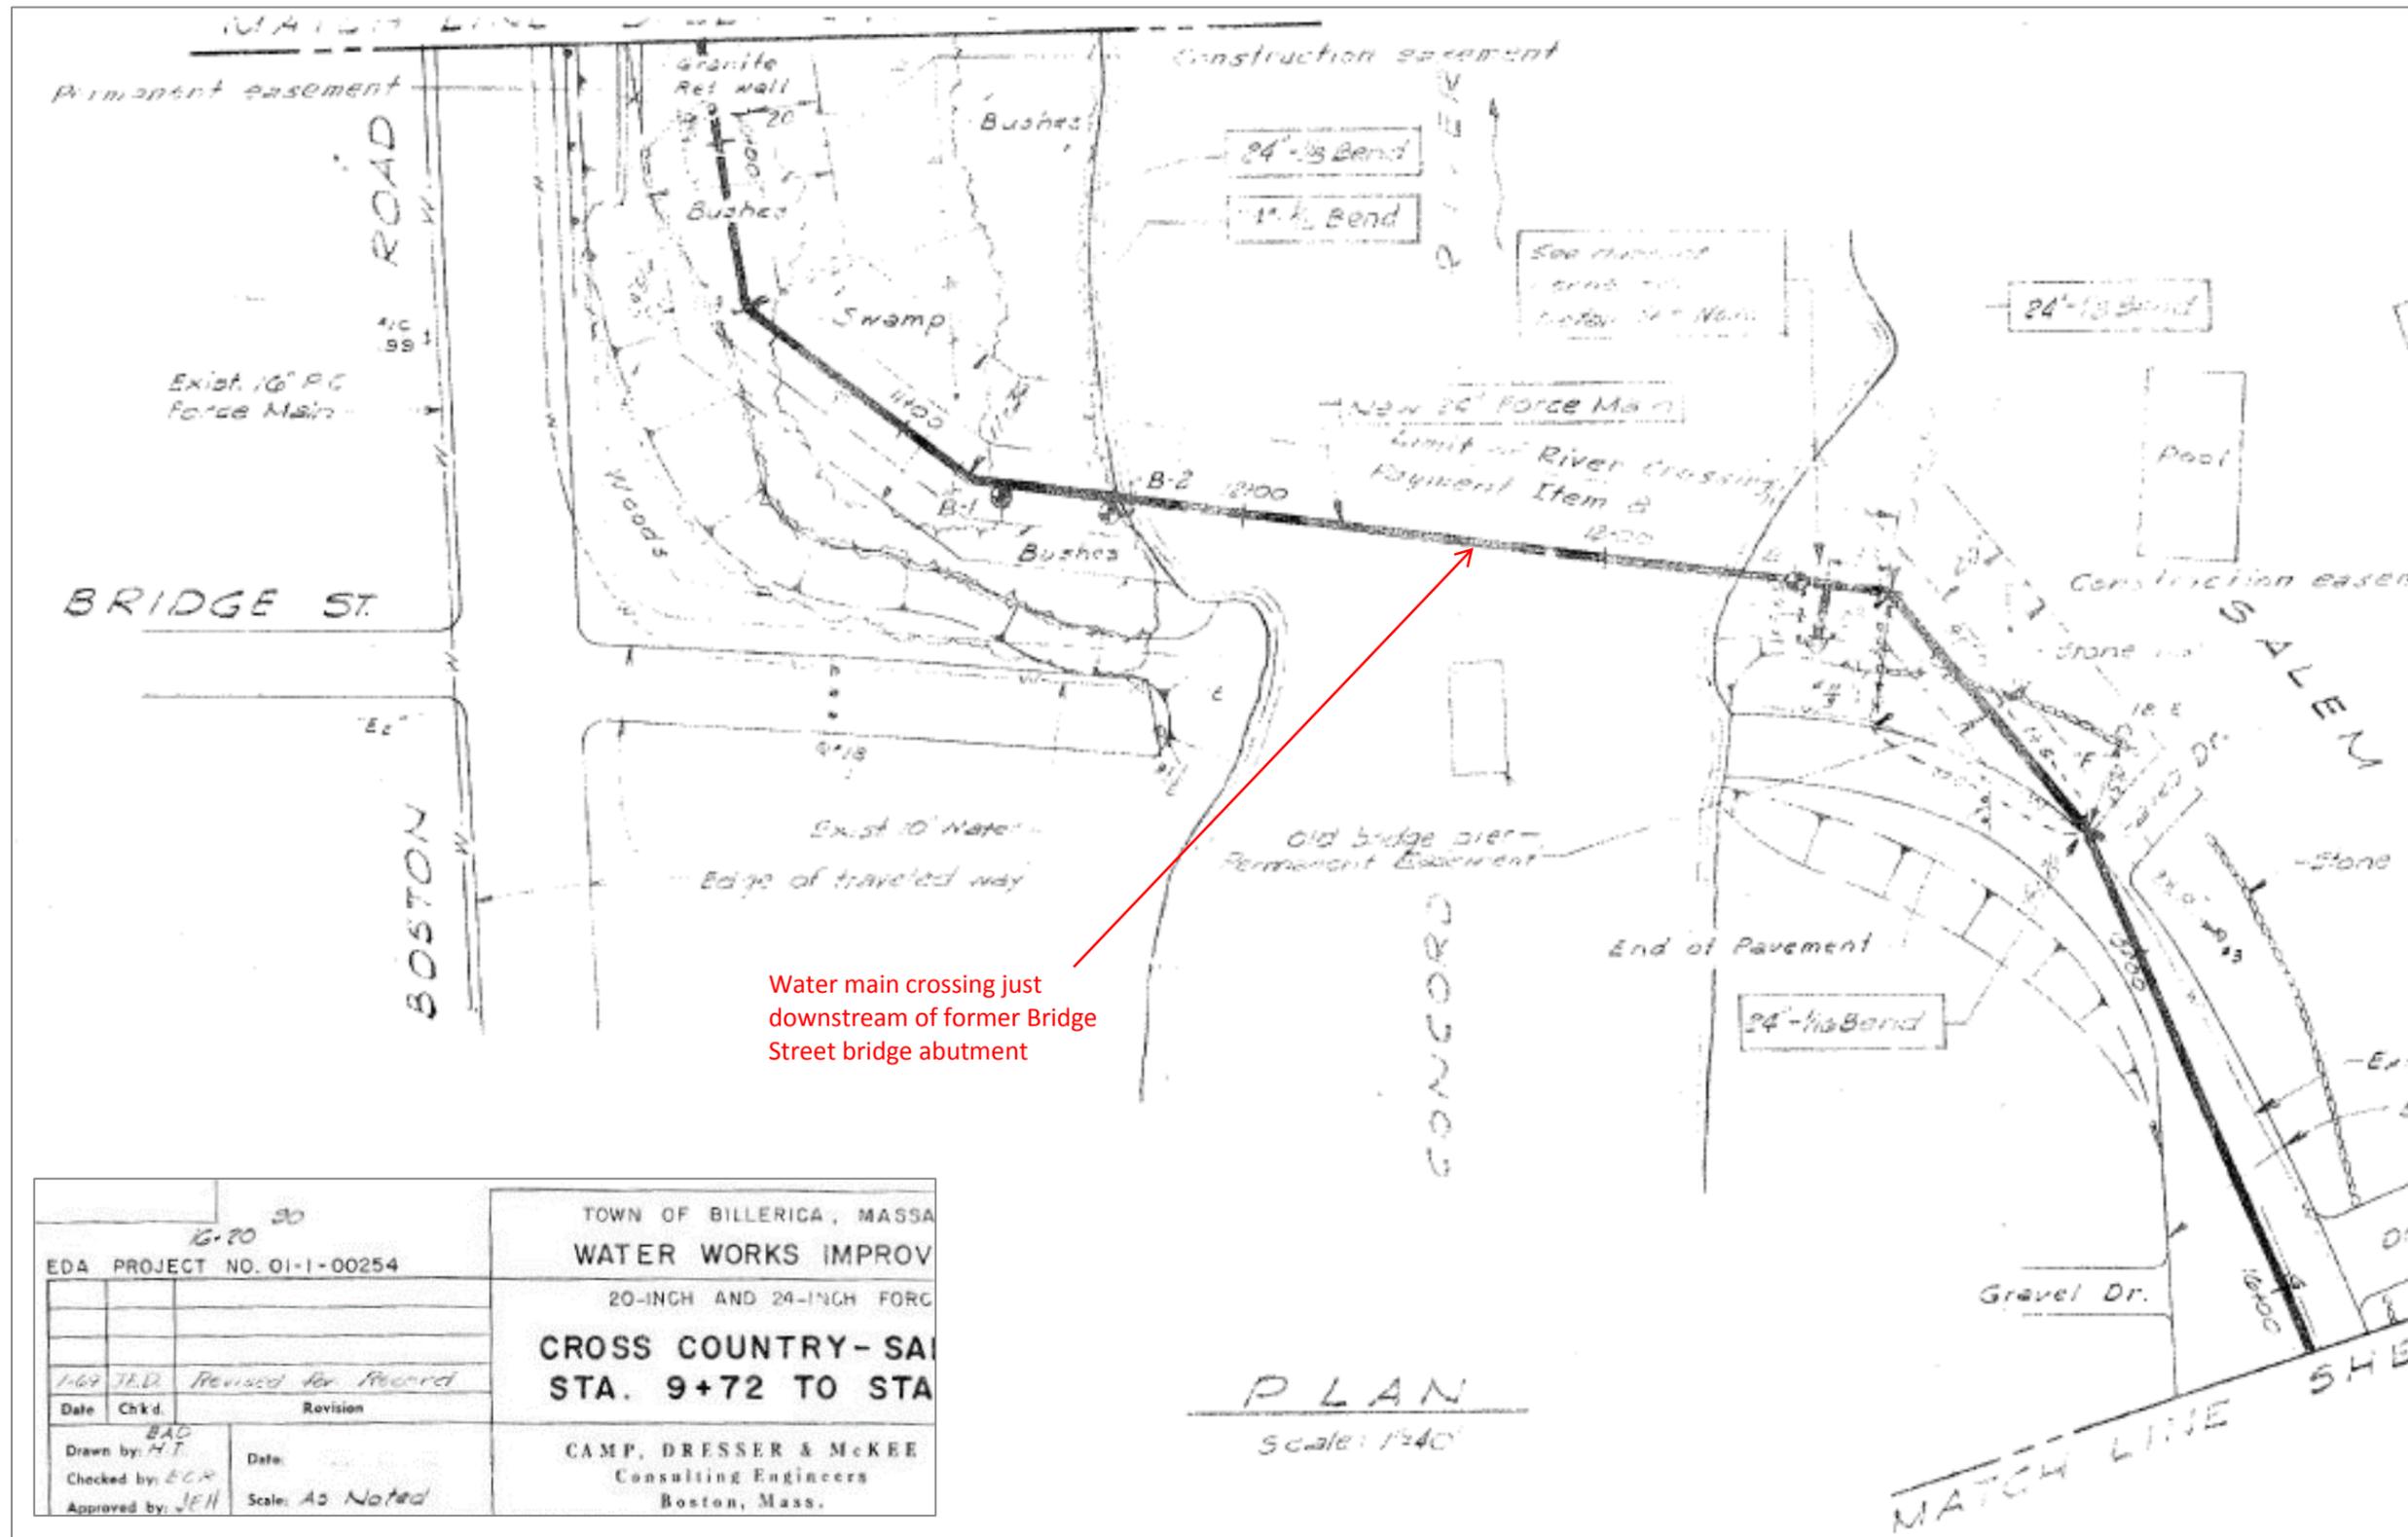
Figure 2.3.2-2: Billerica Water Main Crossing Plan

Water main crossing just downstream of former Bridge Street bridge abutment

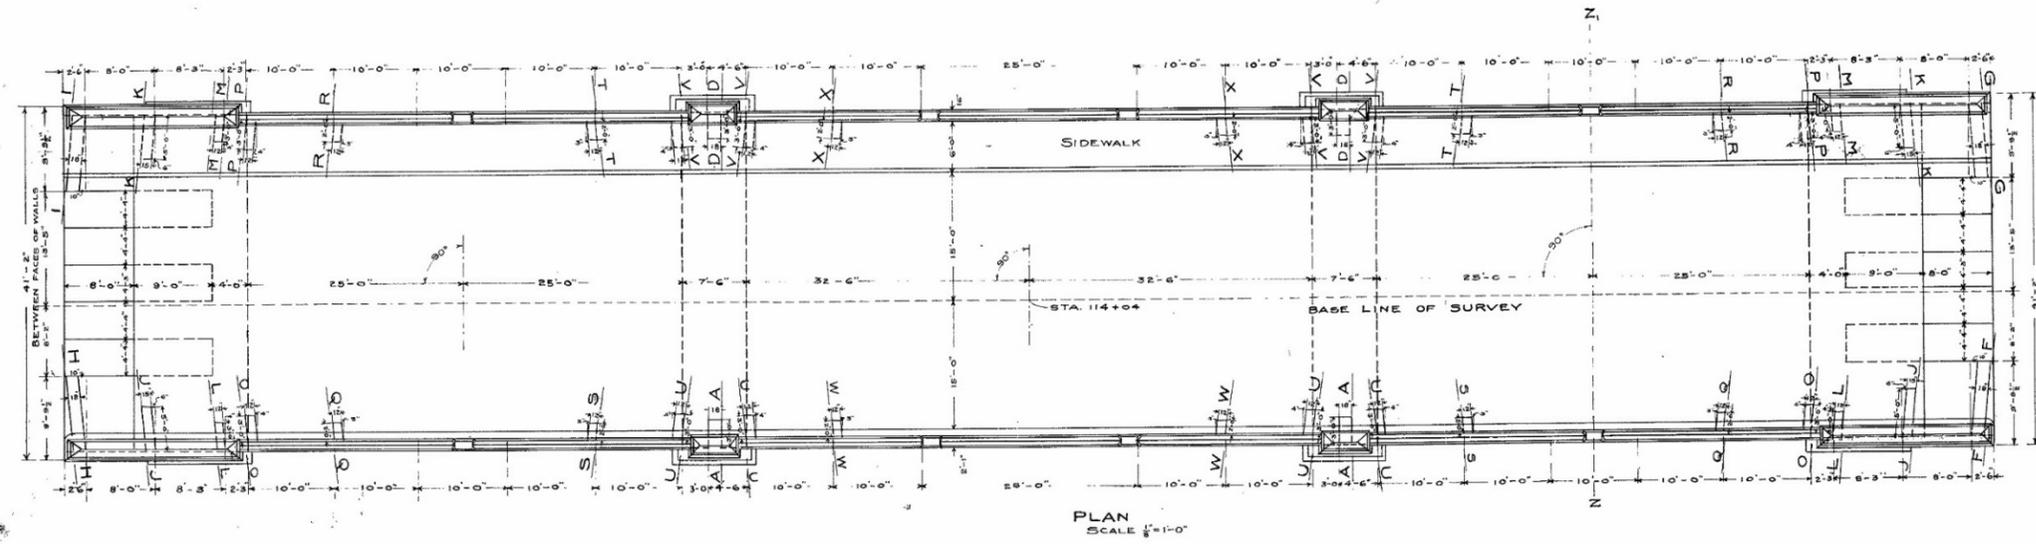
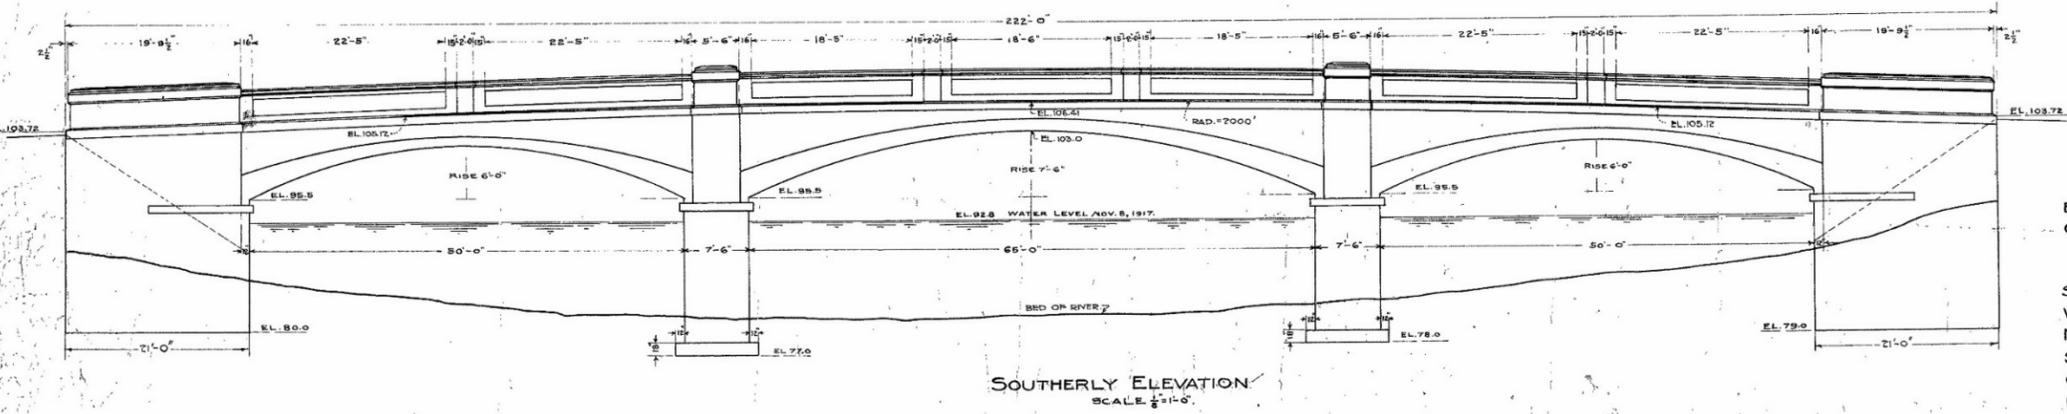
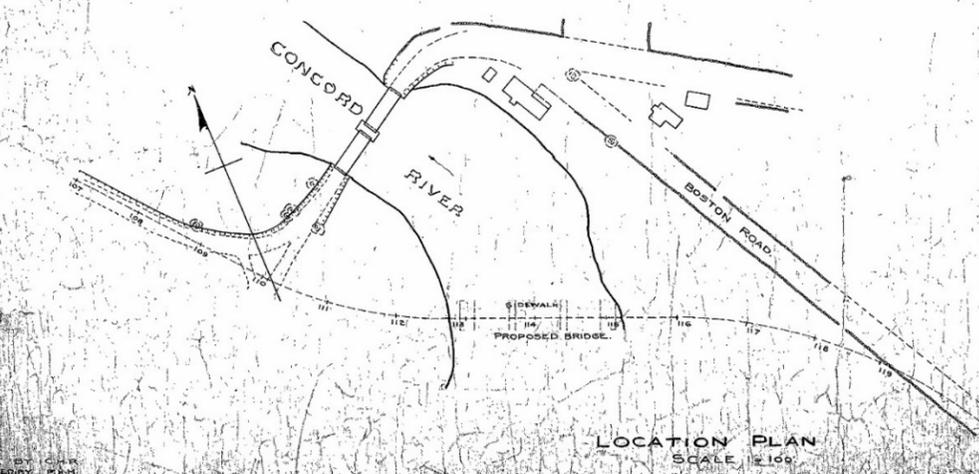
Figure 2.3.3-4: Boston Road/Route 3A Bridge Plan and Profile Drawing

PLAN OF
 PROPOSED REINFORCED CONCRETE BRIDGE
 OVER CONCORD RIVER IN THE
TOWN OF BILLERICA
 STATION 114+04
 SCALE 1/4" = 1'-0" UNLESS NOTED
 AUG. 1918
