APPENDIX A

Figures & Tables

Concord River Diadromous Fish Restoration Feasibility Study

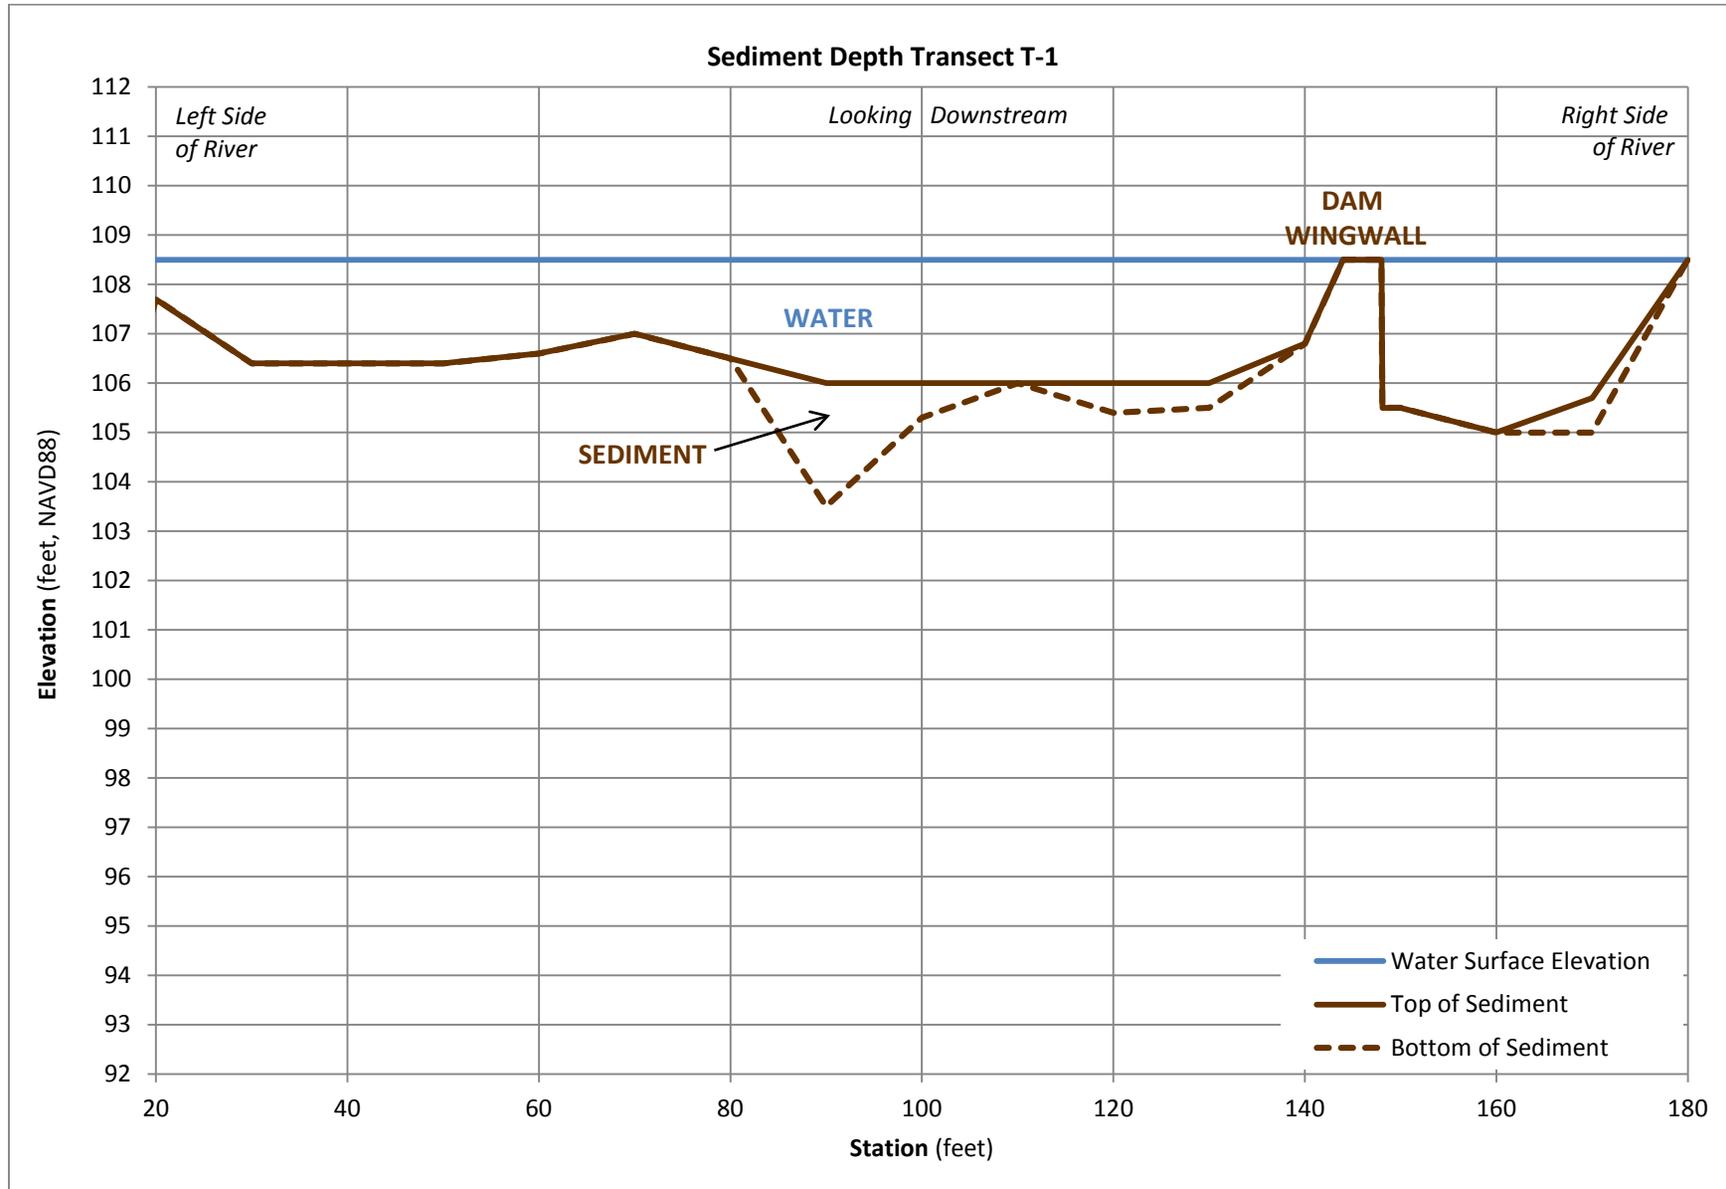
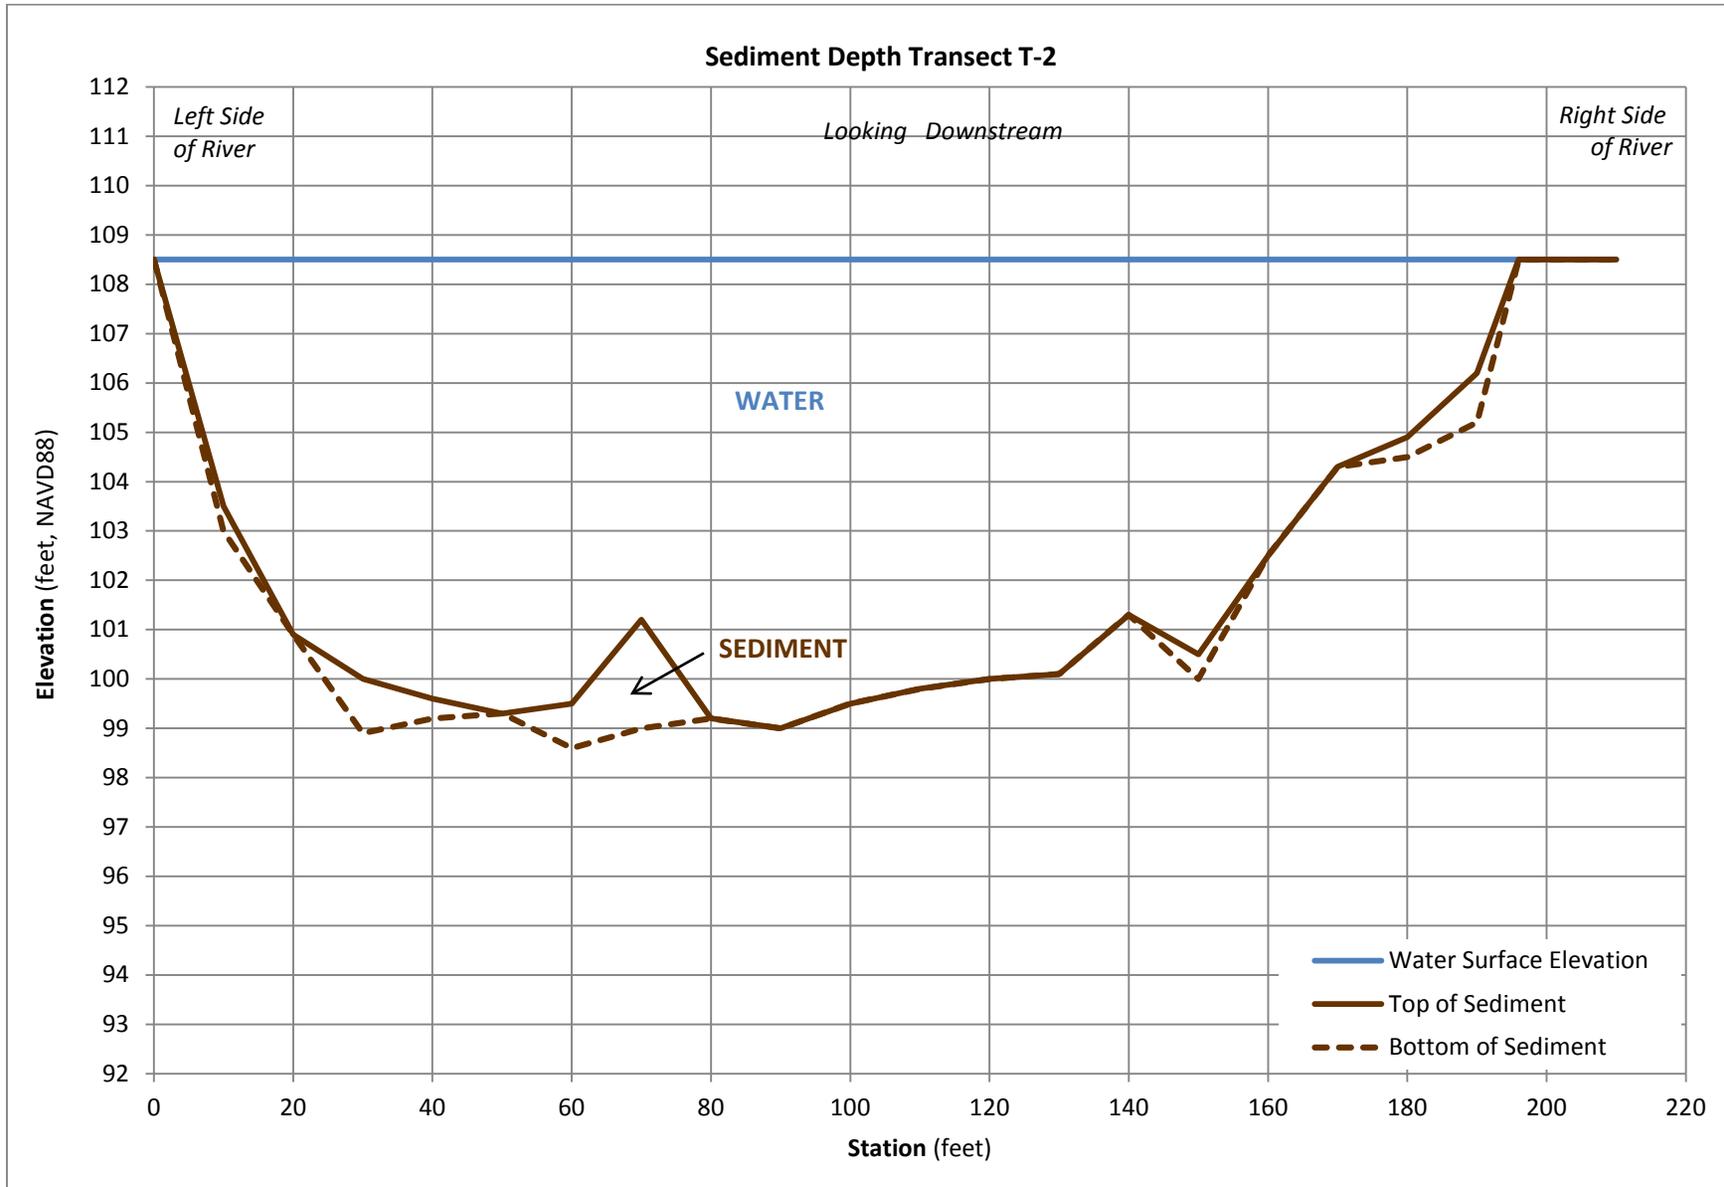
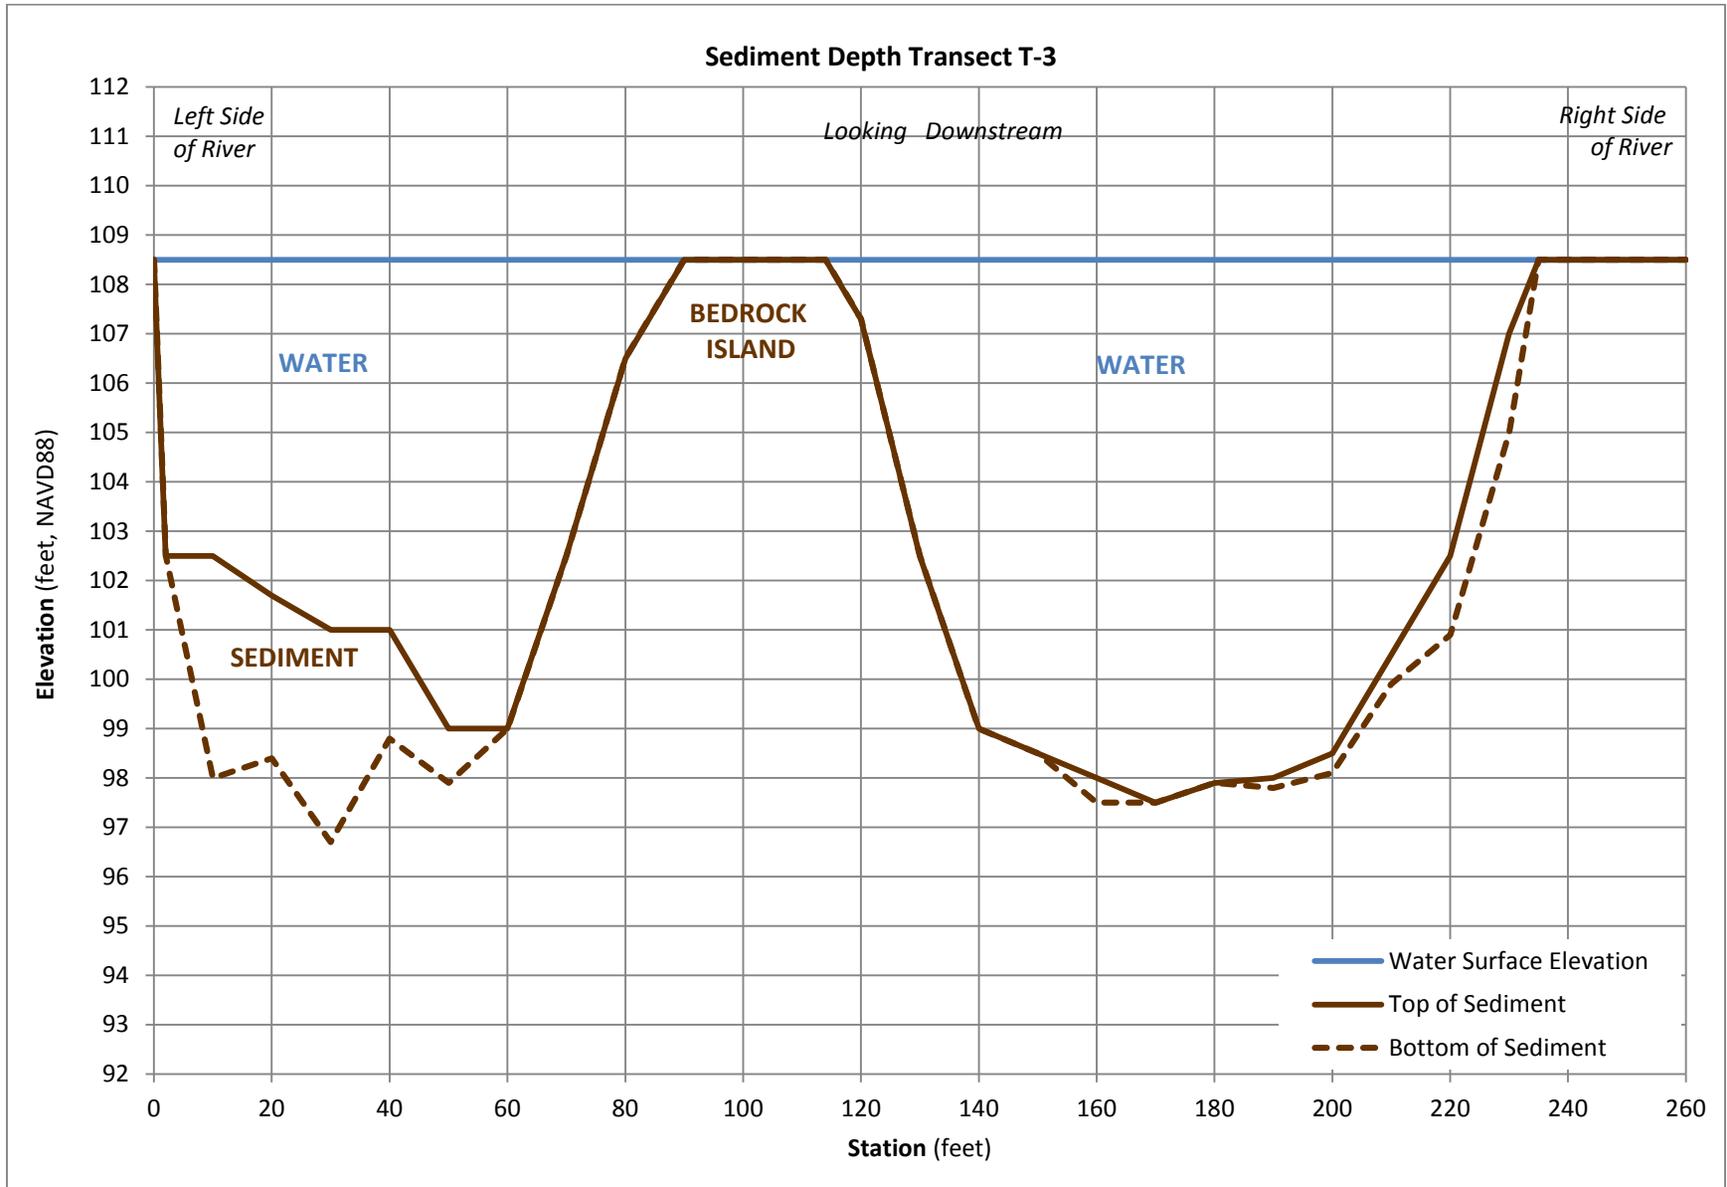
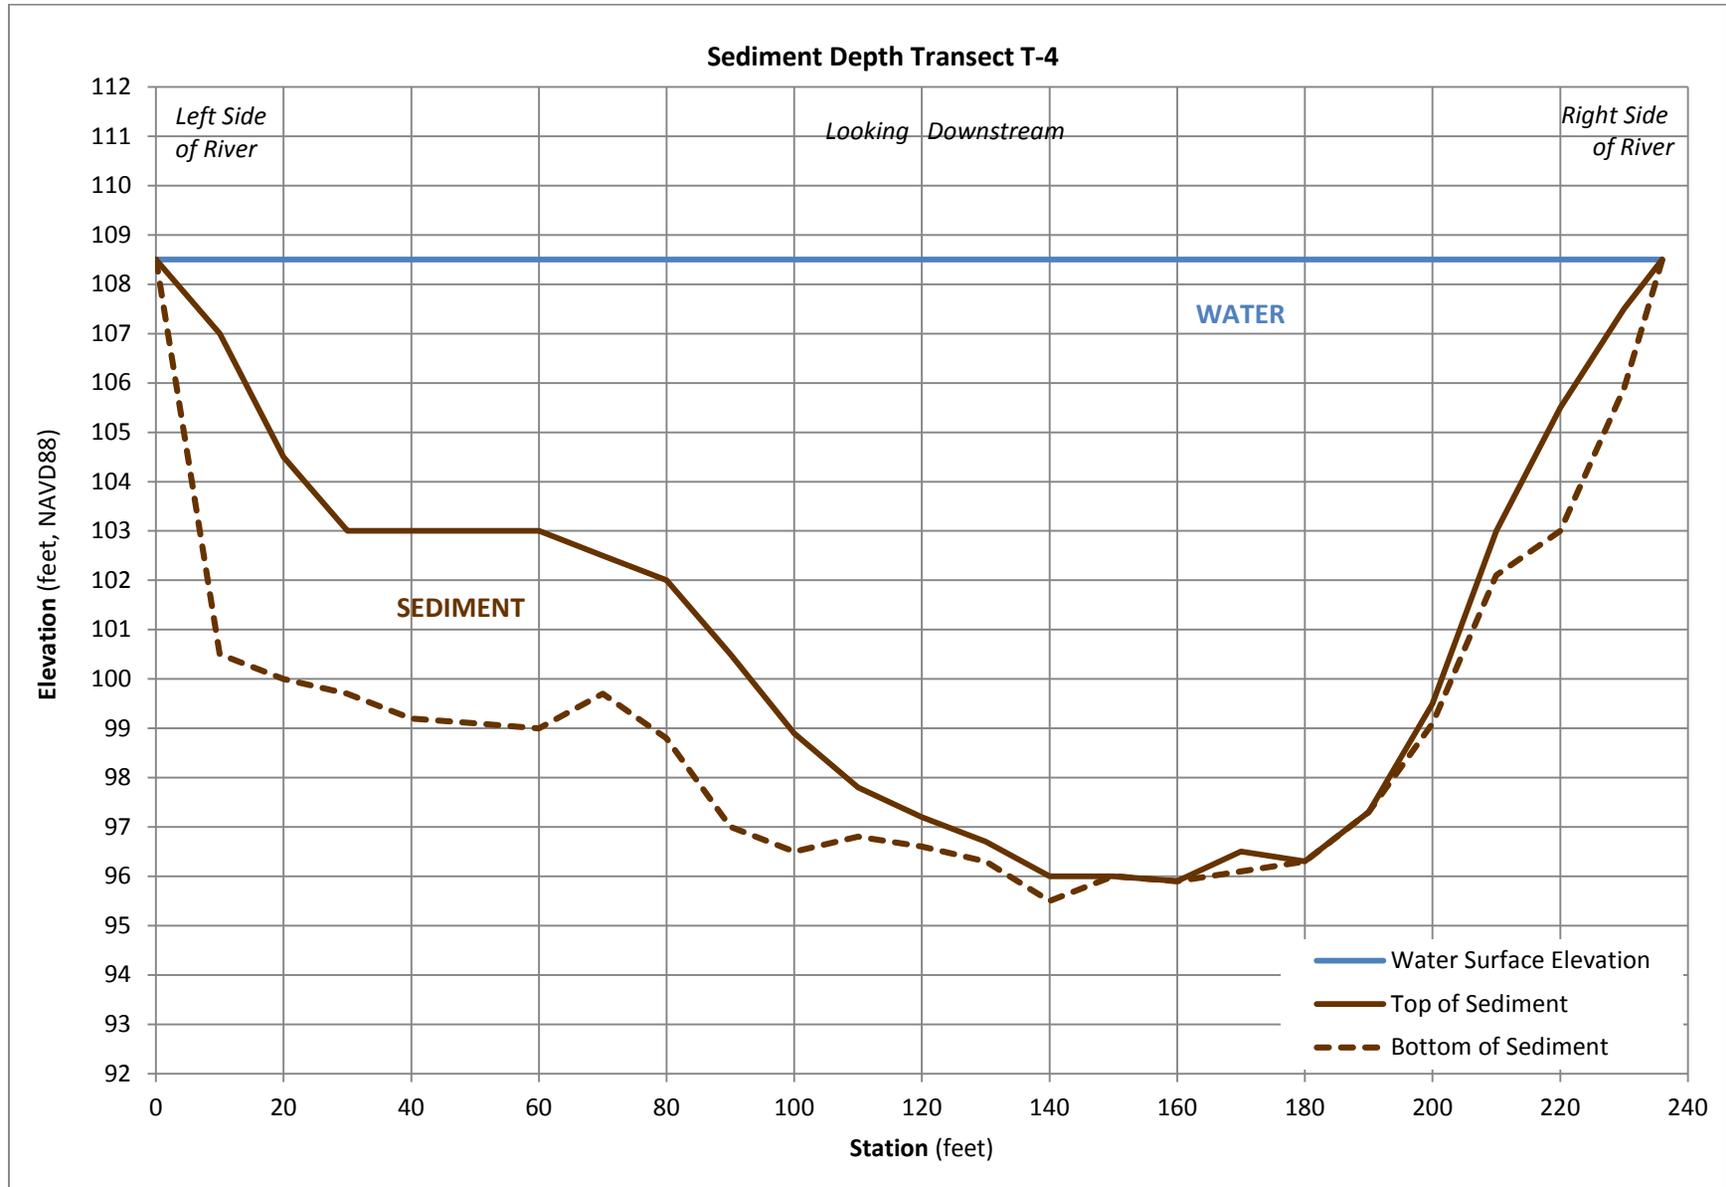
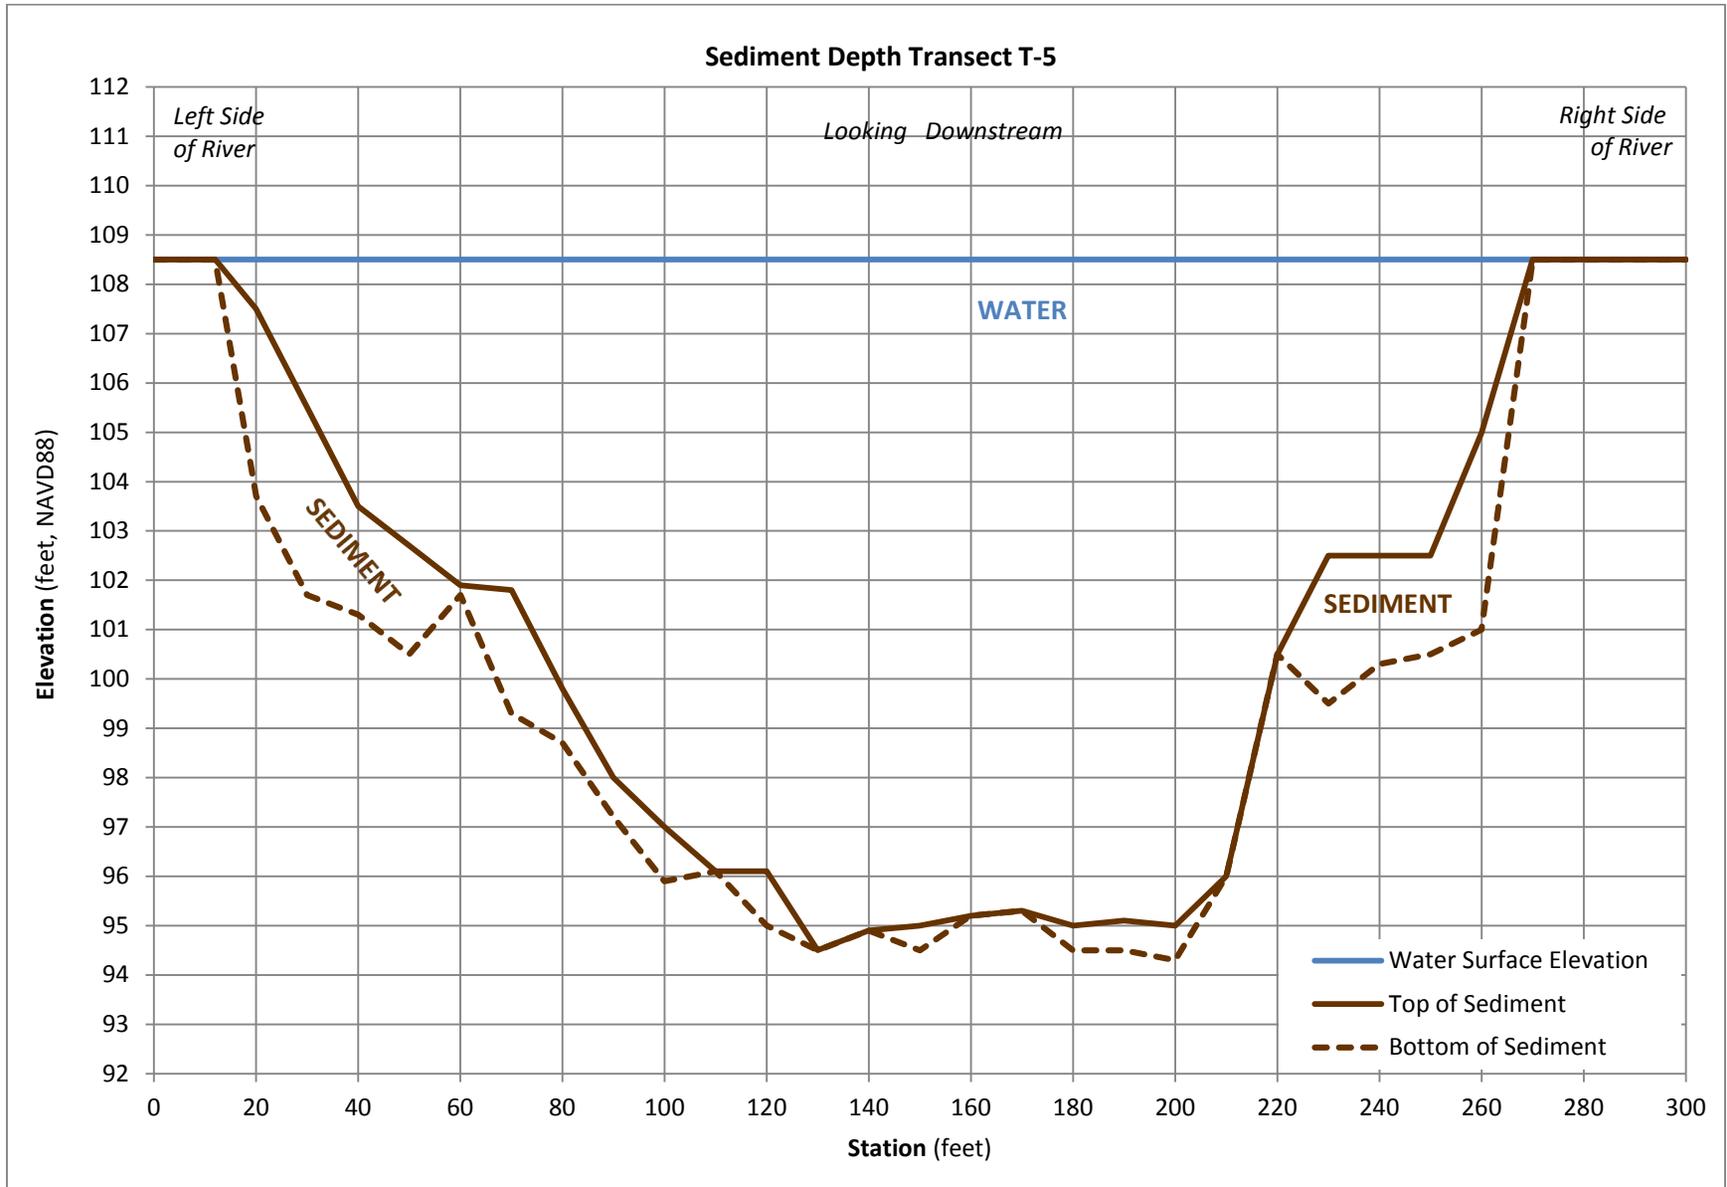
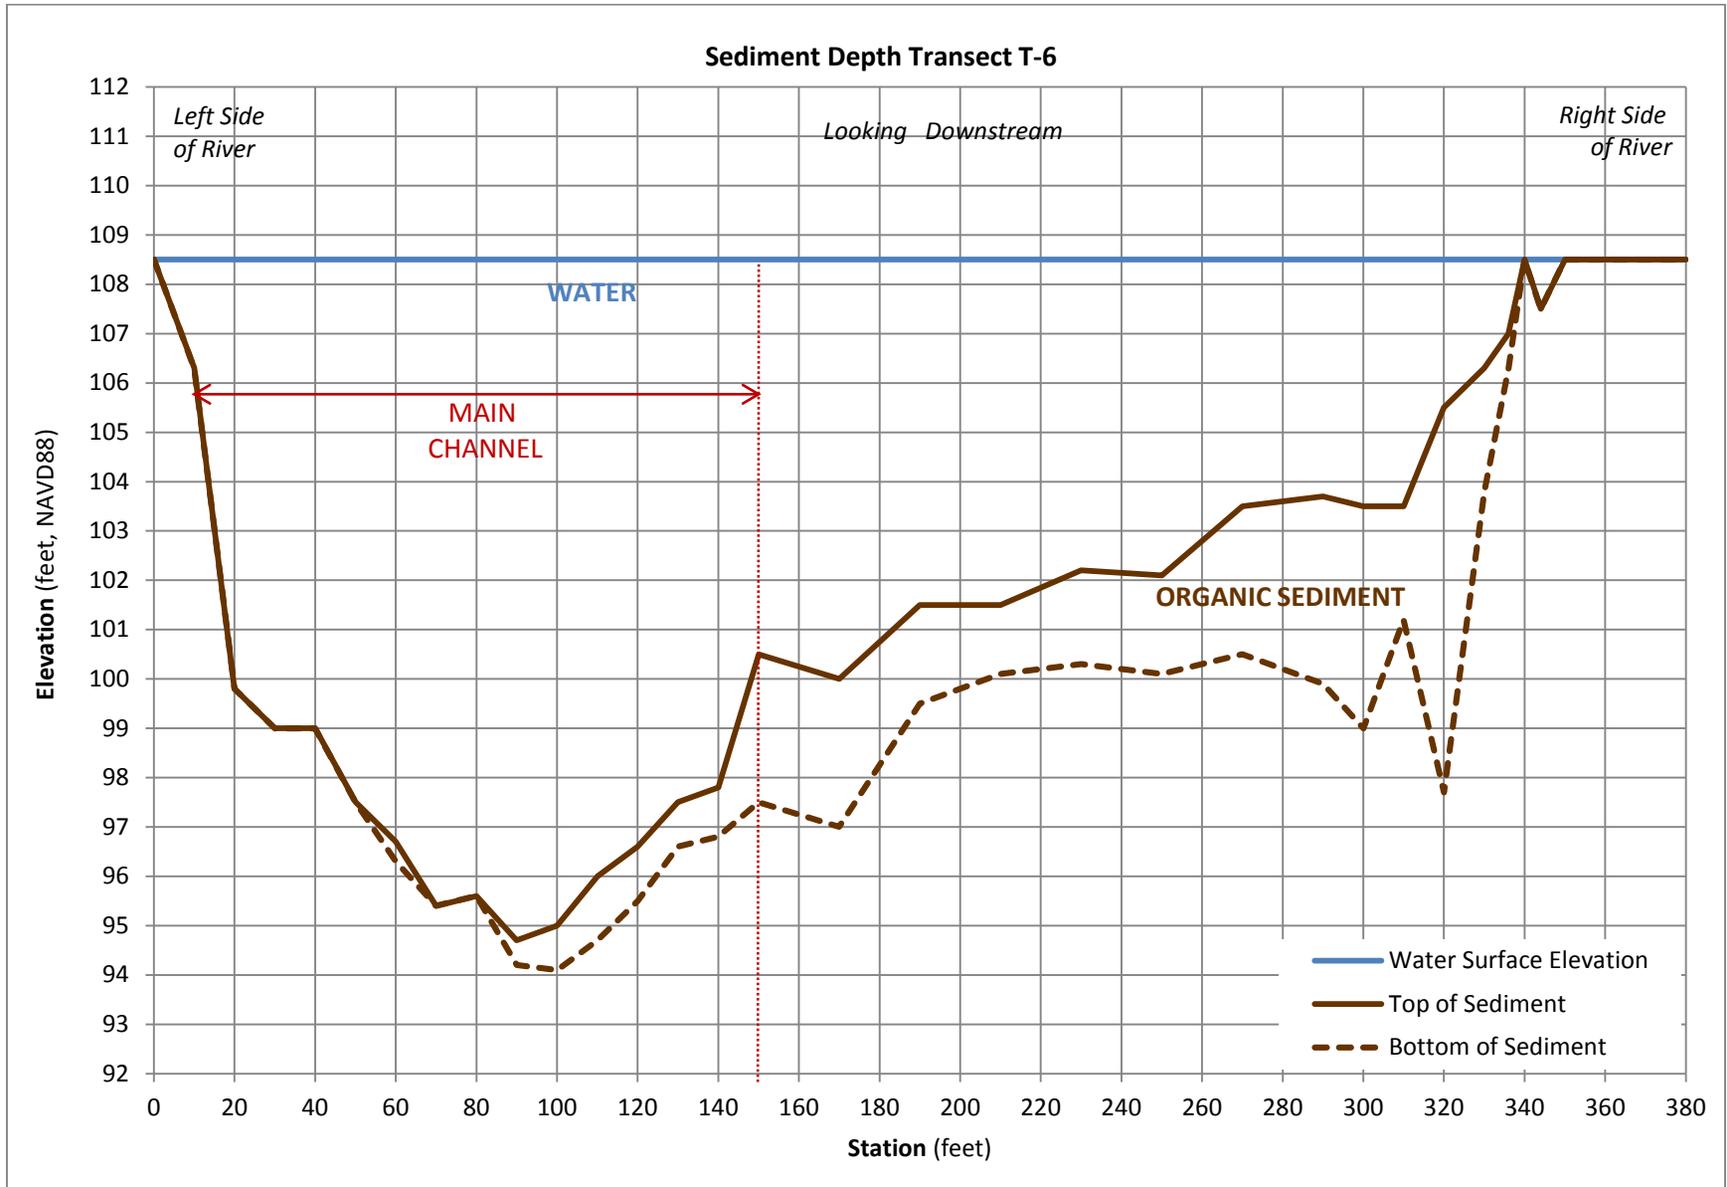
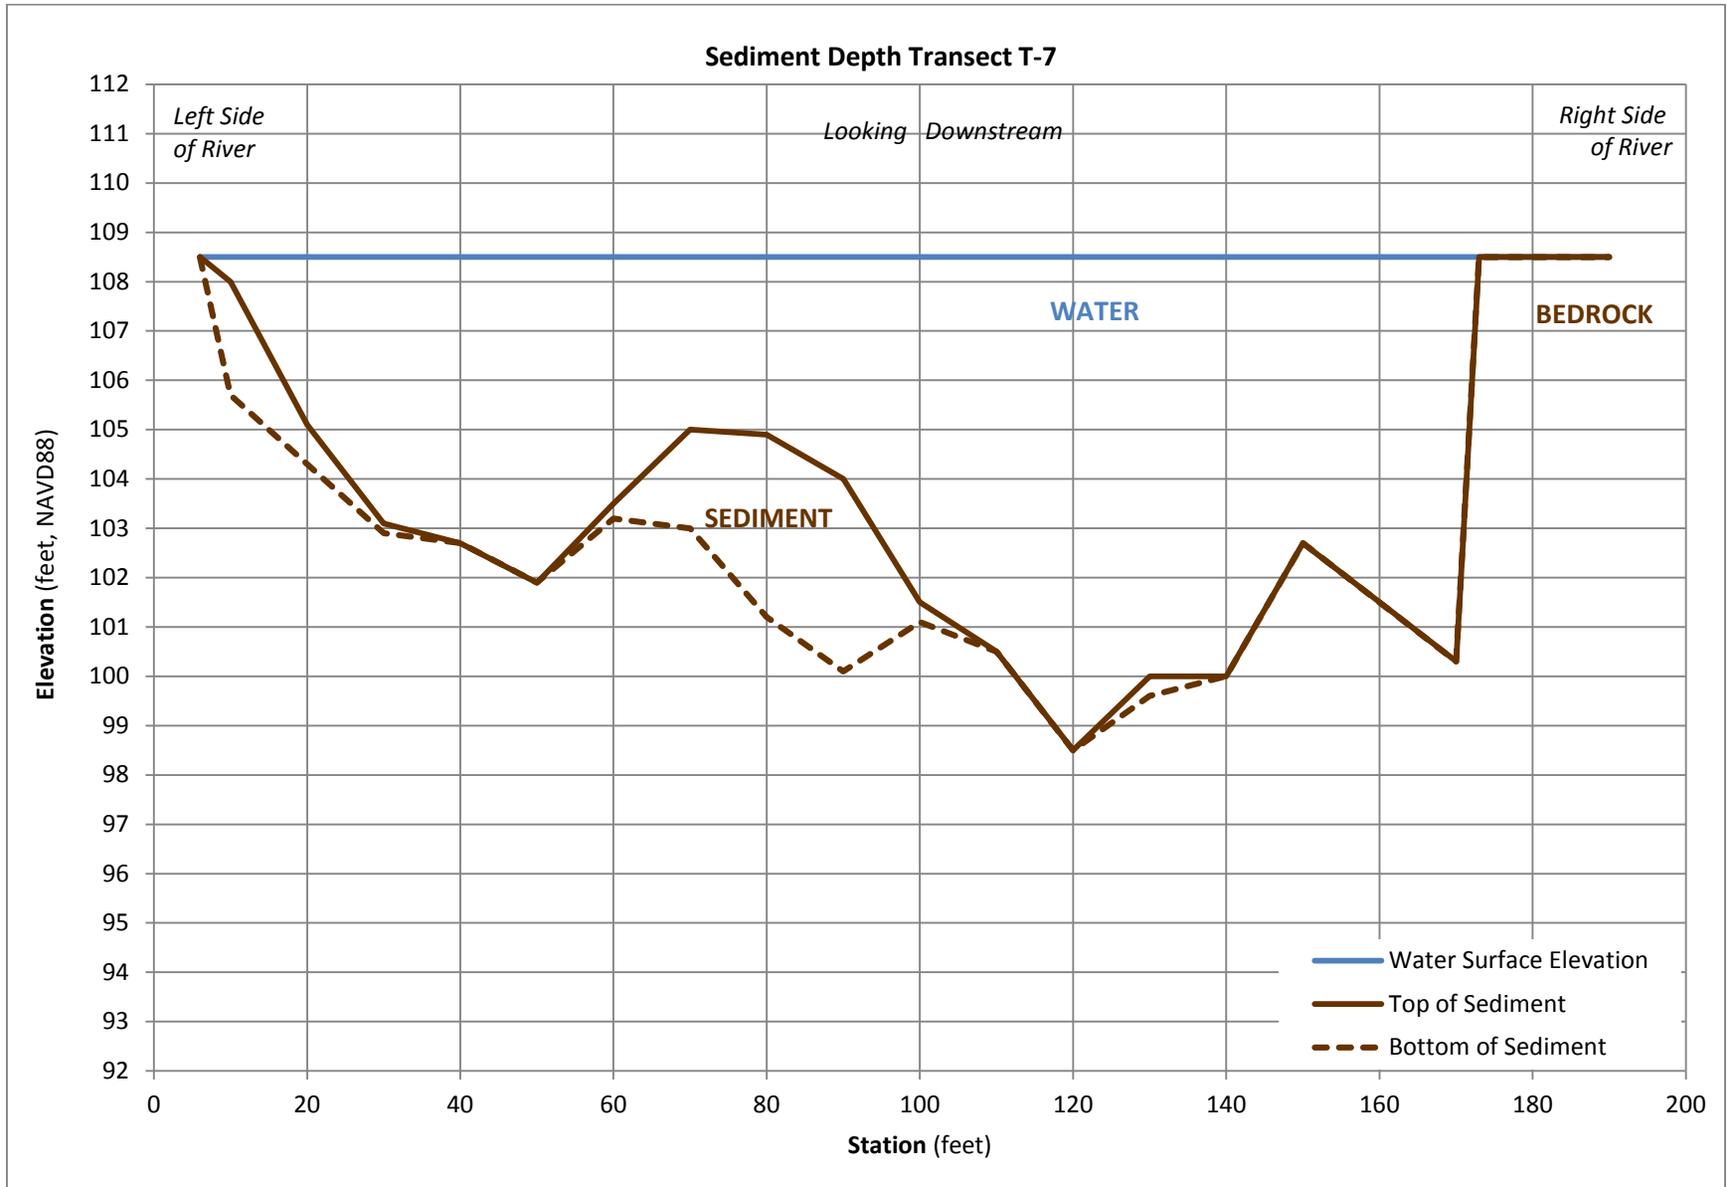
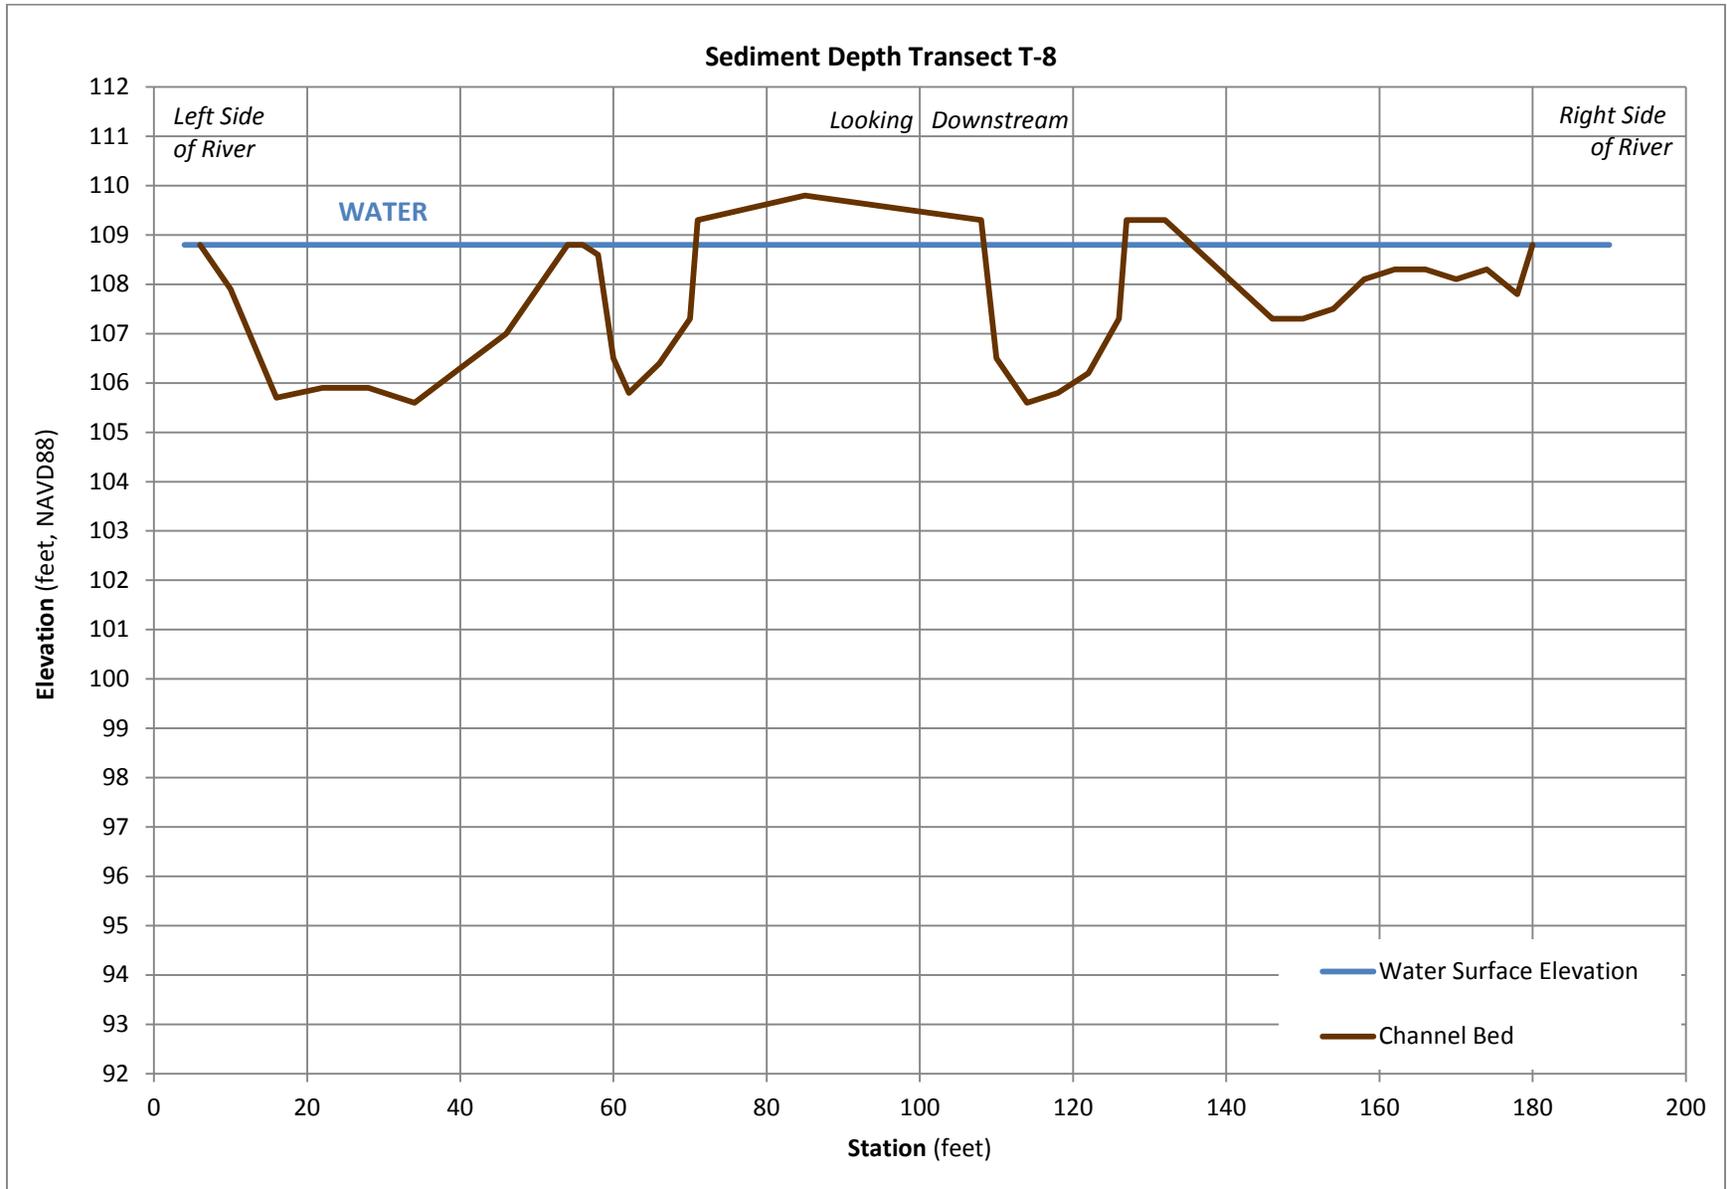
Figure 3.2.1-3: Talbot Mills Dam Impoundment Sediment Depth Transect T-1 (upstream of dam)

Figure 3.2.1-4: Talbot Mills Dam Impoundment Sediment Depth Transect T-2

Figure 3.2.1-5: Talbot Mills Dam Impoundment Sediment Depth Transect T-3

Figure 3.2.1-6: Talbot Mills Dam Impoundment Sediment Depth Transect T-4

Figure 3.2.1-7: Talbot Mills Dam Impoundment Sediment Depth Transect T-5

Figure 3.2.1-8: Talbot Mills Dam Impoundment Sediment Depth Transect T-6

Figure 3.2.1-9: Talbot Mills Dam Impoundment Sediment Depth Transect T-7

Figure 3.2.1-10: Talbot Mills Dam Impoundment Sediment Depth Transect T-8 (Fordway Bar)
