APPENDIX A

Figures & Tables

Concord River Diadromous Fish Restoration Feasibility Study

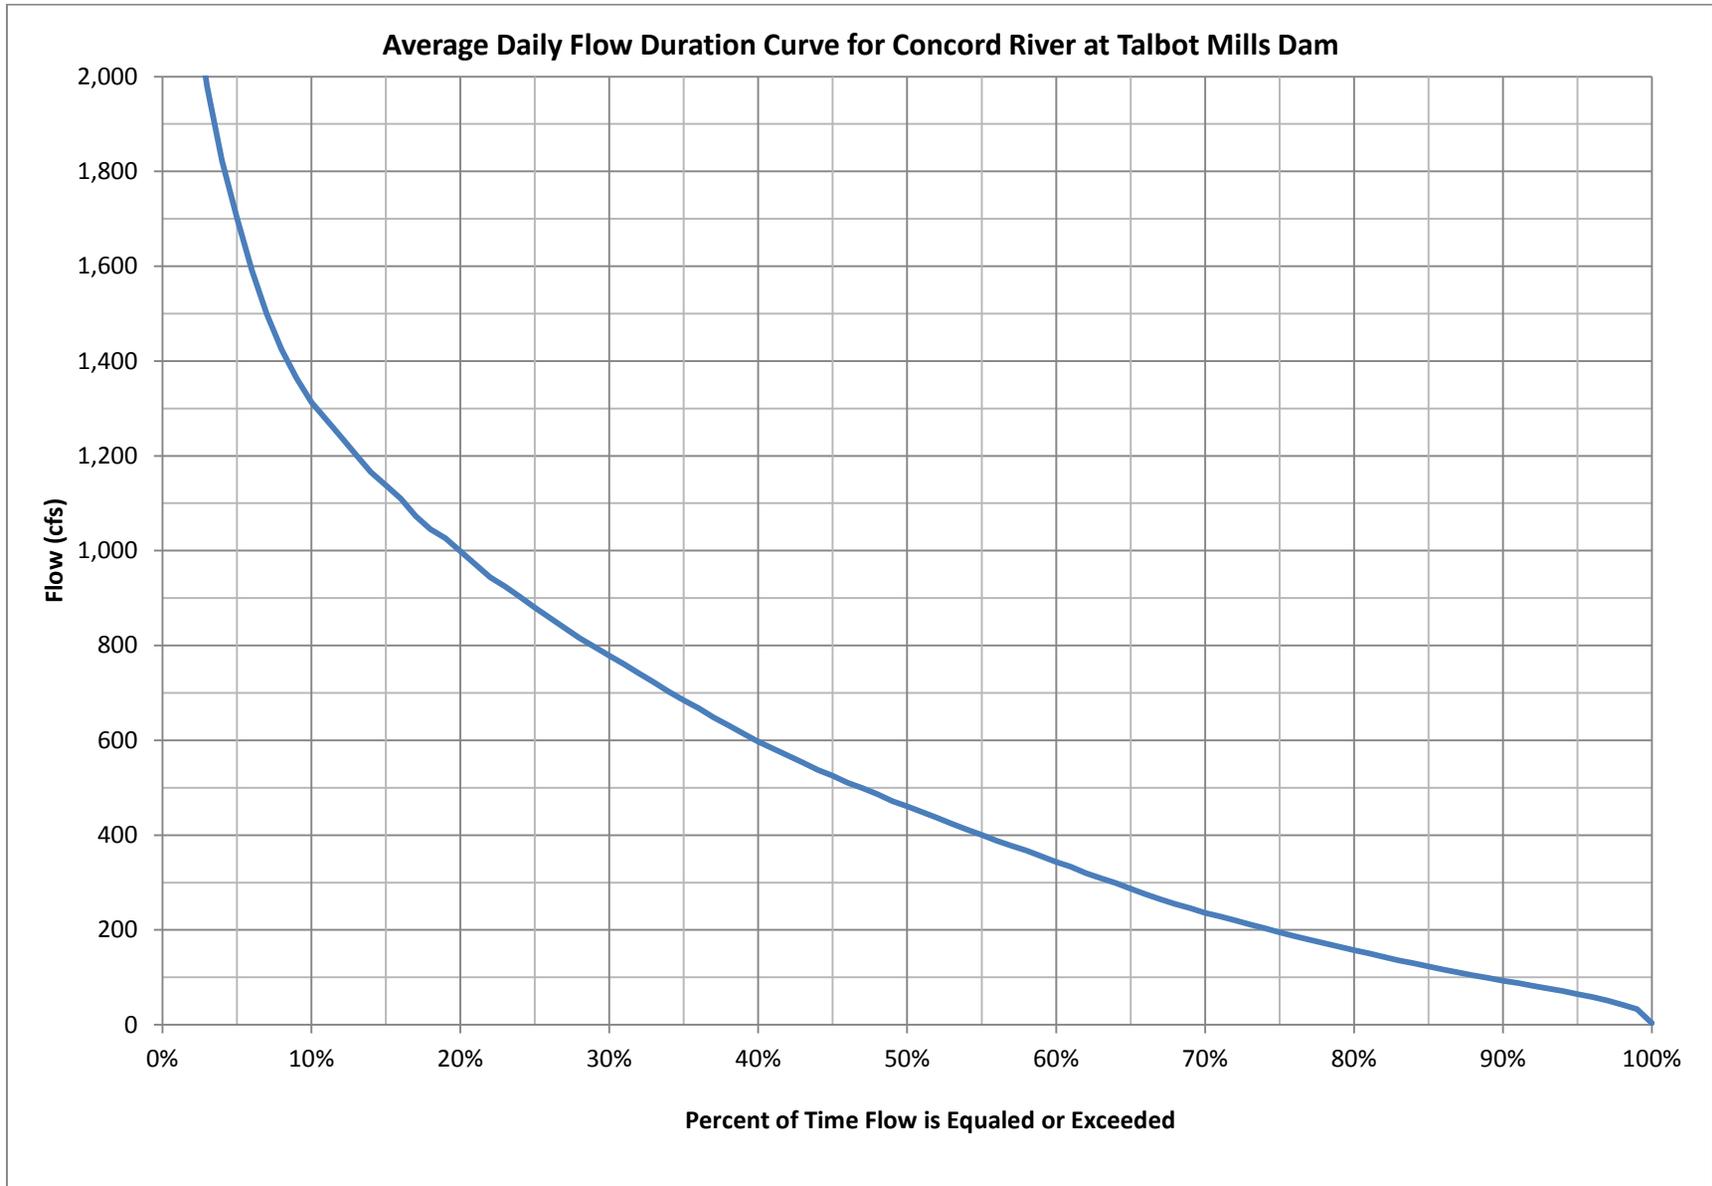
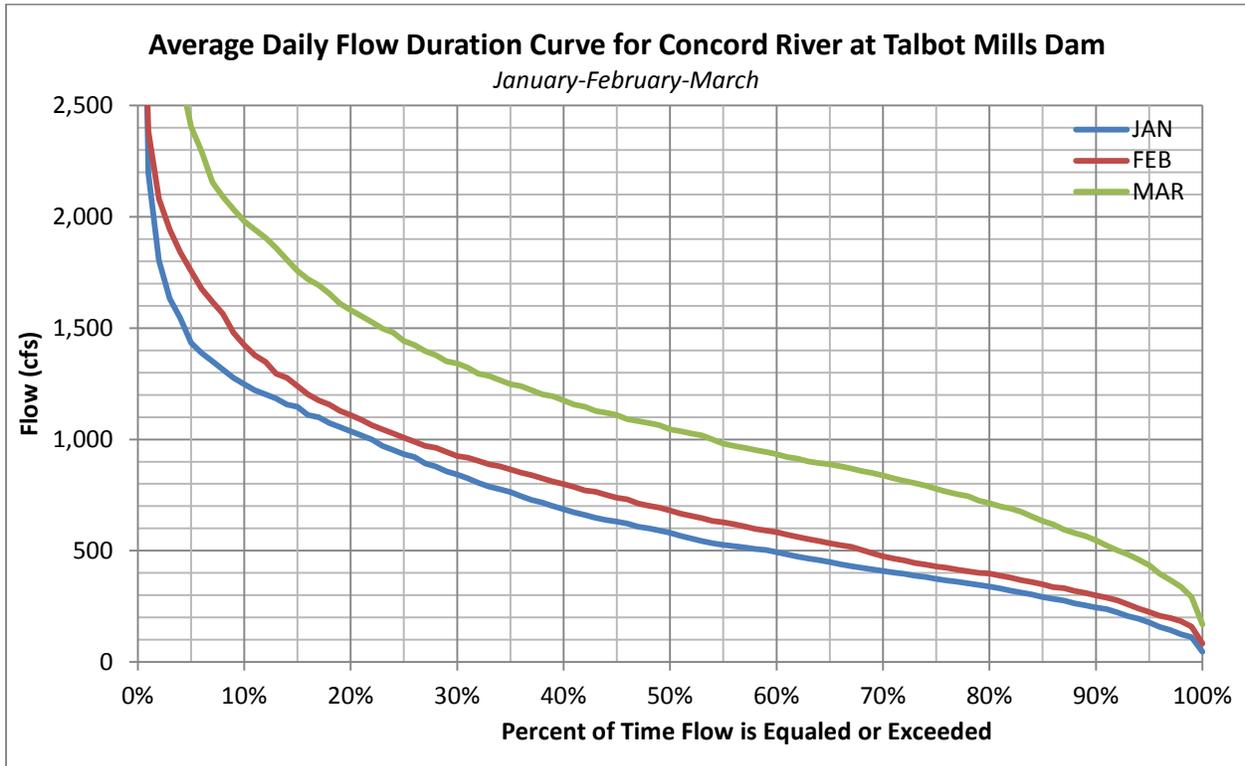
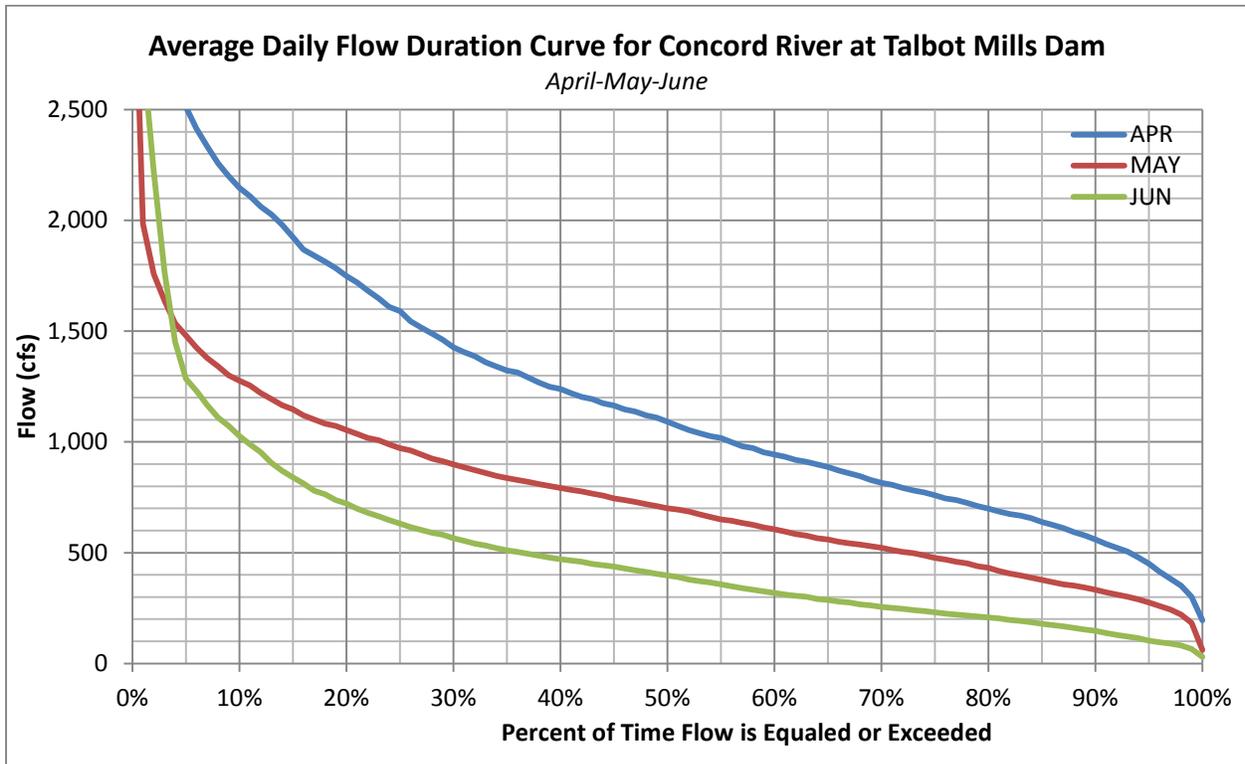
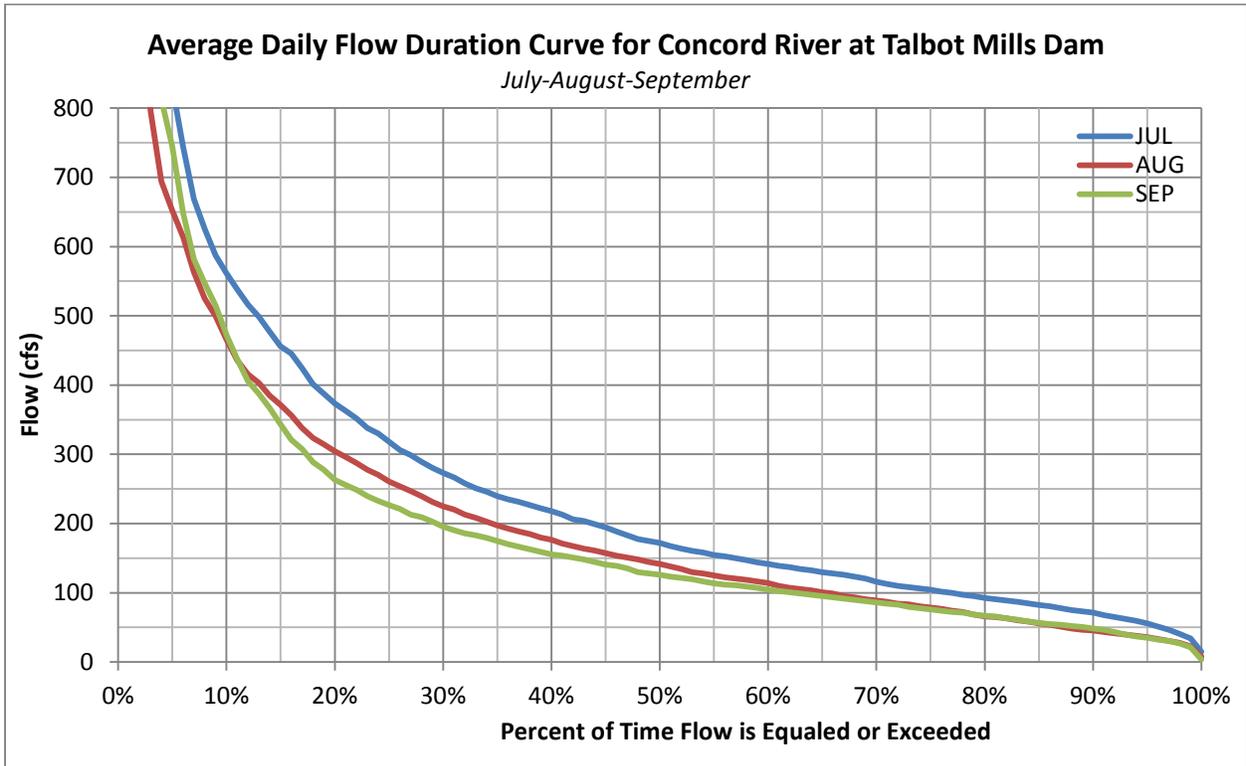
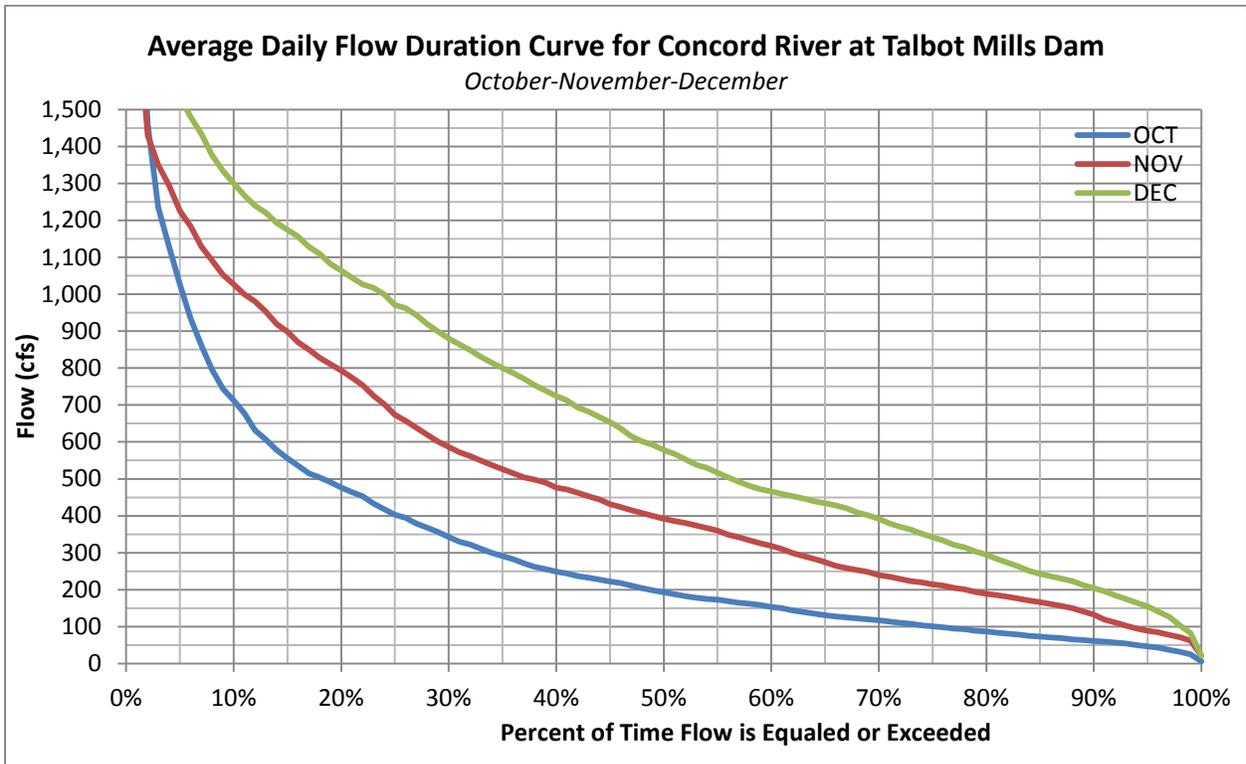
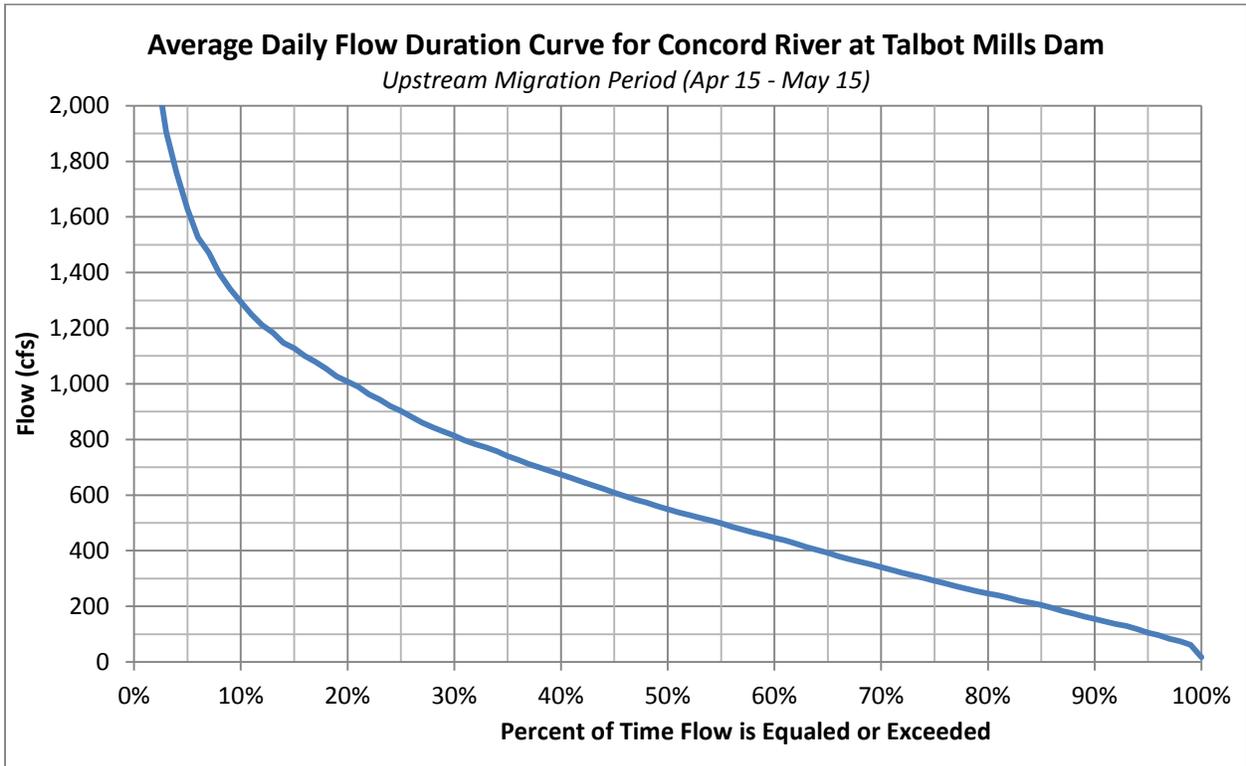
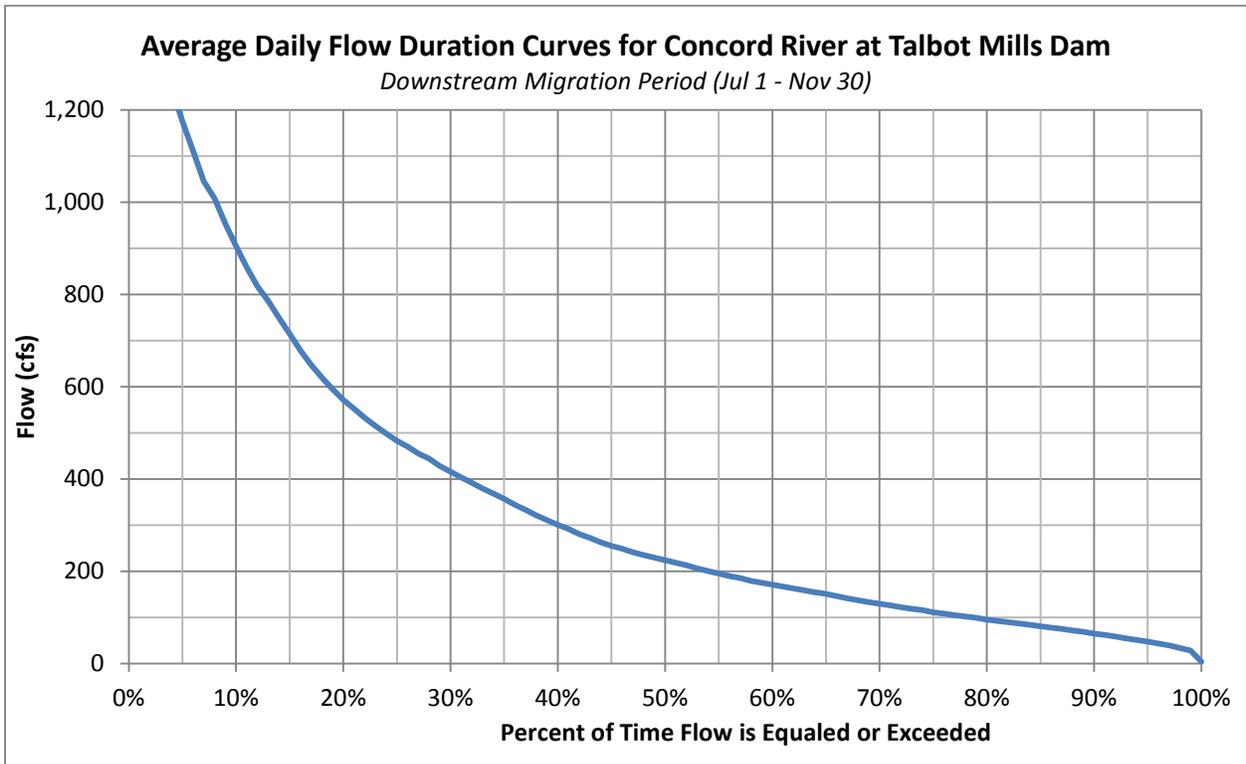
Figure 3.3.1-1: Annual Flow Duration Curve for Concord River at Talbot Mills Dam

Figure 3.3.1-2: Jan-Mar Flow Duration Curves for Concord River at Talbot Mills Dam

Figure 3.3.1-3: Apr-Jun Flow Duration Curves for Concord River at Talbot Mills Dam

Figure 3.3.1-4: Jul-Sep Flow Duration Curves for Concord River at Talbot Mills Dam

Figure 3.3.1-5: Oct-Dec Flow Duration Curves for Concord River at Talbot Mills Dam

Figure 3.3.1-6: Upstream Migration Flow Duration Curve for Concord River at Talbot Mills Dam

Figure 3.3.1-7: Downstream Migration Flow Duration Curves for Concord River at Talbot Mills Dam

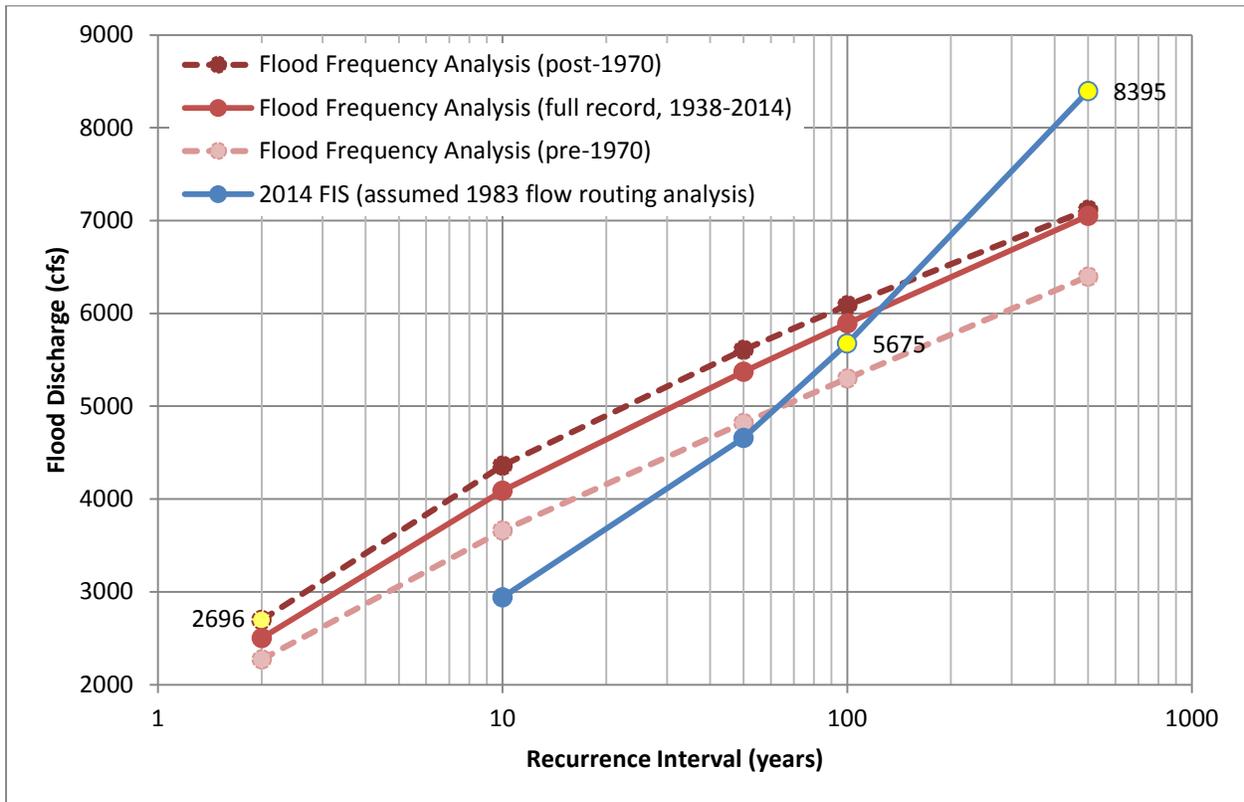
Figure 3.3.2-1: Comparison of Flood Frequency Estimates for the Concord River at Talbot Mills Dam

Note: Points highlighted in yellow were selected for use in the hydraulic model. Note that the published FIS 500-year flood flow does not appear to follow the trend of the available data for lower flood flows. This may be due in part to differences in calculation methods (i.e., a flow routing analysis for the FIS vs. a statistical analysis of stream gage data for the updated flows). Also note that there is a discrepancy between modeled and published flows for the 2014 FIS, as discussed in Section 3.3.2. The modeled 500-year flood flow is approximately 6,950 cfs at the Talbot Mills Dam, which would put it more in line with the trend of the other flows. For this study, the published FIS value was used as it is more conservative; however, this discrepancy could be further investigated in future phases of the project.

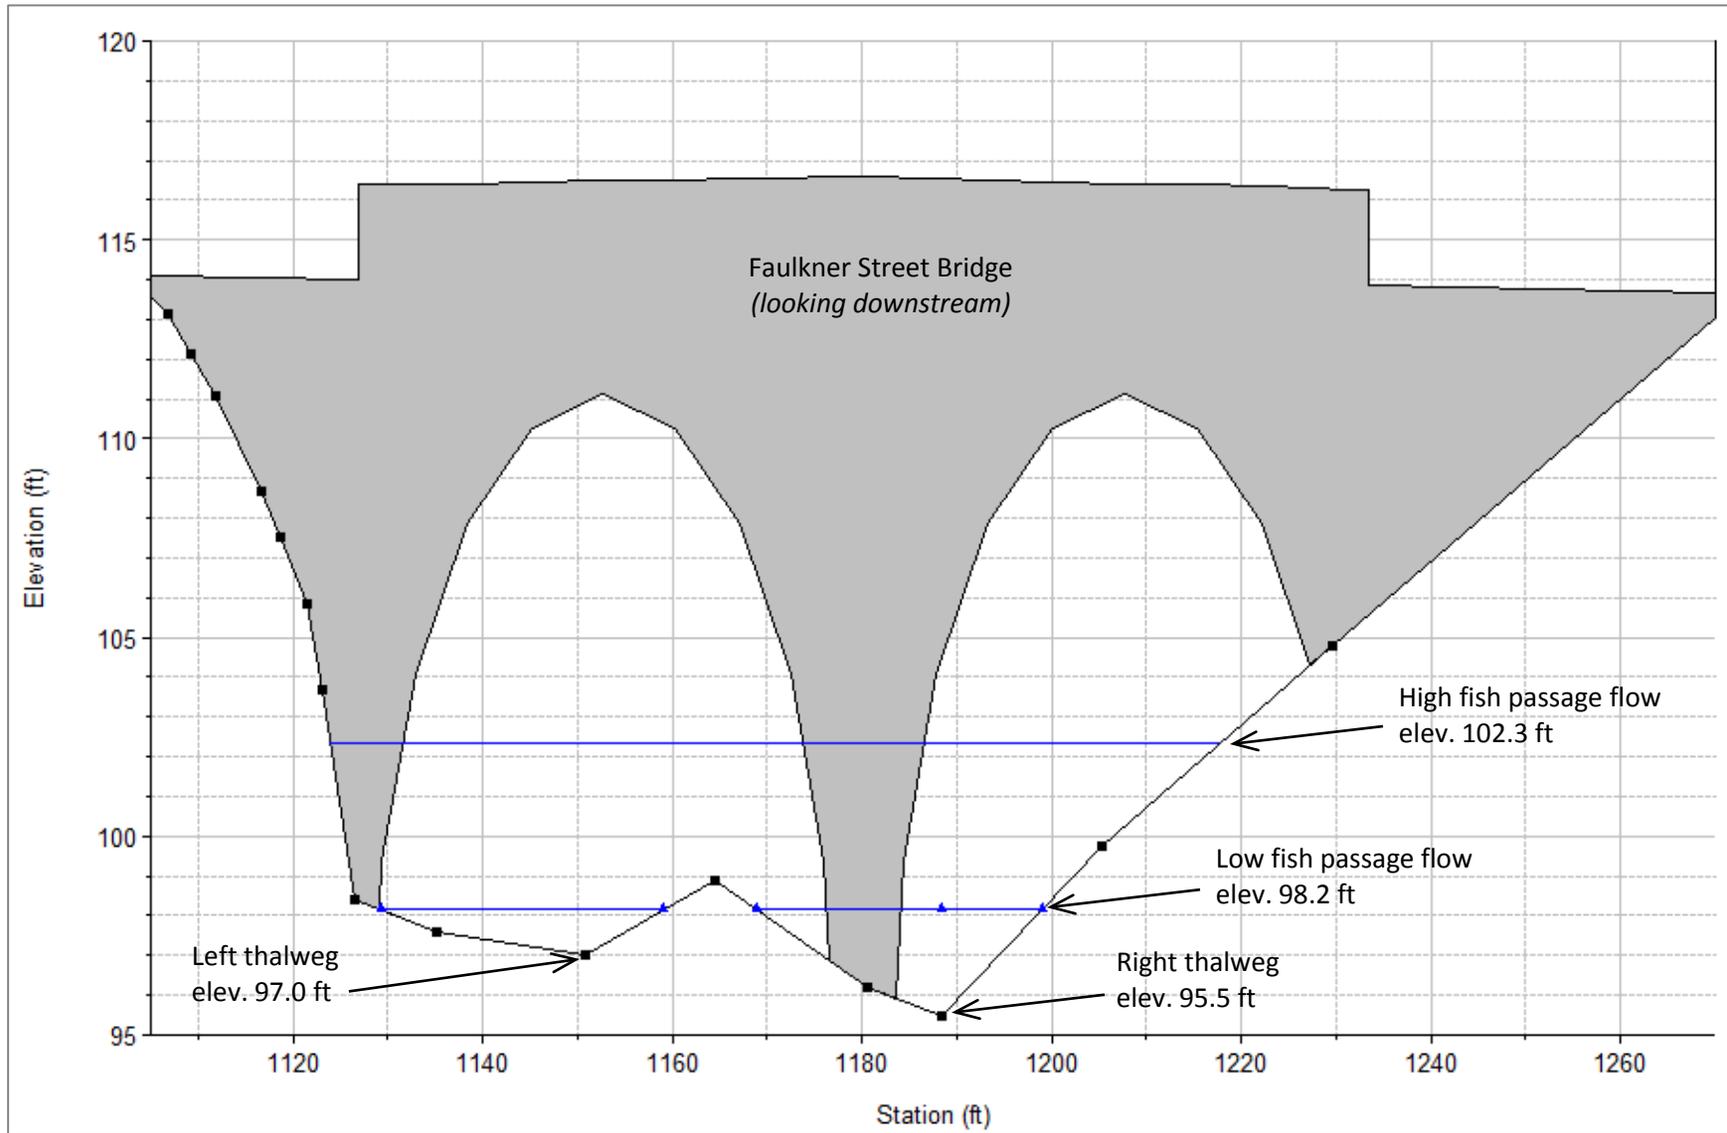
Figure 4.3.2-1: Channel Elevation under the Faulkner Street Bridge

Note: Channel cross-section surveyed for the 2014 FIS.

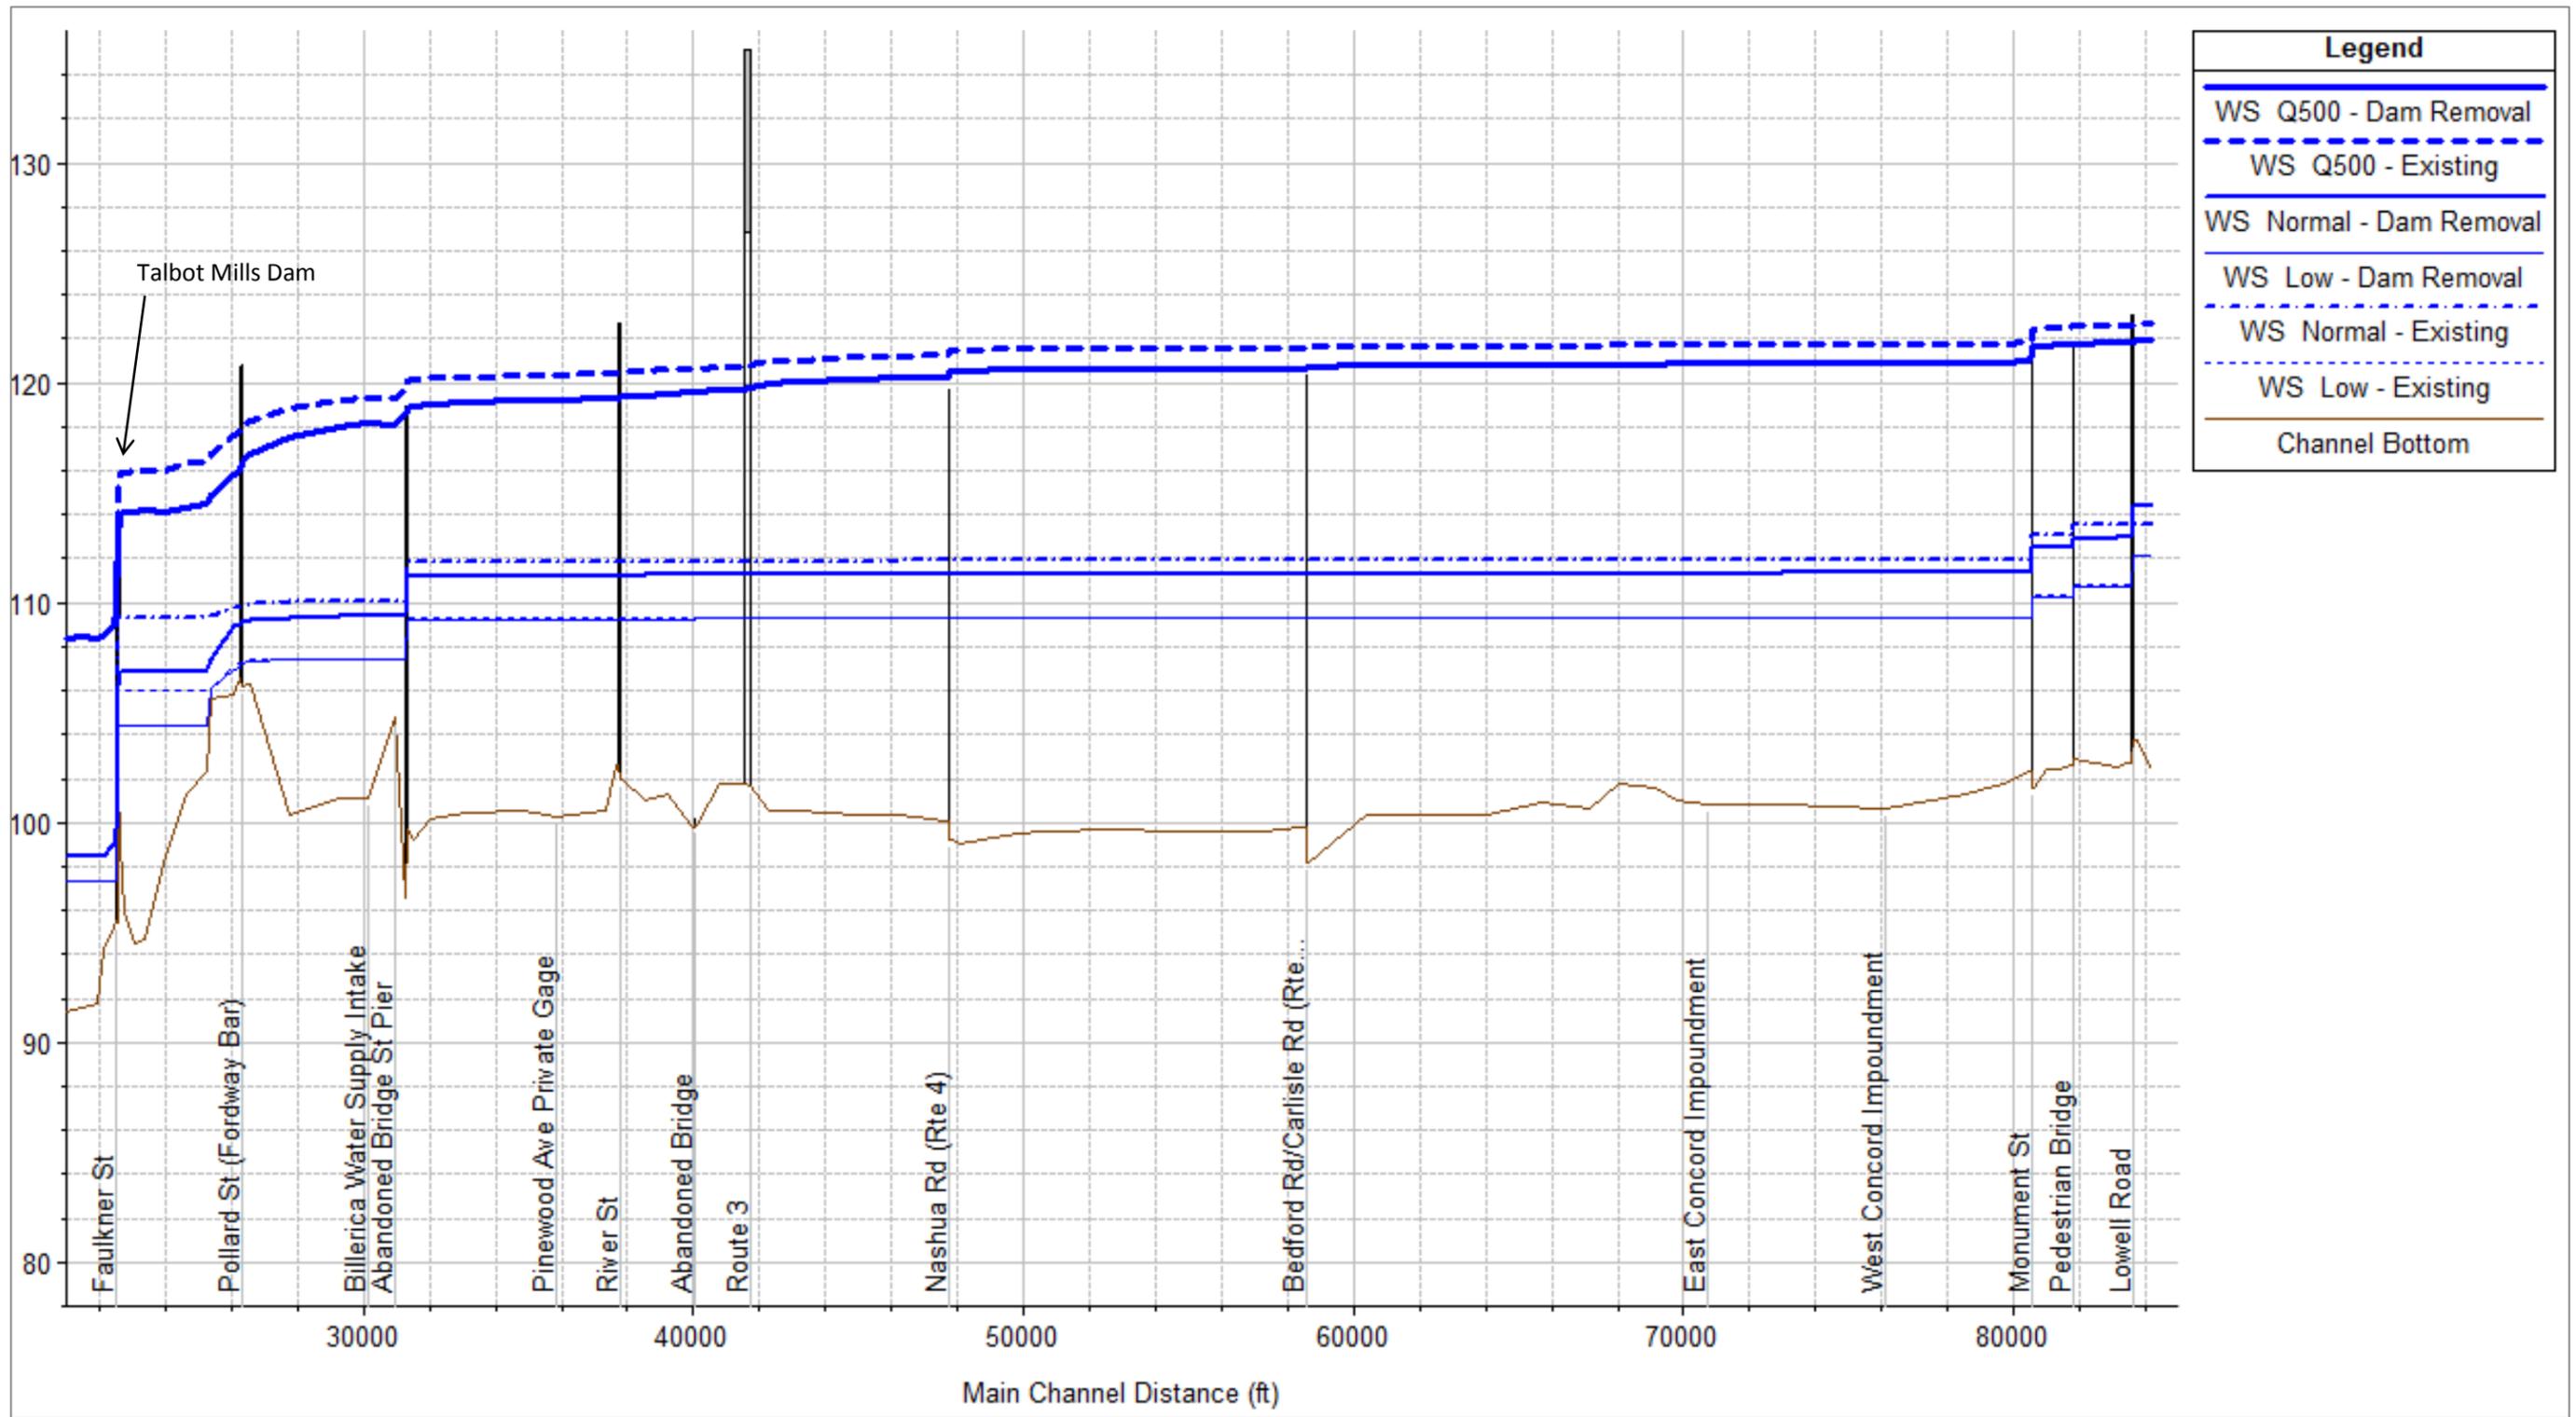
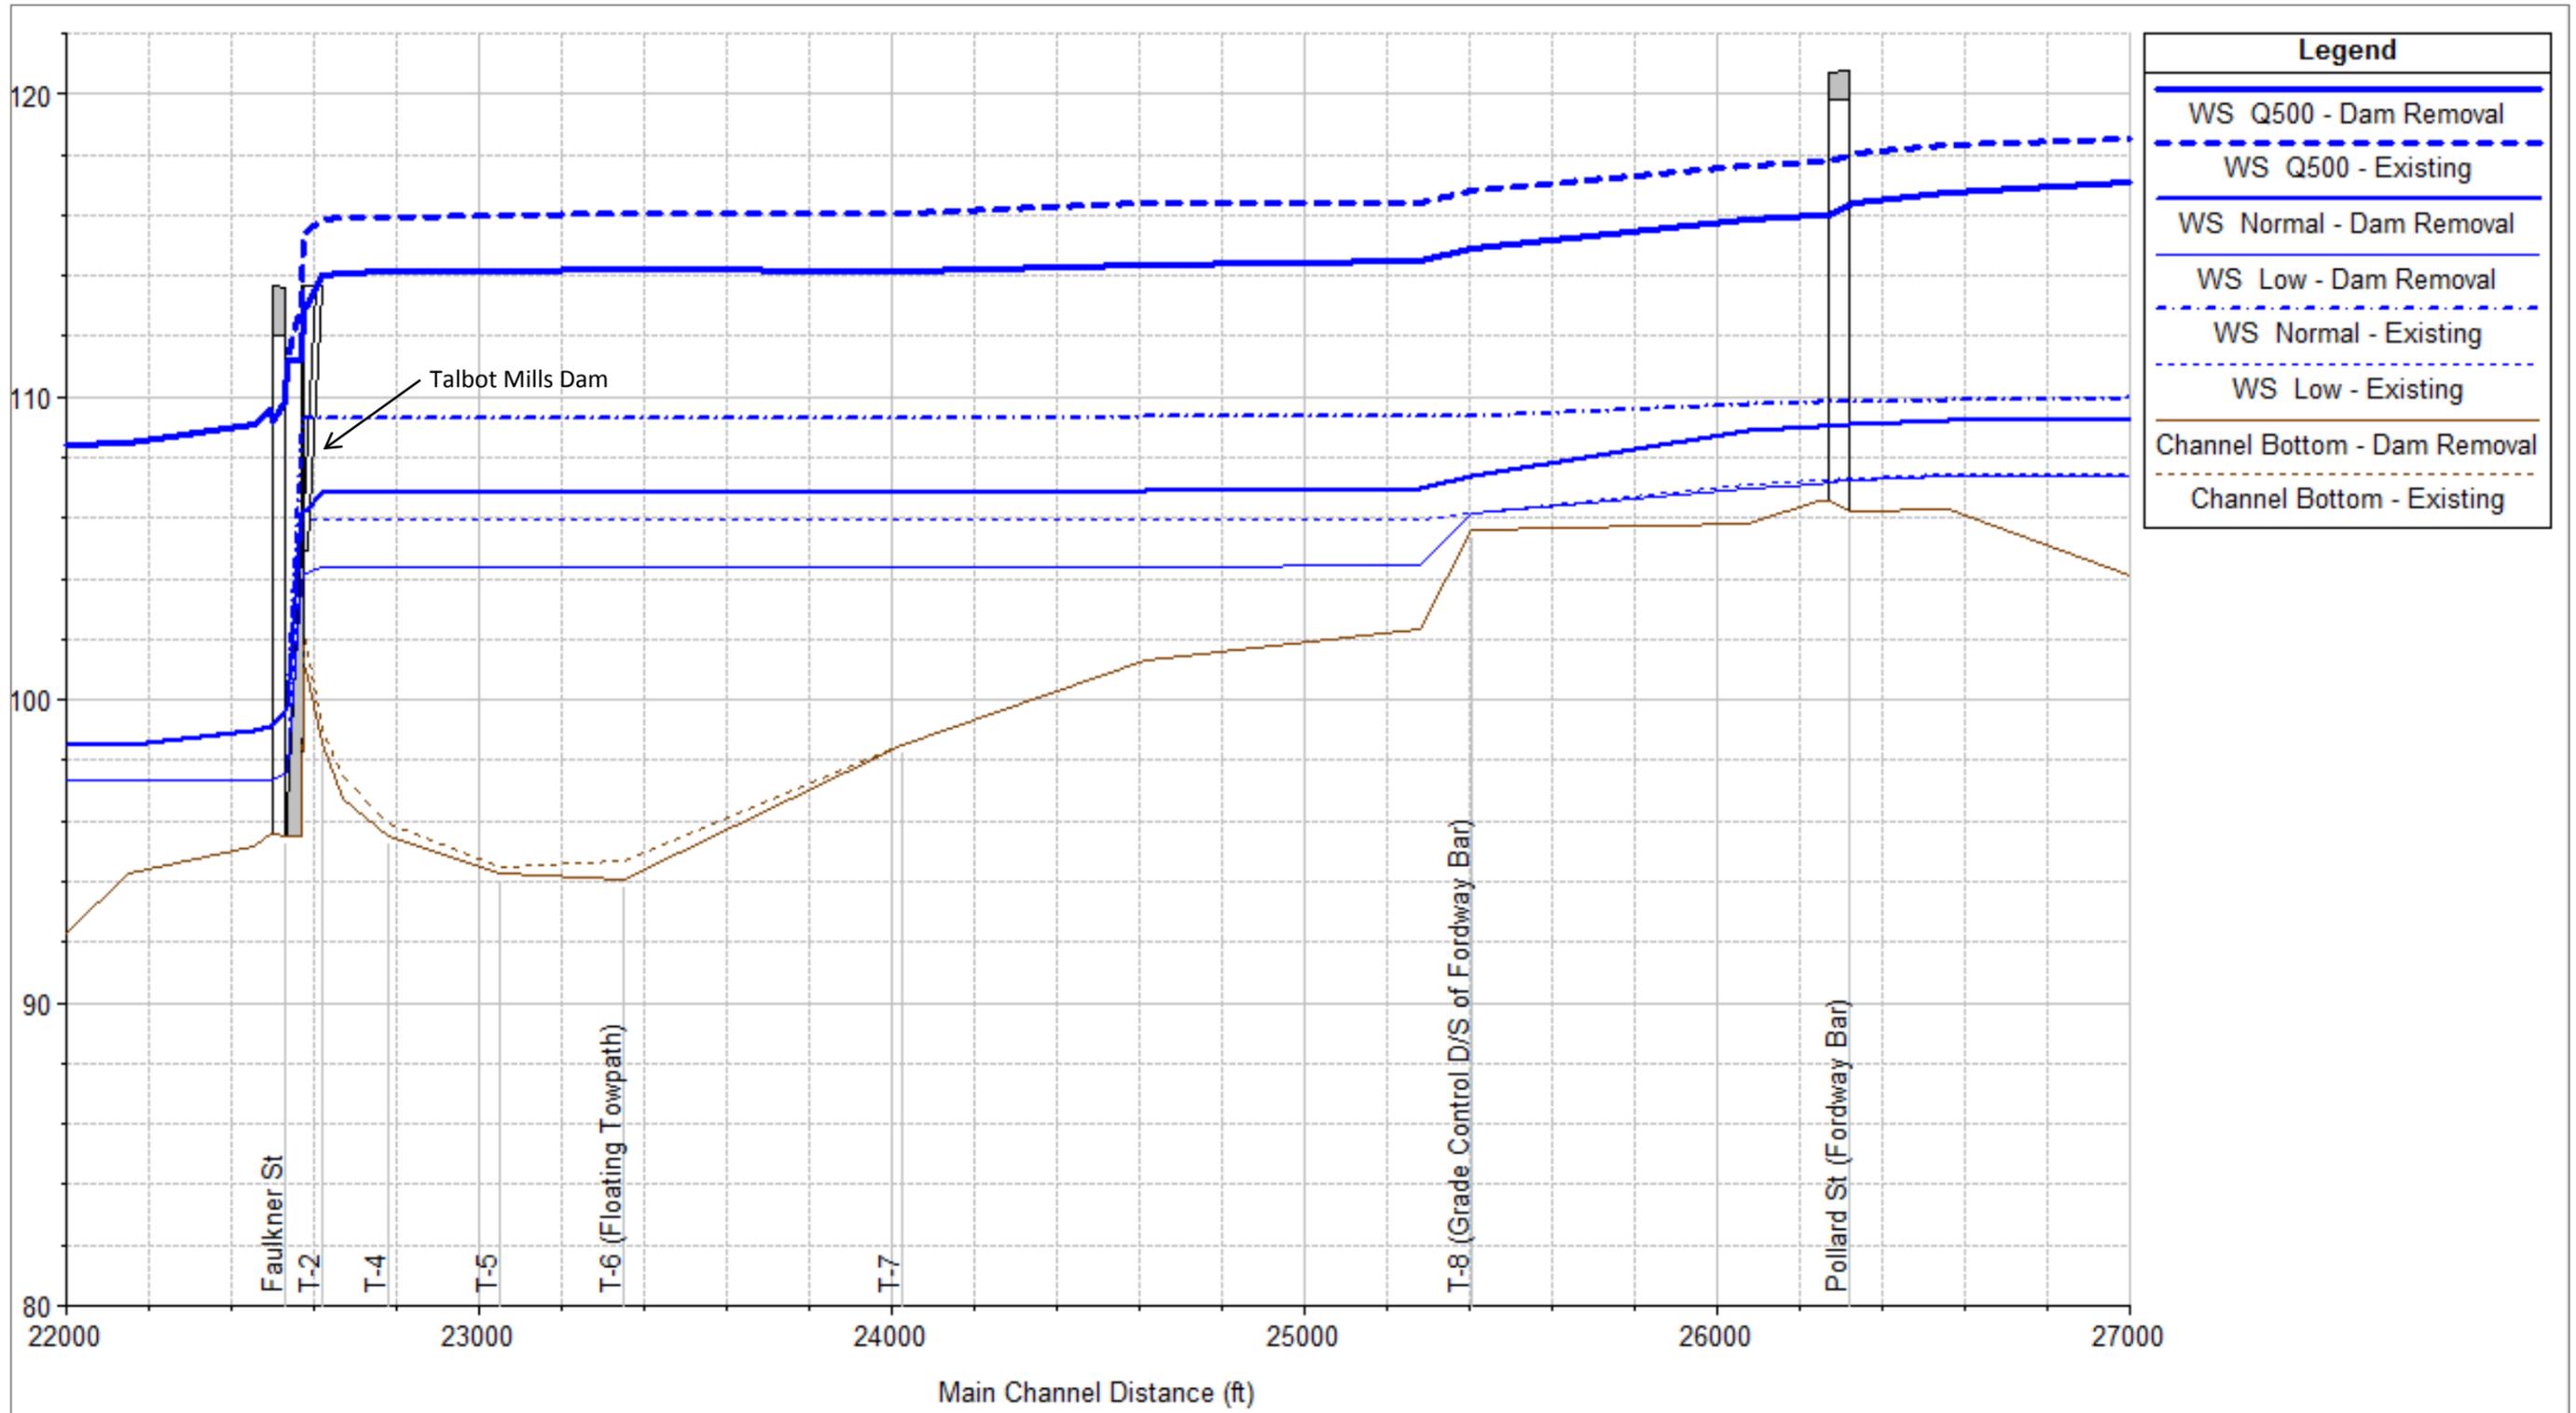
Figure 4.3.3-2: Comparison of Concord River Water Surface Profiles for Existing vs. Partial Dam Removal Conditions (Alt 3B)

Figure 4.3.3-3: Comparison of Concord River Water Surface Profiles for Existing vs. Partial Dam Removal Conditions (Alt 3B) (lower impoundment detail)
