# Concord River Diadromous Fish Restoration

## FEASIBILITY STUDY

*Concord River, Massachusetts*

DRAFT REPORT

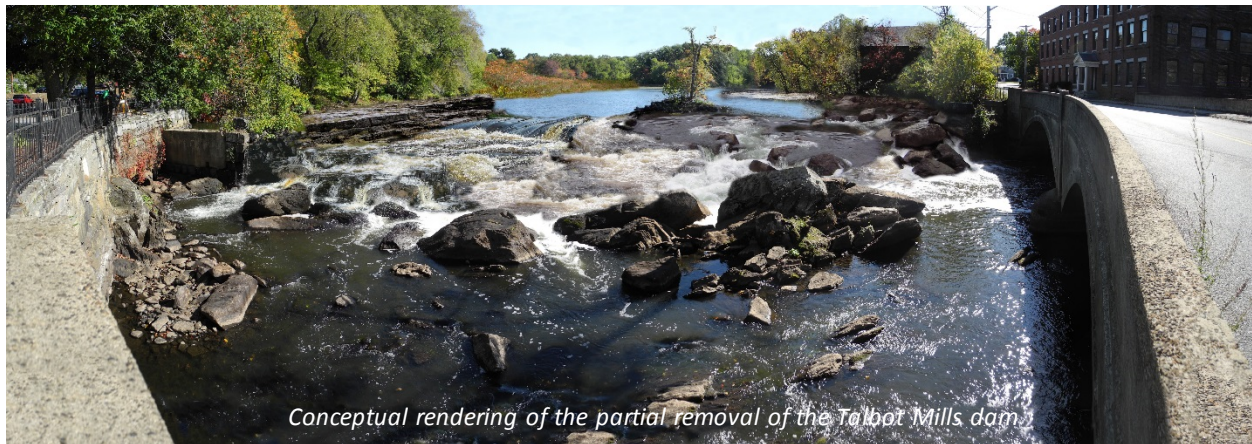
*Conceptual rendering of the partial removal of the Talbot Mills dam.*

The proposed partial removal of the Talbot Mills Dam (Alternative 3B) would provide effective passage for target species as well as significant benefits for other resources. Water quality, aquatic habitat connectivity, and natural riverine sediment and flow regimes would be restored. Increased upstream flooding resulting from the dam would be reduced. Aging and unsafe infrastructure would be decommissioned, eliminating ongoing operation, maintenance, and liability costs and concerns. Recreation and aesthetic resources may improve as well, although these benefits are subject to individual preferences of the members of the public using the resources. With the exception of cultural resources, few impacts to other resources are anticipated. As such, partial removal of the Talbot Mills Dam is a feasible alternative for restoring diadromous fish in the Concord River that could be further evaluated in future phases of this project.

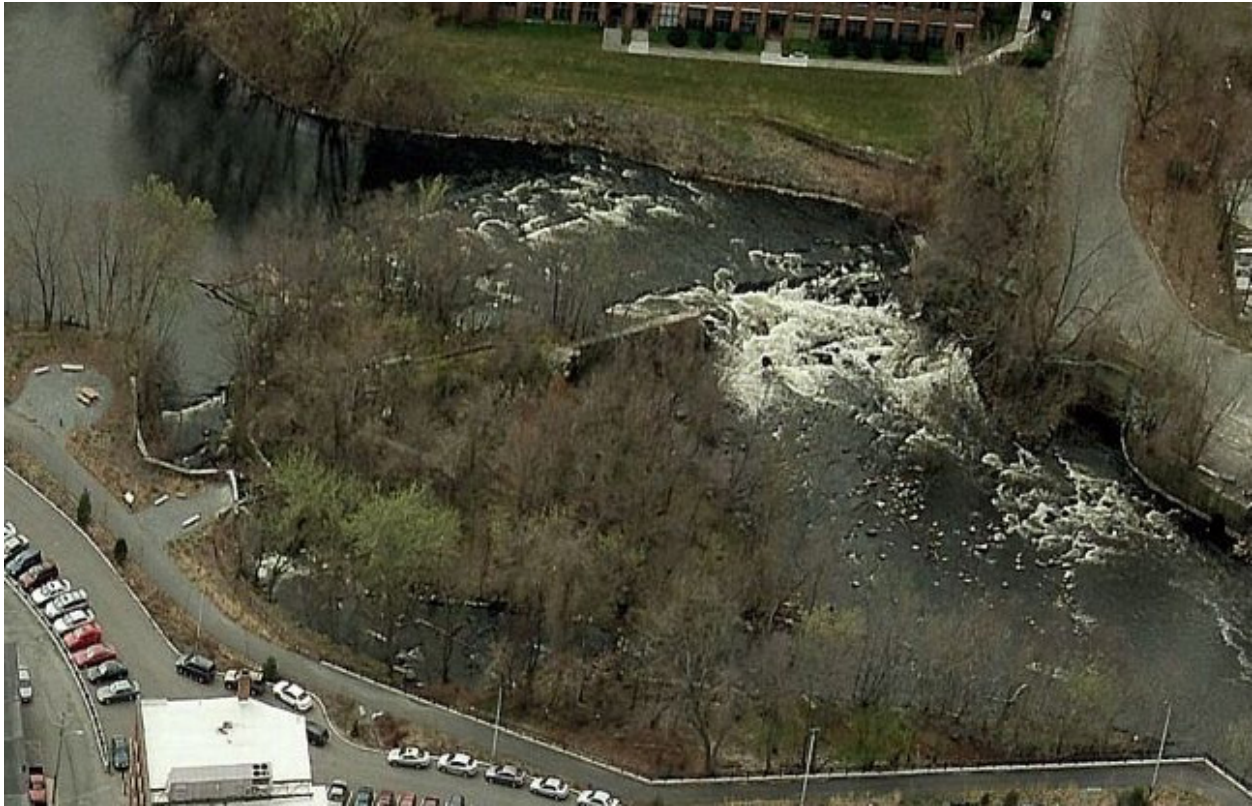
*Middlesex Falls (looking upstream), showing major (river left) and minor (river right) channels. See **Figure 2.2.1-1** for a labeled version of this aerial image (Bing, 2015).*

minor channel on river right, defined by the remains of the former mill race/power canal. **Figure 2.2.1-1** shows an aerial image of the site with key features labeled. Photographs of the site can be found in **Appendix B**.

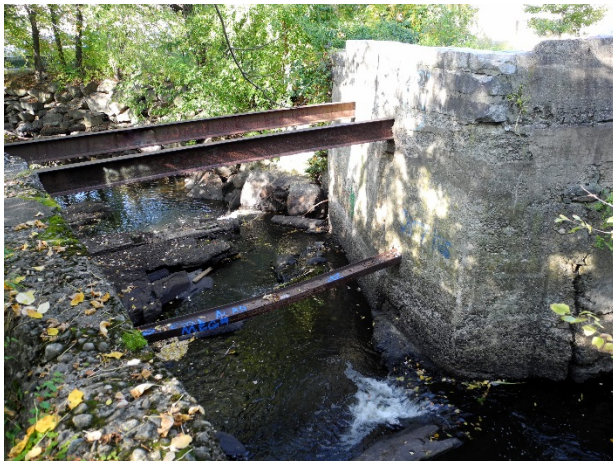
*Former mill race/power canal in minor channel on river right (looking downstream).*

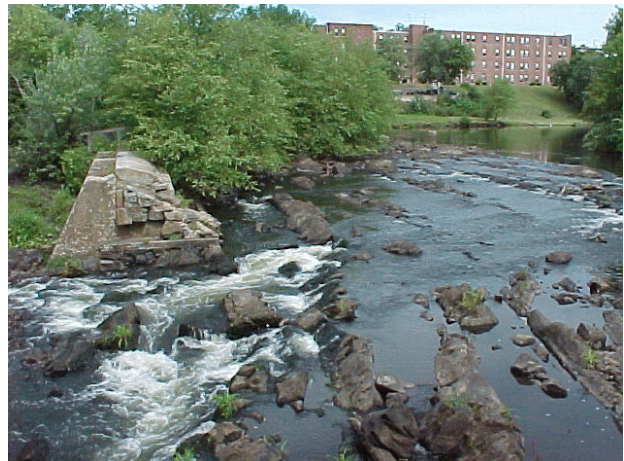
*Main channel on river left showing proposed passage route along remaining abutment (looking toward island) (McKeon, 2002).*

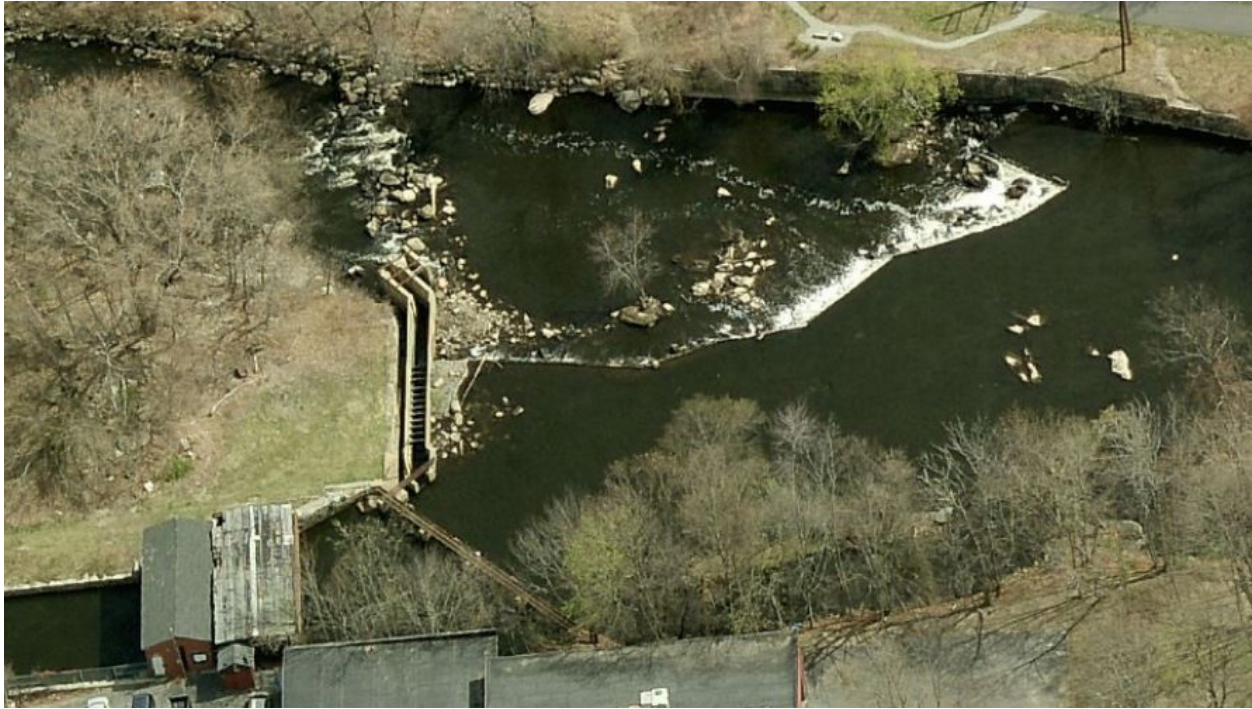
*Centennial Falls Dam (looking downstream), showing the power canal and gatehouse on the left, spillway and bypass reach below on the right, and fish passage structures adjacent to the river left side of the dam. See **Figure 2.2.2-1** for a labeled version of this aerial image (Bing, 2015).*

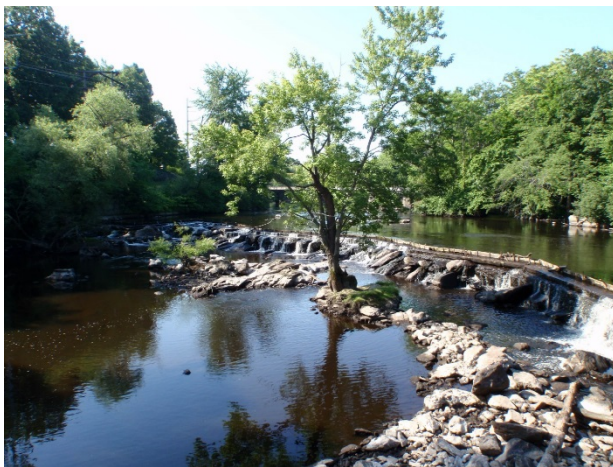
*Centennial Falls Dam (looking upstream). Fishway is out of view to the right side of picture (Smithwood, 2013).*

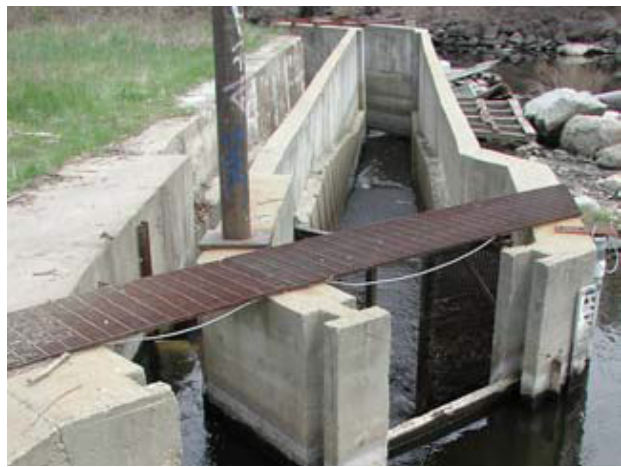
*Centennial Island fish passage structures, showing downstream bypass entrance on the left and Denil fish ladder exit on the right (Brady et al., 2005).*

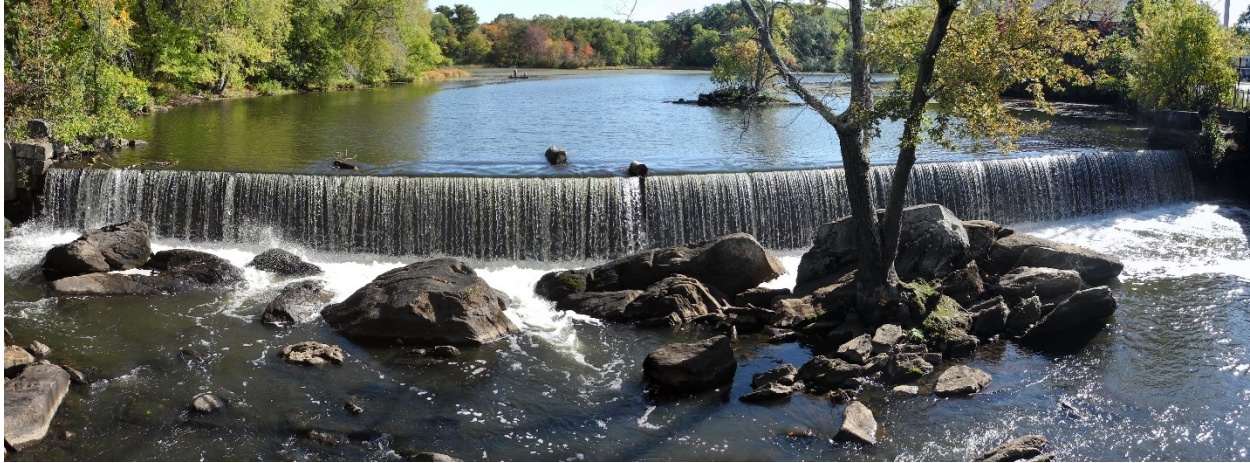
*Talbot Mills Dam (looking upstream), showing the bedrock channel downstream of the dam.*

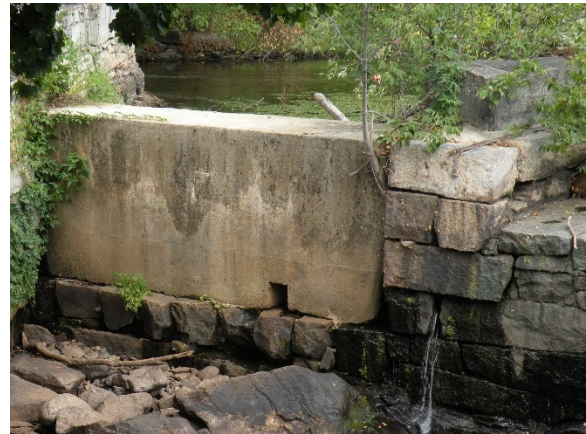
Historical plans of the dam showing evidence of the former fishway are shown in **Figures 2.1.2-2, 2.2.3-9 and 2.2.3-10**. The fishway was reportedly filled with concrete sometime after the 1960s, rendering it useless and obscuring its original appearance (Ingraham, 1995). However, based on the historic plans and reports, it is likely that the former fishway was simply an opening in the dam through which fish could swim under suitable flow conditions. The most probable location is the portion of the right spillway abutment currently comprised of concrete (pictured at right). The granite capstones under the concrete “plug” likely formed the sill over which fish swam. The concrete plug (and the assumed former fishway opening) is about 16 feet wide by 6.5 feet high with a bottom elevation (top of the granite sill under the concrete plug) of approximately 104.3 feet NAVD 88. The opening was probably fitted with wooden stoplogs or a gate structure (as suggested by the wood line across the fishway opening in **Figure 2.2.3-10**) so that it could be closed at times of the year outside of the mandated fish migration period (which was noted in the Act of 1820 above as April 1<sup>st</sup> through May 20<sup>th</sup>). The small notch in the bottom of the concrete plug may have been formed by a remnant of a wooden structure associated with the fishway that has since rotted away. The fishway opening could have also been used to draw down the impoundment (e.g., to inspect or repair the dam) or help reduce

upstream flooding, as noted in historical accounts, such as: “The fish-way was used to keep the water down, before and after the new [1828] Dam” (MA House of Representatives, 1860, page 272). It is unknown how effective the former fishway was at providing for upstream fish passage under the range of flows experienced during the migration period.

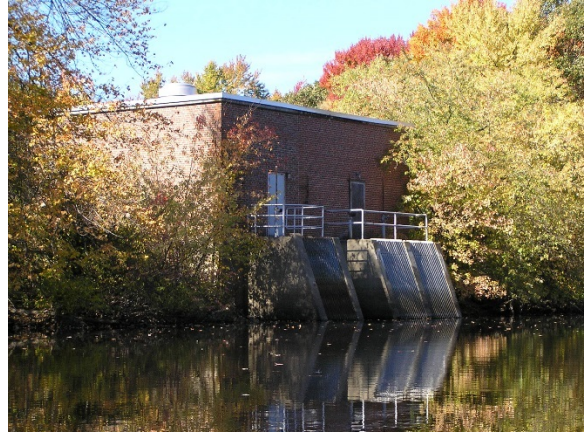
The water supply intake (pictured at right) is located approximately 6,700 feet (about 1 ¼ miles) upstream of the Talbot Mills Dam (about 1,200 feet downstream of the Route 3A/Boston Road bridge), which is within the dam's impoundment<sup>41</sup>. The intake structure was built in 1955 and consists of a screened wet well and three pumps used to withdraw water from the river (J. McGovern, personal communication, 2014). **Figure 2.3.2-1** provides an excerpt from the 1954 engineering plans for the intake structure showing the following key elevations:<sup>42</sup>

- Maximum flood elevation = 117.2 feet NAVD 88
- Normal high water elevation = 113.2 feet NAVD 88
- Minimum low water elevation = 107.2 feet NAVD 88
- Structure invert elevation = 102.2 feet NAVD 88

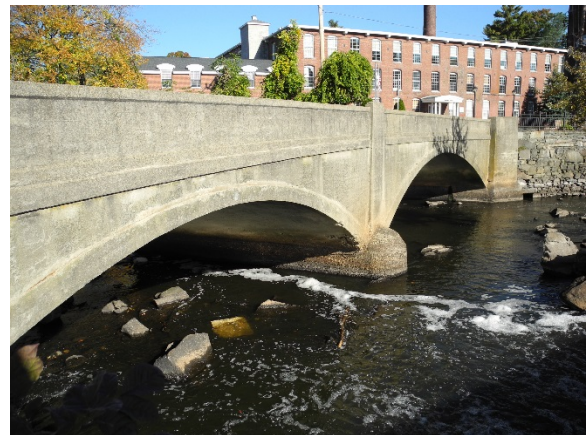
The Faulkner Street bridge is located immediately downstream of the Talbot Mills Dam. The left bridge abutment is directly connected to the left spillway abutment, while the right bridge abutment is connected to the right spillway abutment by an approximately 100-foot-long stone masonry retaining wall. The curved concrete double arch structure was constructed in 1910 and is approximately 106 feet long, 32 feet wide, and has two individual spans about 42 feet wide at the base separated by a center pier (FEMA, 2014; Geotechnical Consultants, 2015). The center pier and abutments appear to be armored and founded directly on bedrock, and no significant indications of scour have been observed during inspections (Geotechnical Consultants, 2015).

No plans for the Faulkner Street bridge could be found on file with the Town of Billerica or the Massachusetts Department of Transportation (DOT).

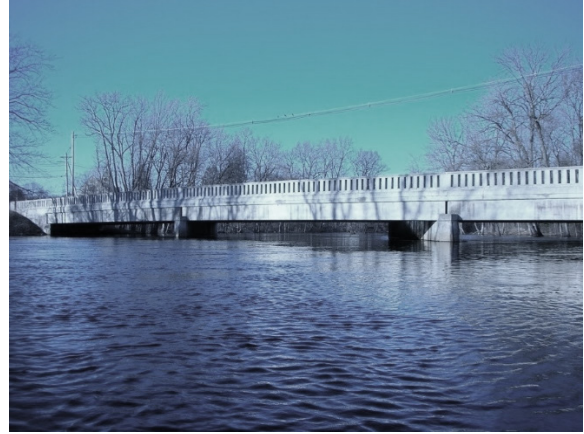
The Pollard Street bridge (State Bridge No. B-12-5) is located approximately 2,935 feet upstream of the Talbot Mills Dam. The 1998 concrete structure has an overall span of about 182 feet, with two 4-foot-wide piers set 62 feet apart on center and a deck width of approximately 48.8 feet. The bridge reportedly passes over the Fordway Bar, a natural bar of hard gravel that is about 700 feet in length, stretching between points approximately 2,700 to 3,400 feet upstream of the dam (see **Section 2.1.2**), and in fact used to be known as the Fordway Bridge. According to an 1861 survey, the elevation of the Fordway Bar is about 107.2 feet NAVD 88. The channel bottom immediately downstream of the Pollard Street bridge was re-surveyed for the 2014 FIS, and was found to have a minimum channel elevation of 106.59 feet NAVD 88. Since the midpoint of the Fordway Bar is reported to be about 100 feet above the bridge, it is likely that the highest point of the bar feature lies somewhere upstream as reported by the 1861 survey; however, this was not confirmed as part of this study. A bridge was present at this site as early as 1659, but after being rebuilt several times and carried away by a flood in 1699, it was not rebuilt for almost 200 years until 1893. The predecessor to the current structure was built in 1912 and represented the best known early example of a continuous multi-span reinforced concrete T-beam bridge in Massachusetts (NPS, 1996). The present bridge was designed with piers that are better aligned with the flow of the river, which may have contributed to lower peak flood elevations observed upstream of the bridge for larger floods (E. Reiner, personal communication, February 4, 2016).

Plan and profile views of the Pollard Street bridge are shown in **Figure 2.3.3-1**. Boring logs are provided in **Figure 2.3.3-2**. According to the boring data, it appears that the bridge abutments and piers are founded on dense to very dense substrates that are likely not particularly susceptible to erosion to due scour.

Upstream of the dam, nine bridges cross the impoundment, including the Pollard Street and Boston Road/Route 3A bridges within 1 ½ miles upstream. The hydraulic modeling results show that if the dam were removed, the water surface elevation is predicted to drop about 1.2 to 1.6 feet at the Pollard Street bridge under the 2- and 100-year floods, respectively, with velocities increasing approximately 25% (to 3.0 and 4.4 ft/s, respectively). This could present a moderate risk for scour at the Pollard Street bridge. If dam removal progresses to the next level of feasibility analysis, a sediment transport study could be conducted in which the grain size of the sediment under the bridge would be characterized and the potential for predicted water velocities to transport or “scour out” the sediment in the area of the bridge piers/abutments would be evaluated. Additionally, visual inspection and probing could be conducted around the bridge piers/abutments to confirm whether the dense substrates indicated by the boring logs (**Figures 2.3.3-2 and 2.3.3-3**) are present and would reduce the risk for scour.

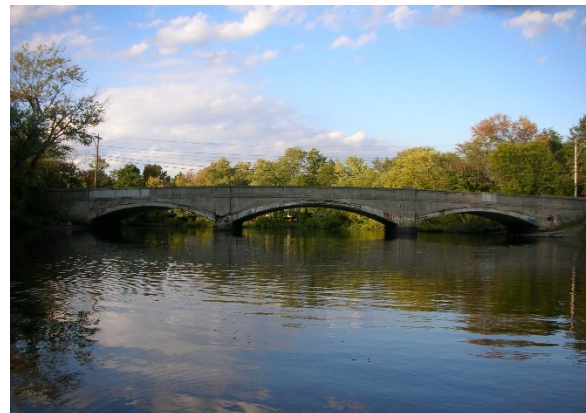
The Boston Road/Route 3A bridge (State Bridge No. B-12-003) is located approximately 1 ½ miles upstream of the Talbot Mills Dam. The 1920 triple arch concrete structure has an overall length of about 180 feet and a deck width of approximately 39.2 feet. It has a 65-foot-wide center arch flanked by two 50-foot wide arches. The bridge has received various repairs over the years. According to the DOT's list of scheduled projects, it is currently in the preliminary design phase for approximately \$4 million worth of rehabilitation work (DOT, 2015).

Plan and profile views of the Boston Road/Route 3A bridge are shown in **Figure 2.3.3-4**. Boring logs are provided in **Figure 2.3.3-5**. According to the boring data, it appears that the bridge abutments and piers are founded on very hard sand and gravel substrates and boulders that are likely not particularly susceptible to erosion to due scour.

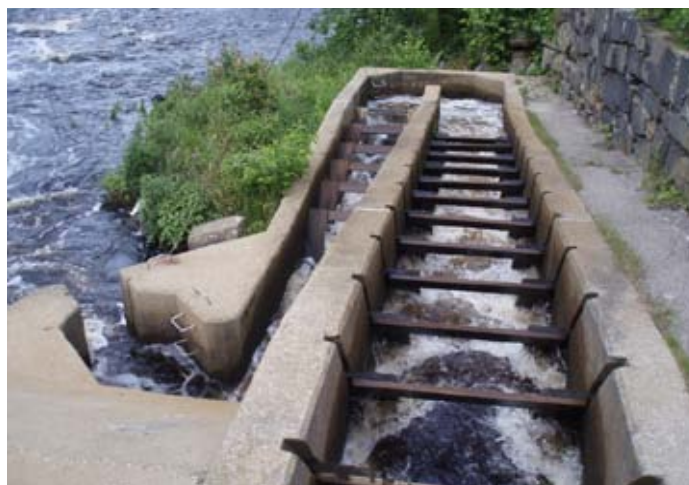
Standard Denil fishway schematic (left) and example (right) at Potter Hill Dam, Pawcatuck River, Westerly, RI.

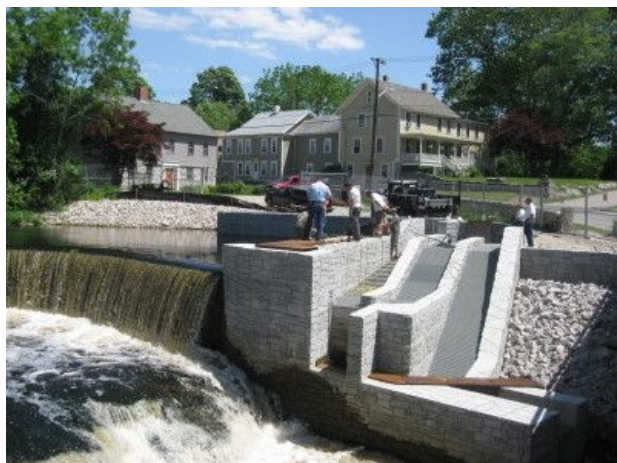
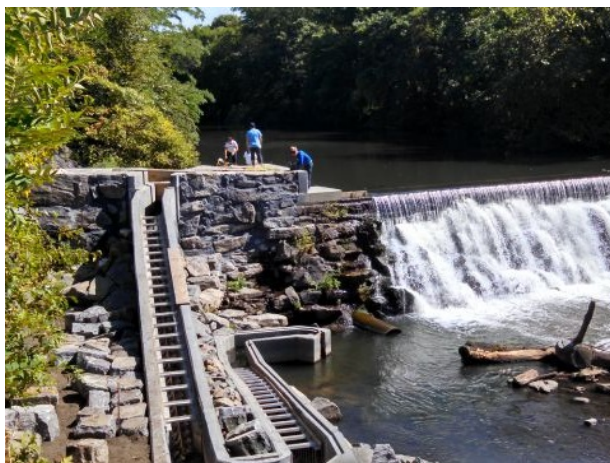
*Examples of fish ladders installed at historic dams: A Denil ladder with integrated eelway at Horseshoe Falls Dam on the Pawcatuck River in Shannock Village, Rhode Island (left) and a steep pass (with eel ramp later added) at East 182<sup>nd</sup> Street Dam on the Bronx River in Bronx, NY (right).*

Fish ladders can be fabricated from many different materials including concrete, metal, and wood. Concrete in particular lends itself to custom modification to blend with surrounding structures, such as historic stone masonry. Below are several examples of fishways installed at historic dams where aesthetics were a primary concern for stakeholders, including a detail of concrete stamped and stained to match existing stone masonry as a requirement of a Section 106 historical consultation process.

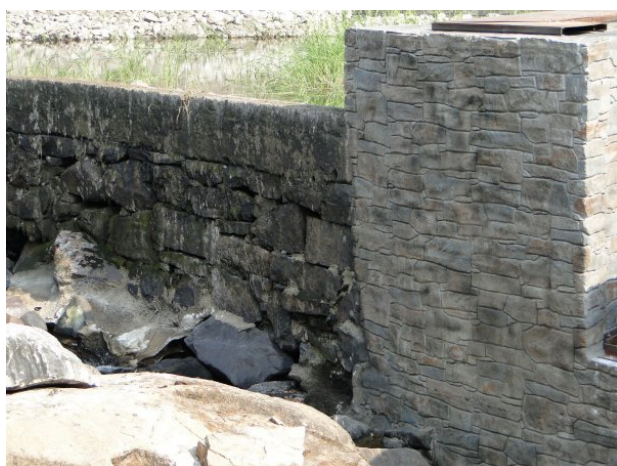
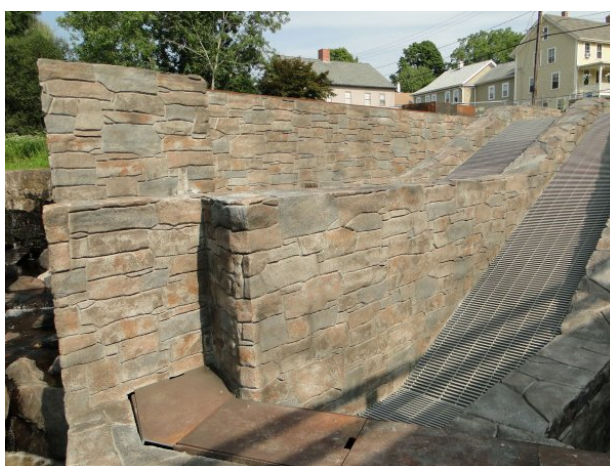
*Example of a concrete Denil fish ladder stamped and hand-stained to match existing stone masonry of a historic dam spillway as a requirement of the Section 106 consultation process for the Horseshoe Falls Dam on the Pawcatuck River in Shannock Village, Rhode Island.*

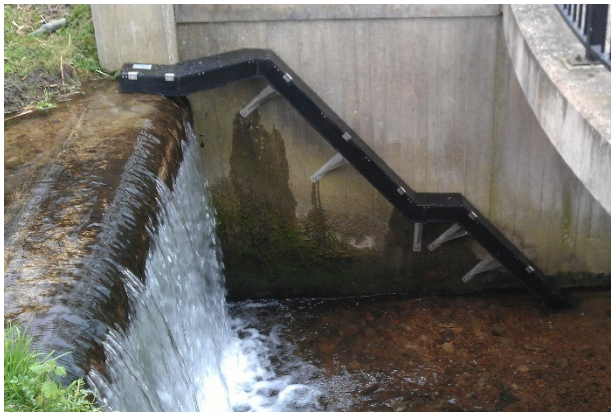
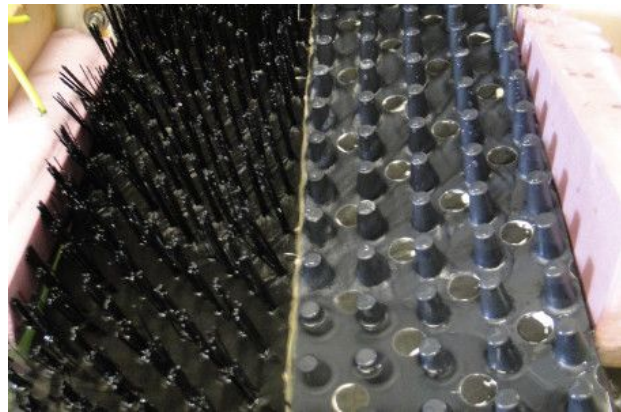
*Example of a simple full-height eel ramp exiting to the headpond (left) and close-up of dual substrate types (right).*

Selection of an appropriate design for an eel pass structure is dependent on habitat, size, and life history stage of the eels to be passed. Occasionally a simple structural modification is implemented by roughening or attaching substrate to the downstream face of the dam or other barrier to enhance the eels' ability to climb directly over the barrier, but these solutions are generally only practical for low-head dams (less than about 6 feet) to minimize the climbing distance and exposure to predators. More often, a separate eel pass is used. The most common design is a ramp furnished with a climbing medium, such as artificial mesh or brushes, which gives eels something to climb through or over. The size of the substrate must be carefully matched to the size range of eels to be passed at the site; sometimes a mix of substrates is used to target a broader range. Typically, small amount of flow is directed down the ramp to create a constantly wetted climbing surface, and attraction flow is supplied at the entrance. Water depth over the ramp is carefully balanced to accommodate ascending eels while preventing the flushing of small eels down the ramp by excessive flow. A lateral slope can be incorporated into the design (as shown in the figure at right) to provide a constant wetted margin along the climbing substrate under a range of conditions from low (left in figure) to high (right in figure) headpond levels. The ramp is typically covered to protect eels from birds and other predators (Gulf of Maine Council on the Marine Environment, 2007; Brownell et al., n.d.).

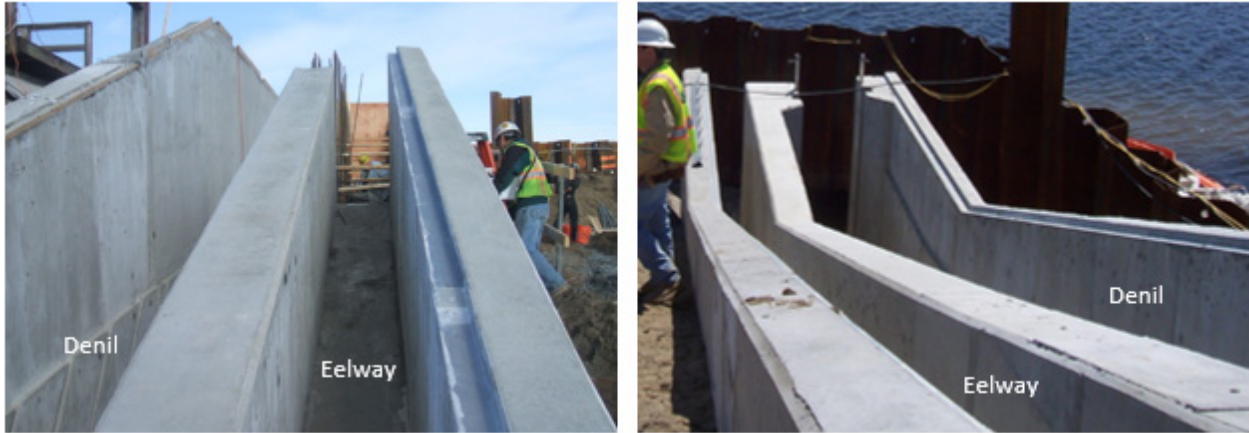
*Example of an eel ramp incorporated into a concrete Denil fishway at Upper Mystic Lake Dam in Massachusetts.*

An eelway can also be incorporated into the design of a traditional fish ladder, such as a Denil, as shown in the images below and in the Horseshoe Falls Dam fish ladder example shown above.
