APPENDIX B

Photographs

Concord River Diadromous Fish Restoration Feasibility Study

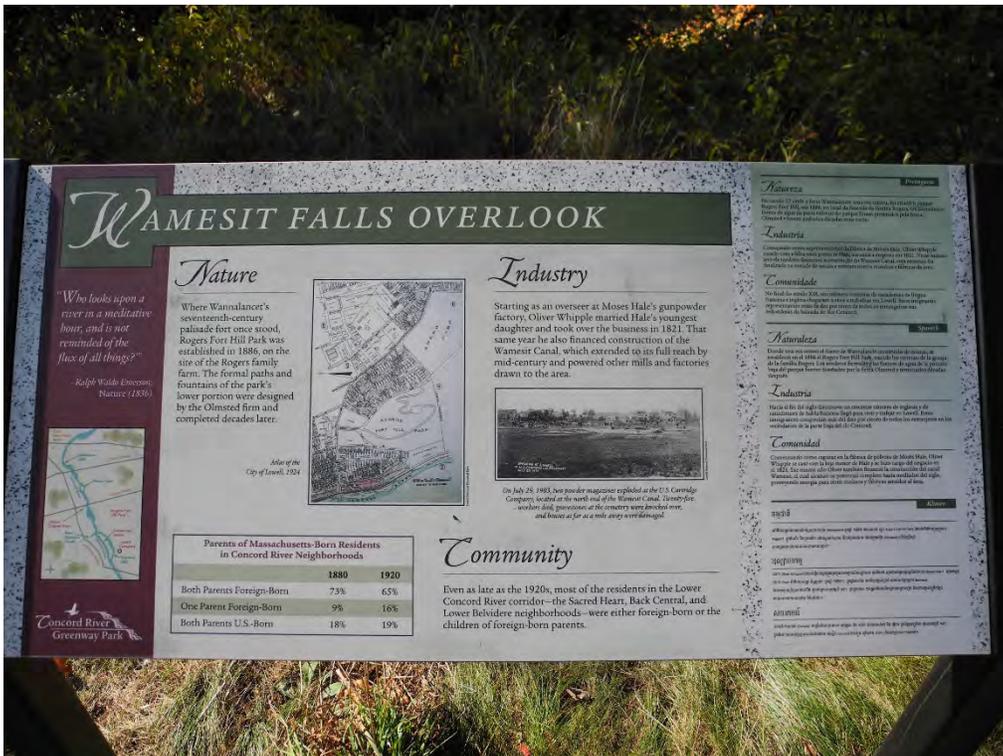
Photo 20: Centennial Falls Dam – Interpretive Sign

Interpretive sign on trail adjacent to dam (GSE, 10/6/14)

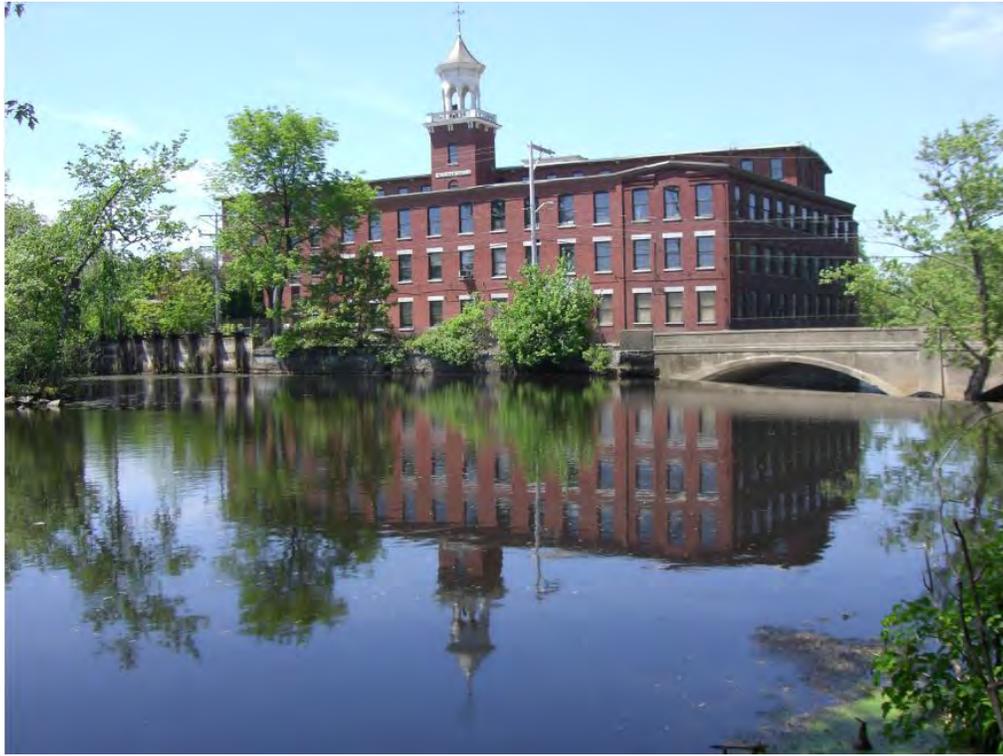
Photo 47: Talbot Mills Dam – Mill Buildings

View of Talbot Mill from across impoundment; spillway on right (Geotechnical Consultants, 2015)

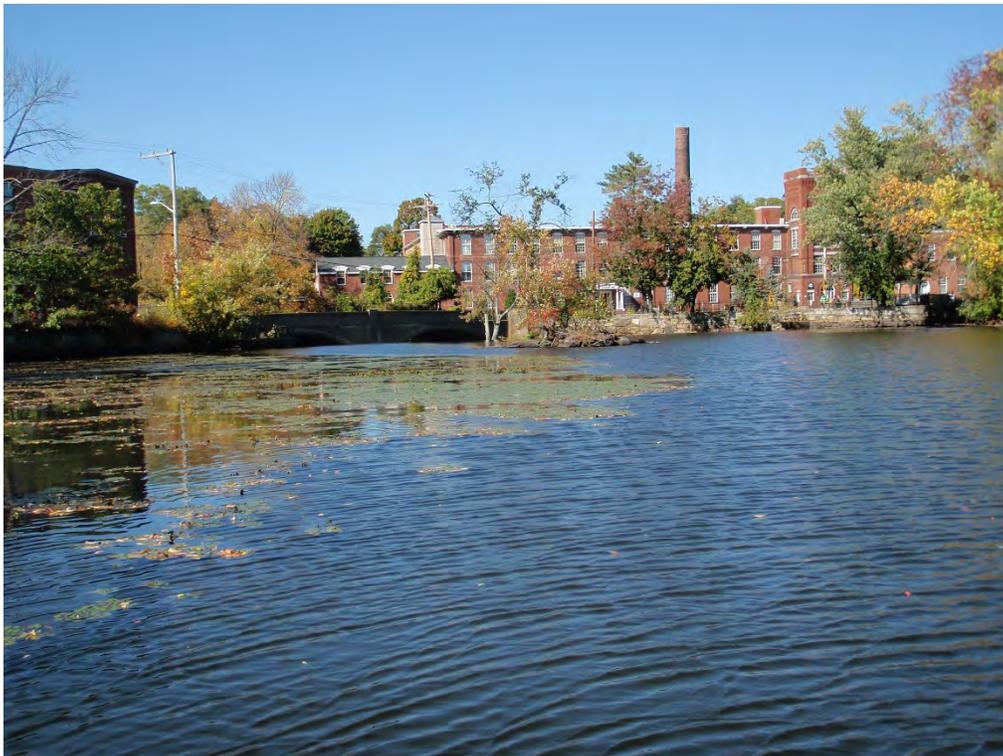
Photo 48: Talbot Mills Dam – Mill Buildings

View of Faulkner Mill from across impoundment (GSE, 10/6/14)

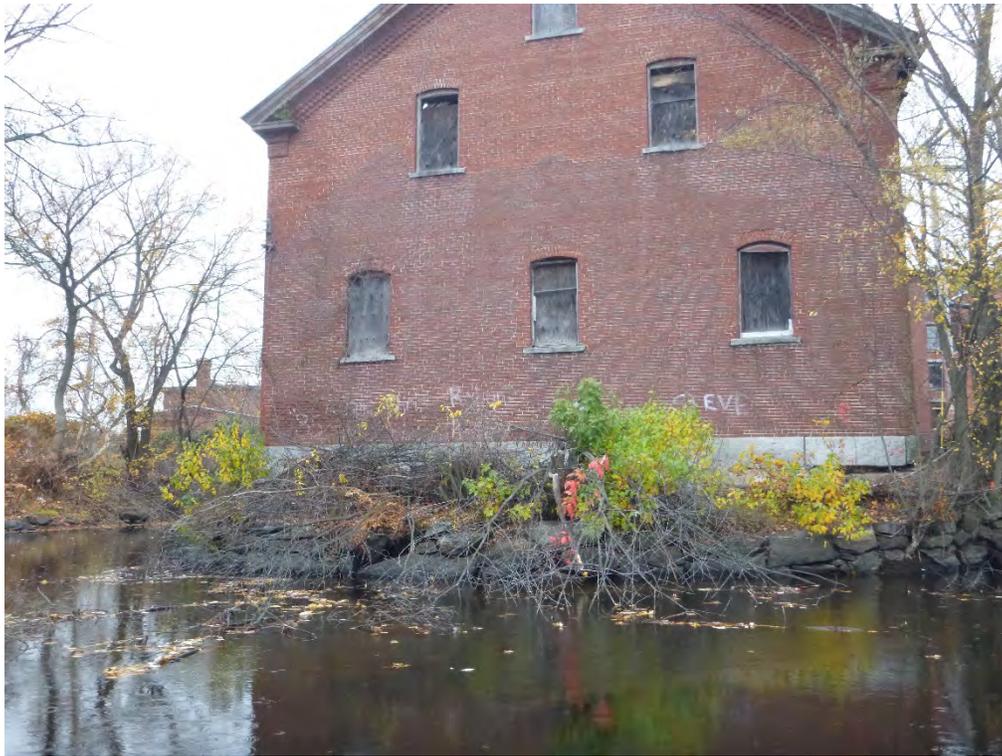
Photo 49: Talbot Mills Dam – Mill Buildings

Former Talbot cloth warehouse and future home of MCA Middlesex Canal Museum (GSE, 11/6/14)

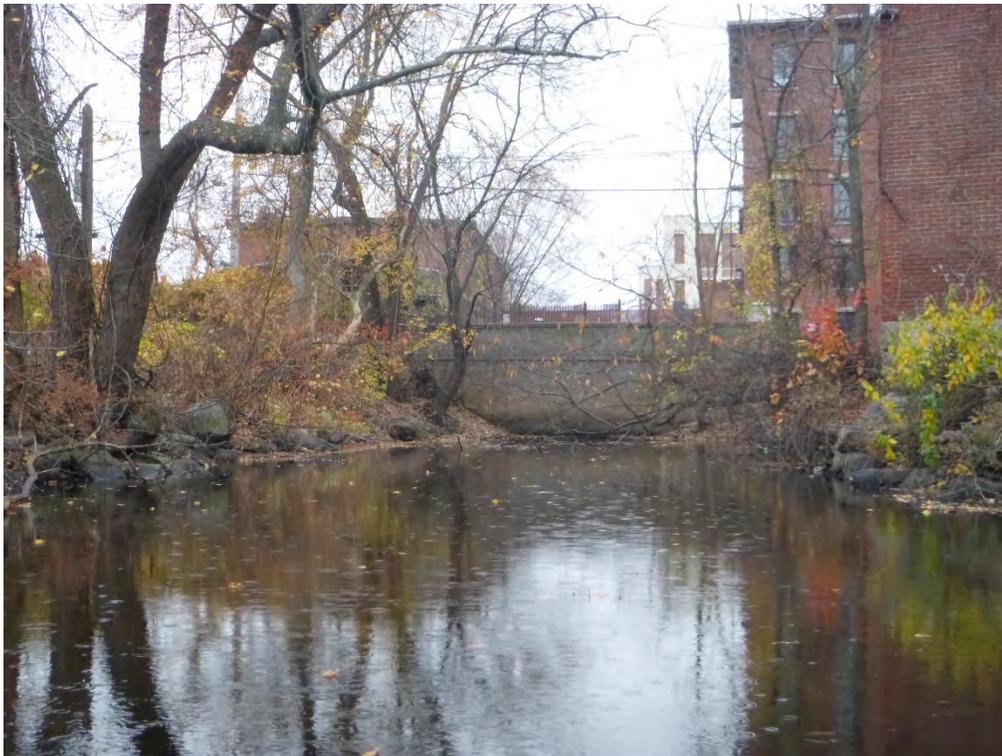
Photo 50: Talbot Mills Dam – Middlesex Canal

Wetted Segment 24 of Old Middlesex Canal adjacent to former Talbot cloth warehouse (GSE, 11/6/14)

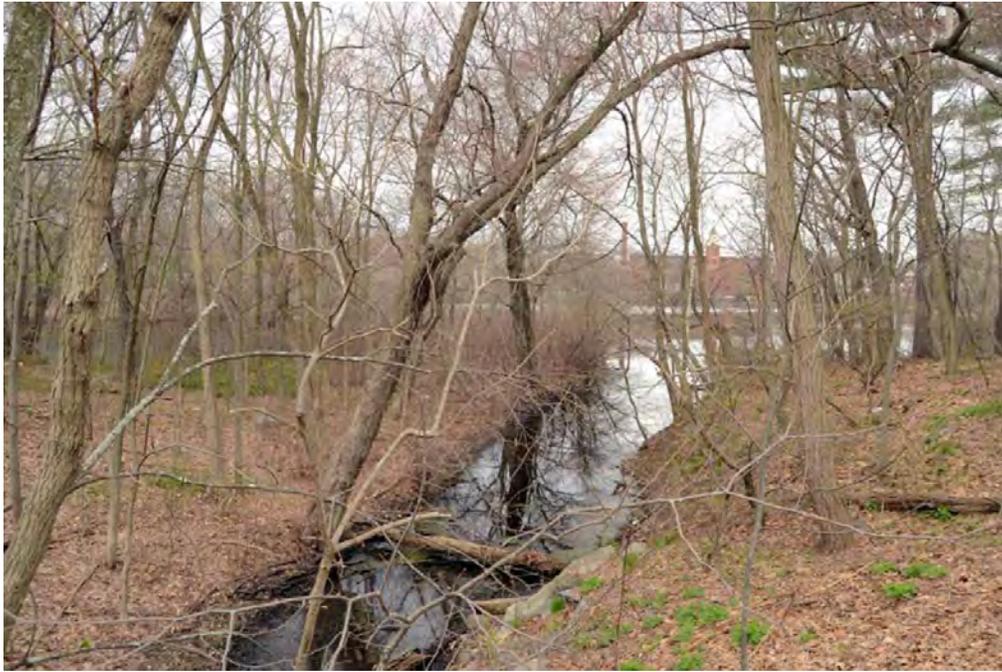
Photo 51: Talbot Mills Dam – Middlesex Canal

Wetted Segment 24 of Old Middlesex Canal on east side of impoundment, looking towards dam (PAL, 2015)

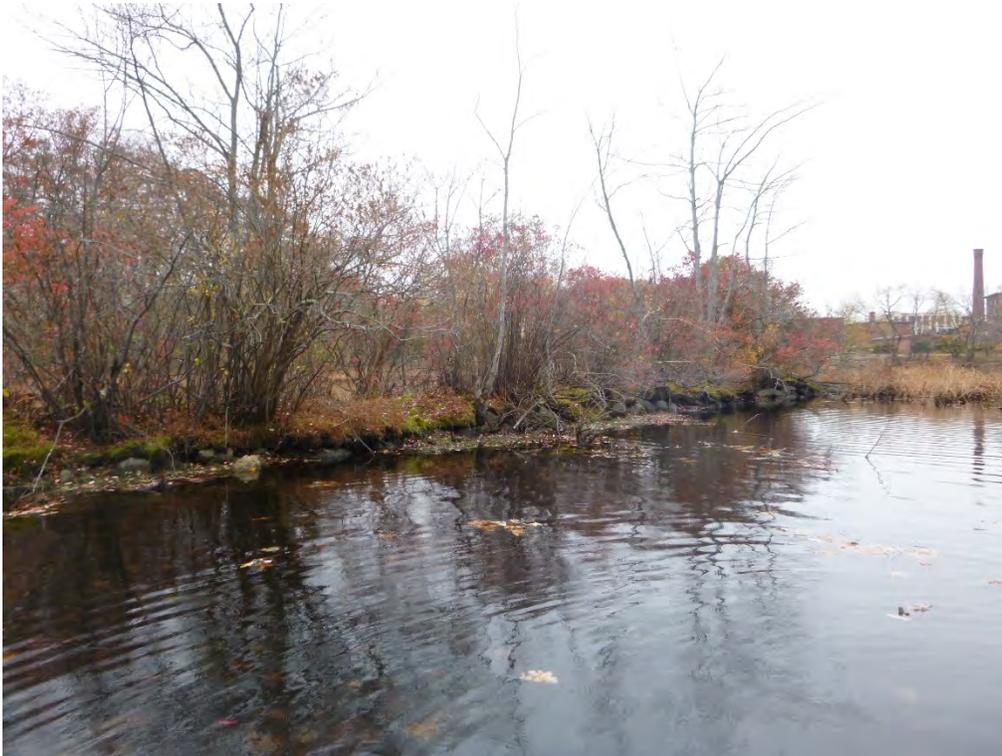
Photo 52: Talbot Mills Dam – Middlesex Canal

Historic floating towpath peninsula (GSE, 11/6/14)

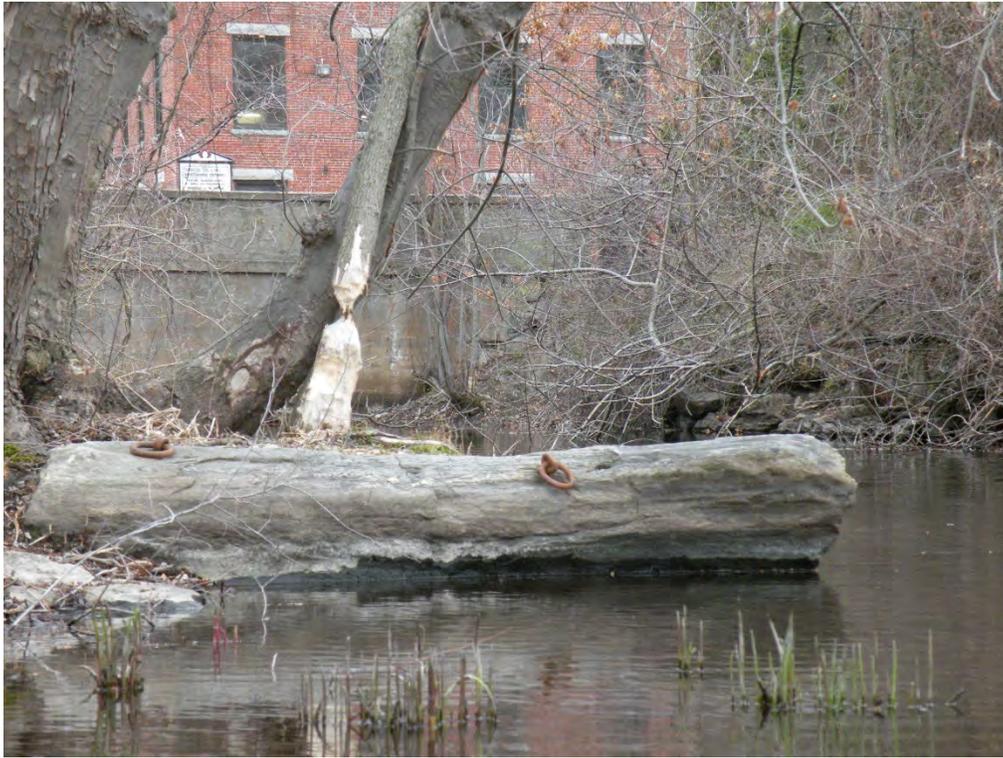
Photo 53: Talbot Mills Dam – Middlesex Canal

Historic floating towpath anchor stone (adjacent to former Talbot cloth warehouse) (Reiner, 4/1/12)

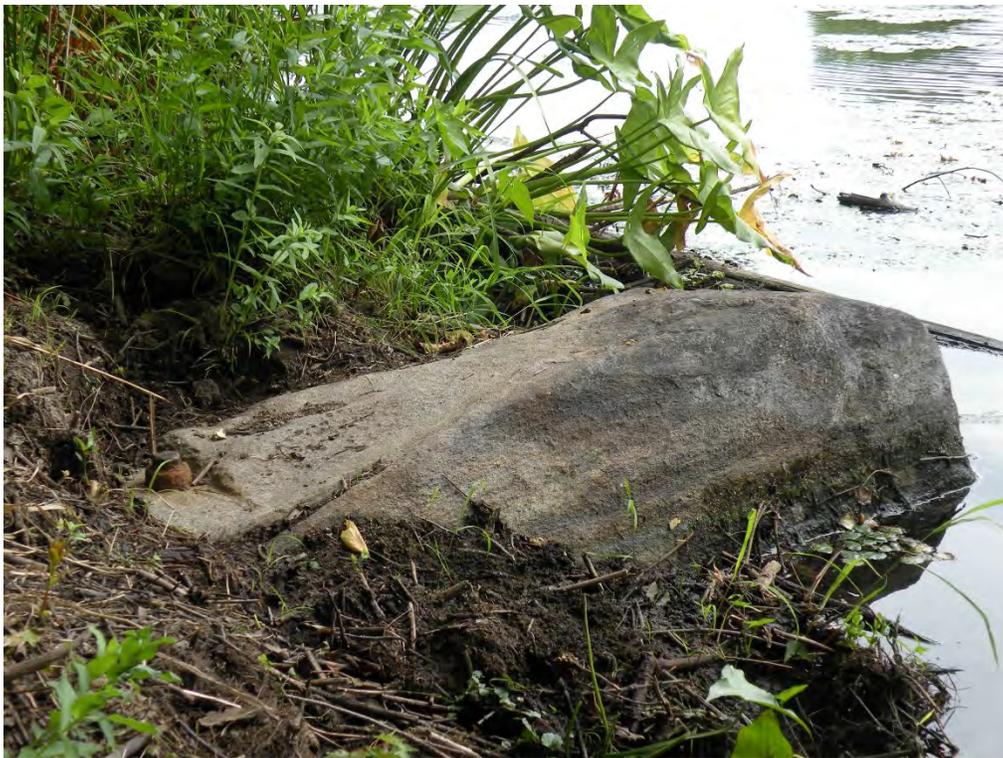
Photo 54: Talbot Mills Dam – Middlesex Canal

Historic 1825 iron bolt benchmark (el. 108.81 ft NAVD 88) on east shoreline of impoundment (Reiner, 8/16/10)

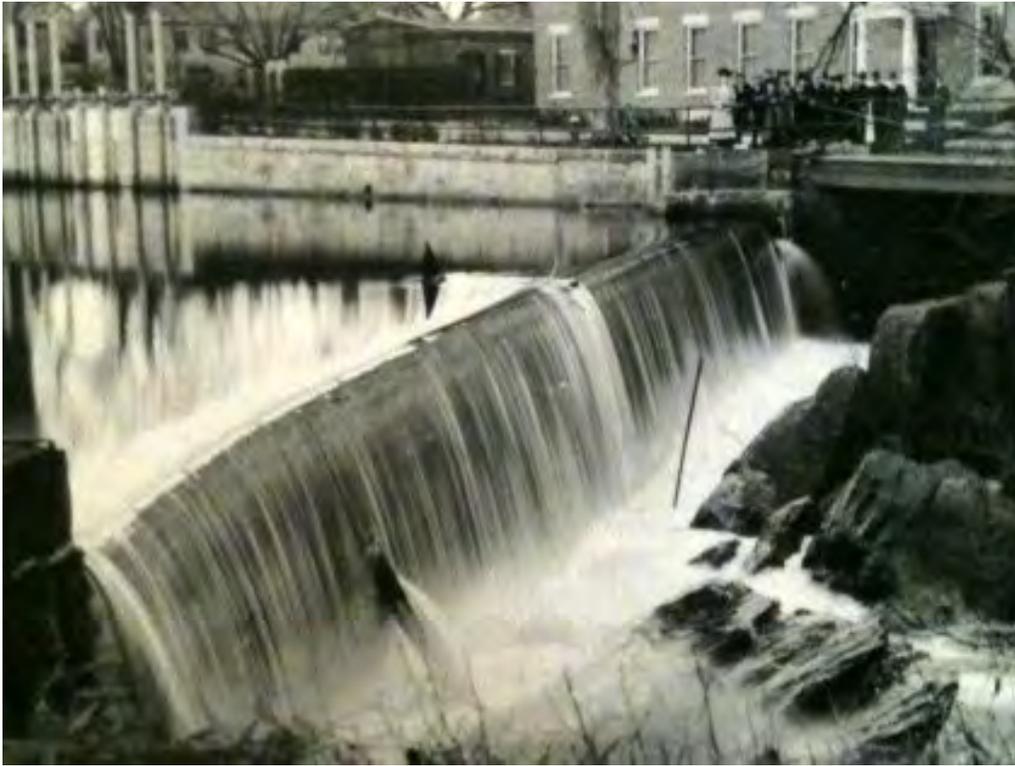
Photo 61: Talbot Mills Dam – Historical Photo

1907 historical postcard view from river right bank (Billerica Historical Society, 2003)

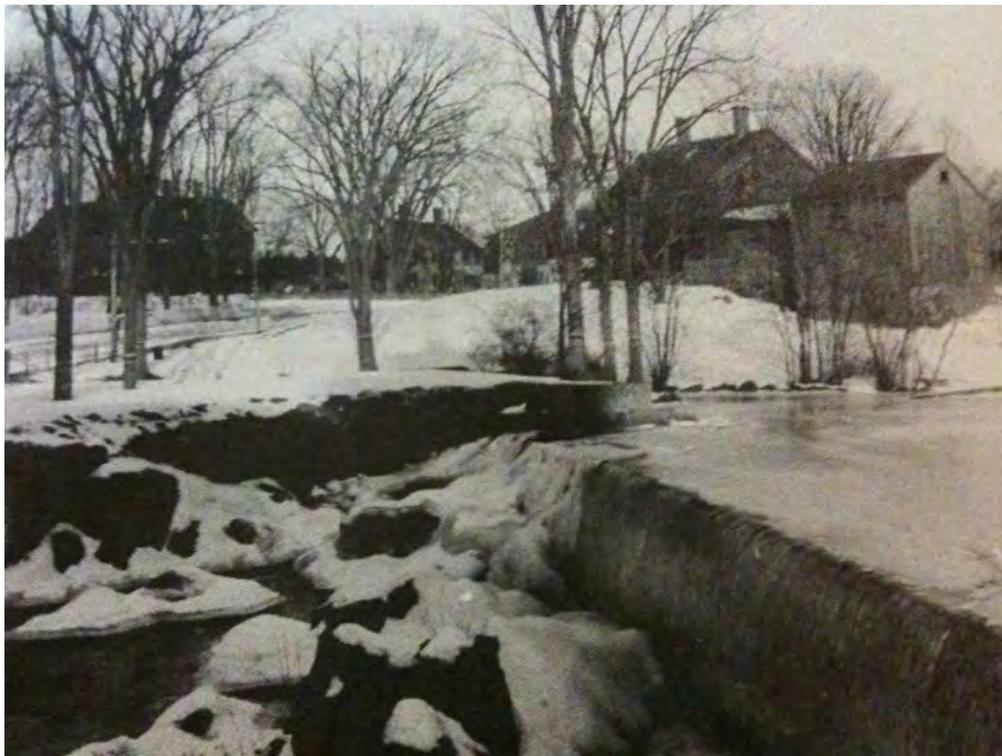
Photo 62: Talbot Mills Dam – Historical Photo

Circa 1900 historical postcard view from Faulkner Street bridge (Billerica Historical Society, 2003)
