Compliance Inspection Report
Helmet Creek Restoration
Adak Petroleum Diesel Spill

January 10, 2014

Polaris Applied Sciences: on behalf of Adak Petroleum LLC

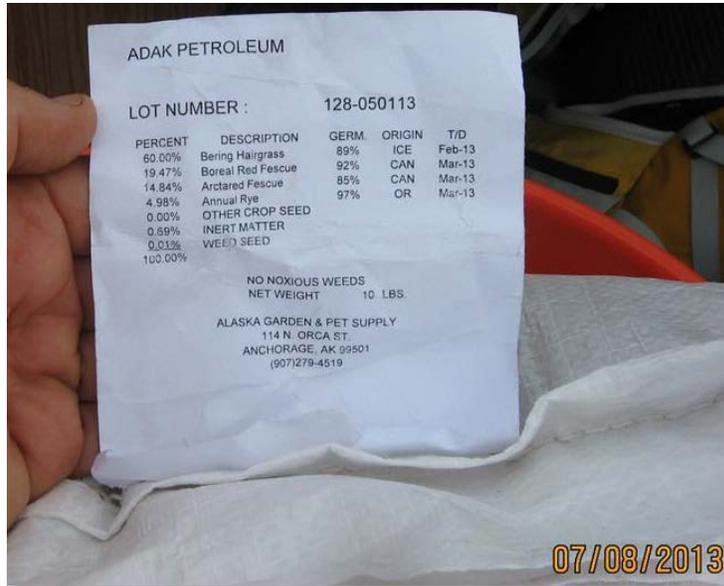
The *Approved Vegetation Mix* identified for this project was developed by the Alaska Plant Materials Center for use in reclamation at various upland landfill locations on Adak Island (Alaska 2011 in RP report). Ten pounds of the seed mix used on the site was obtained from Alaska Garden & Pet Supply, Inc in Anchorage (Figure 16). The seed mix was applied at a rate of approximately 40 lbs/acre (1 lb/1000 sq.ft.) as recommended by the Alaska Plant Materials Center for the type of sandy soils found adjacent to Helmet Creek. No fertilizer was applied due to the proximity of the restoration work to the creek channel. At many locations, dead vegetative material was spread over the recently seeded area to keep the underlying soil moist.

Figure 16: Label from Approved Vegetation Mix

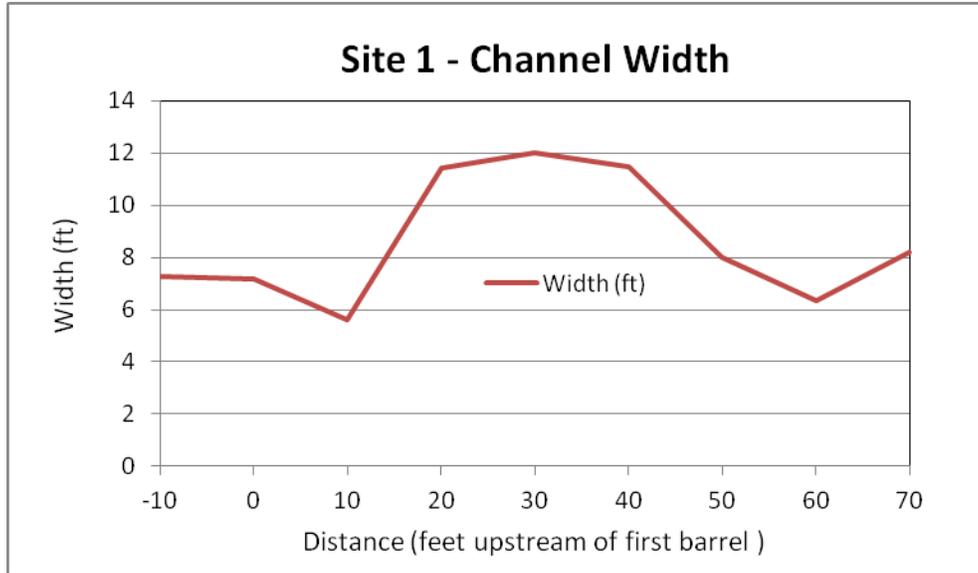
Photo points were established (Figure 12) and a visual assessment of stream bed and stream bank integrity looking downstream and upstream over the area of removal was completed (Figure 20). Stream width was measured through the restoration area (Figure 21). Monitoring frequency for this assessment will be every monitoring year. Vegetation monitoring for this area is covered in Section 6v.

Figure 21: Site #1 – Post Construction channel width measurements

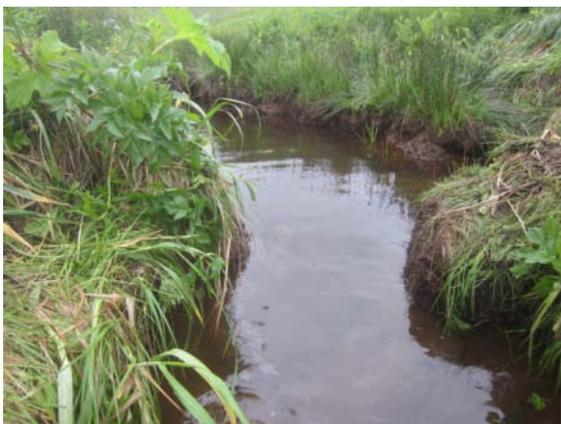
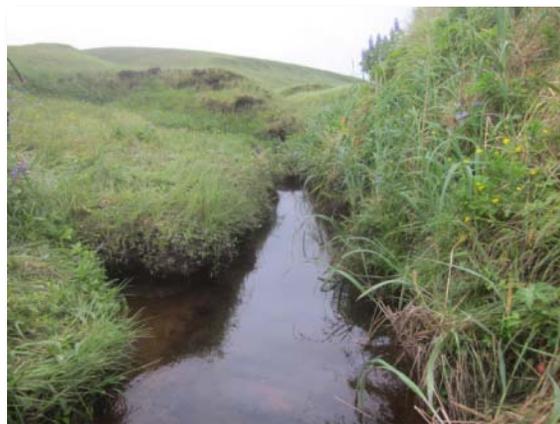
- Photo points were established (Figure 13 – Site #2; Figure 14 – Site #3) and a visual assessment of stream bed and stream bank integrity looking downstream and upstream over the area of removal was completed (Figure 22 – Site #2; Figure 23 – Site #3). Monitoring frequency for this assessment will be every monitoring year.

Figure 22: Site #2 – Post Construction looking upstream (L) and downstream (R)

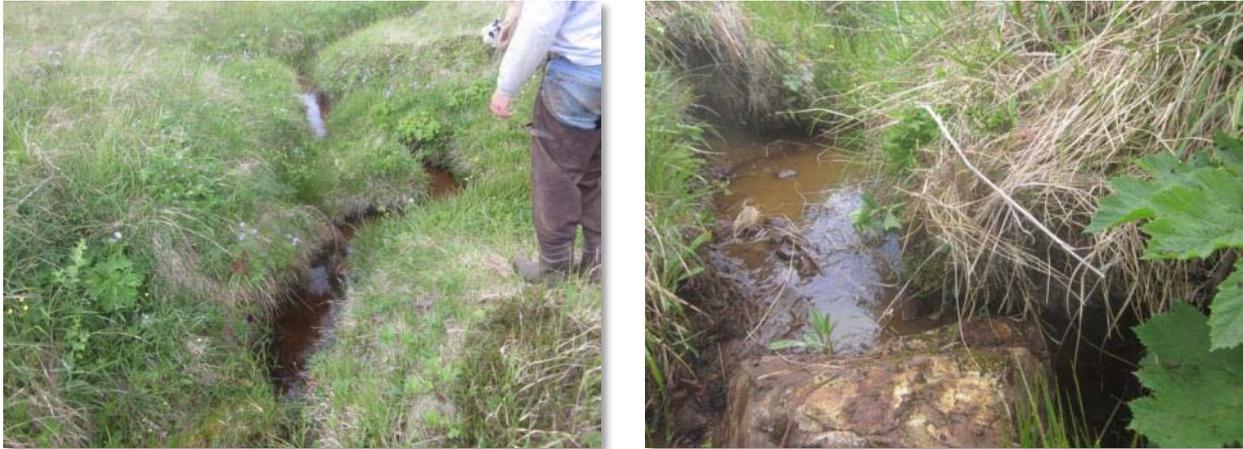
Figure 23: Site #3 – Post Construction looking upstream (L) and downstream (R)
